MIDDLE EAST TECHNICAL UNIVERSITY
EARTHQUAKE ENGINEERING RESEARCH CENTER

**THE OCTOBER 30, 2020
İZMİR-SEFERİHİSAR OFFSHORE (SAMOS)
EARTHQUAKE ($M_w=6.6$)
RECONNAISSANCE OBSERVATIONS
AND FINDINGS**

REPORT NO: METU/EERC 2020-03

**NOVEMBER 2020
ANKARA**

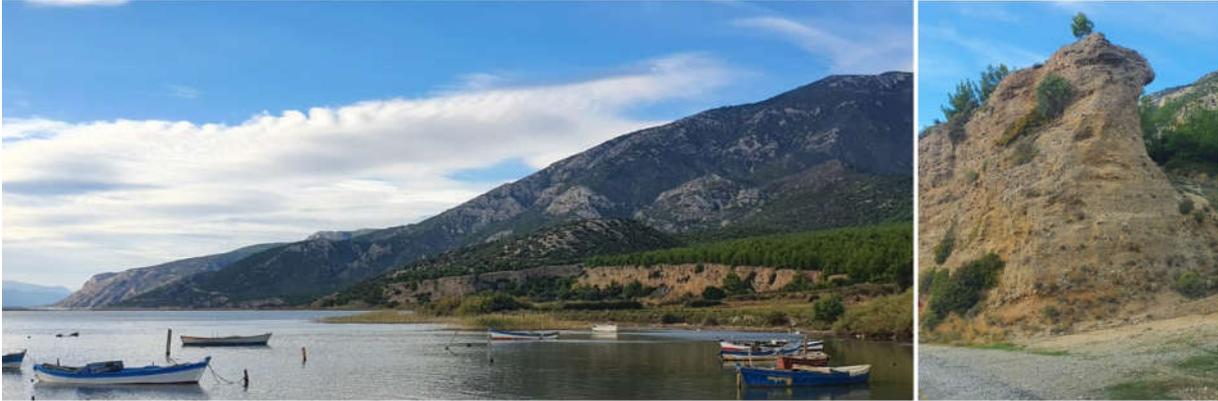
Fig 2.4 Photos taken at the southern side of Dilek Peninsula showing uplifted terrace deposits

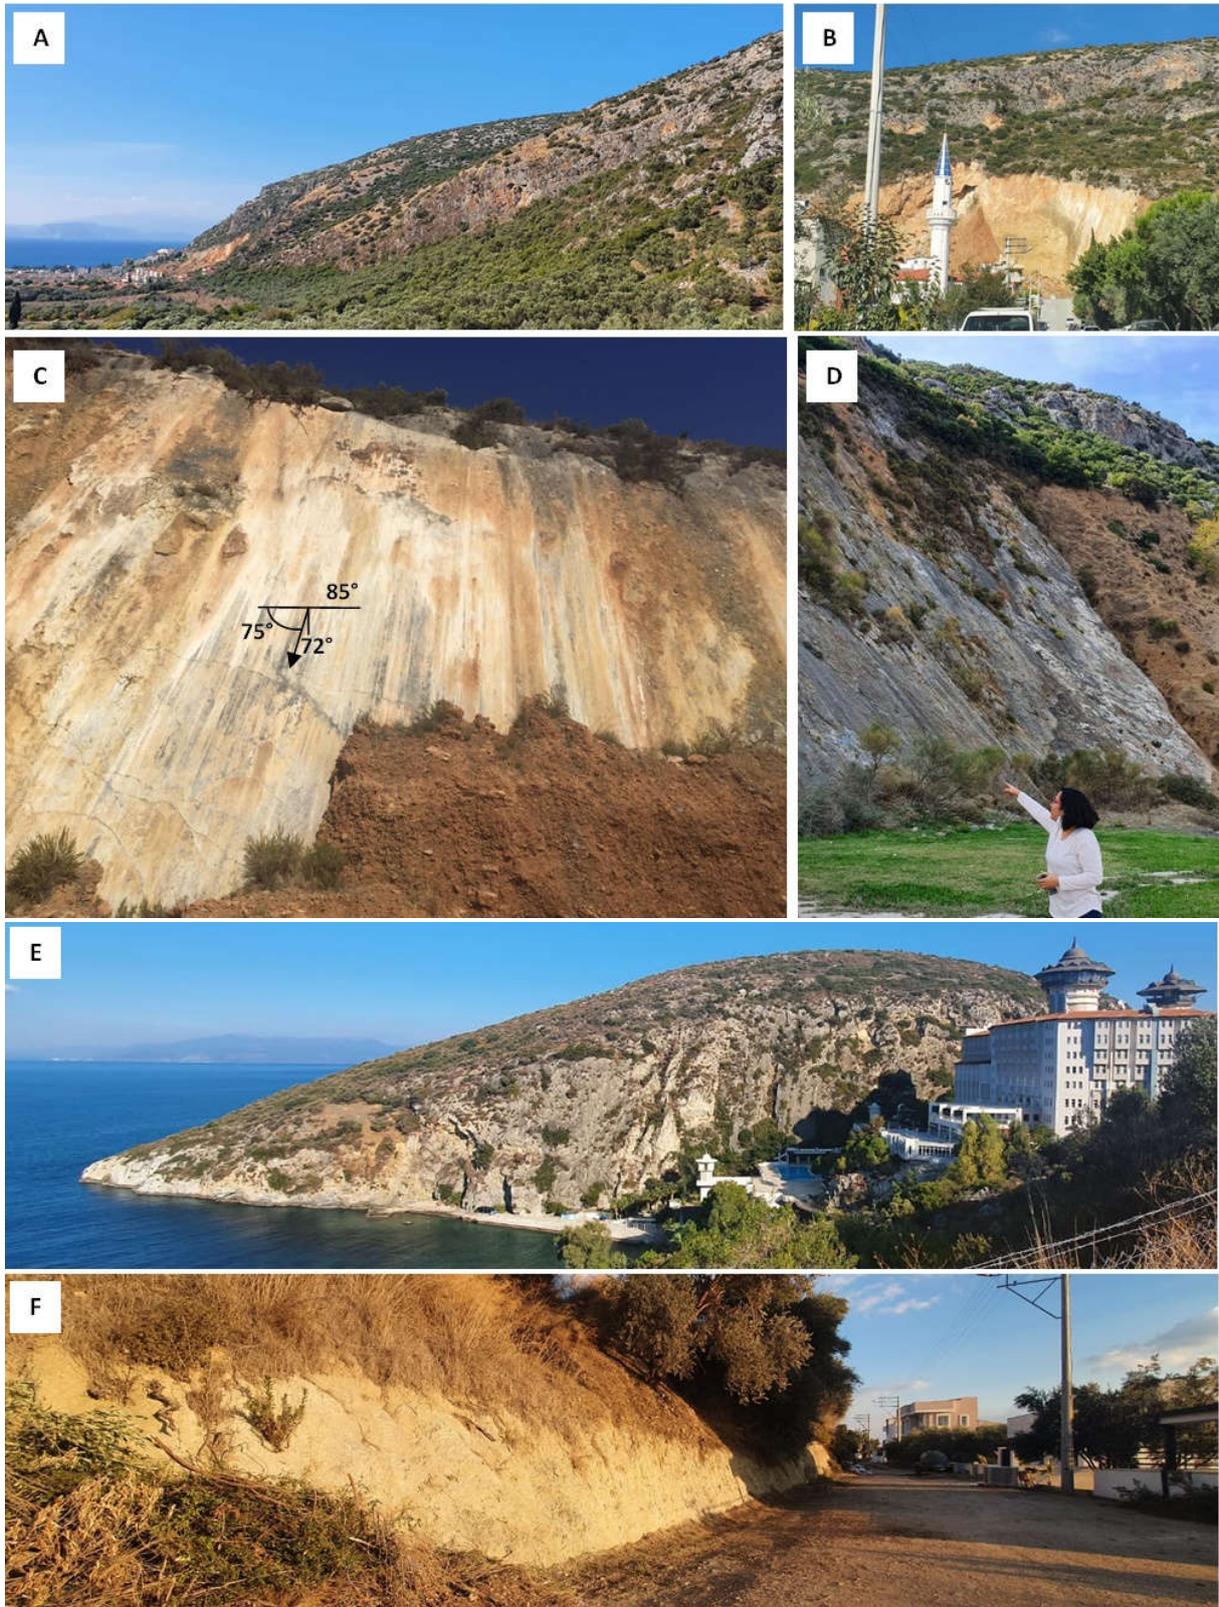
scarps were quite close to residential buildings (e.g. Fig 2.5b, e, f); however, no structural damage was identified in the nearby structures.

Fig 2.5 Active fault observations. Photos of south dipping normal faults near Kuşadası are given in a, b,c and e; Ephesus fault is in d and Gümüldür fault in f

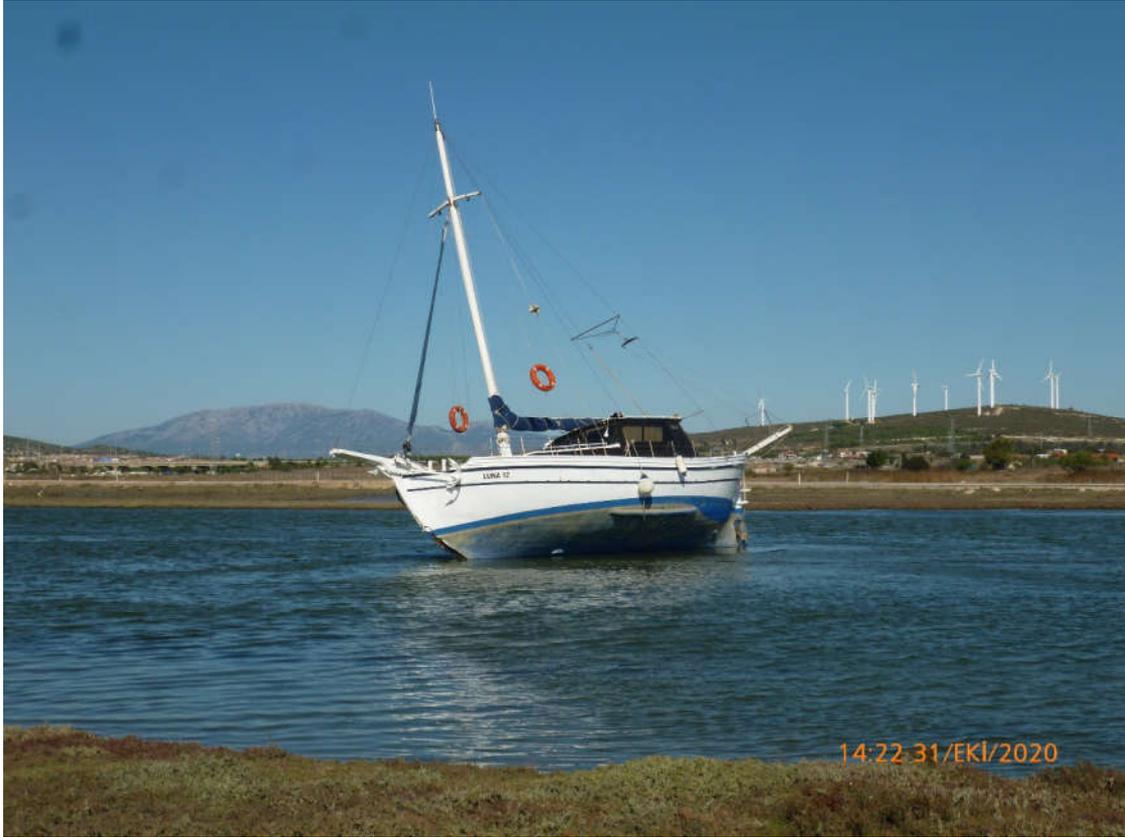
Fig 4.3 Fisher boat on Alaçatı Azmak which was dragged 1162 m away from the shoreline (at 14:22 Local Time on 31 October 2020)

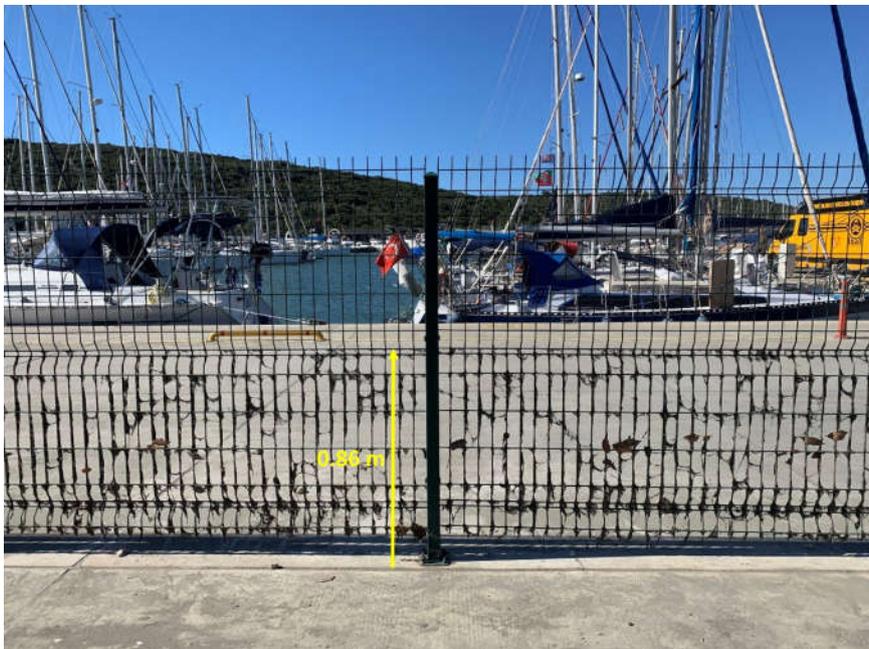
Fig 4.4 Tsunami traces on the garden fence of Teos Marina

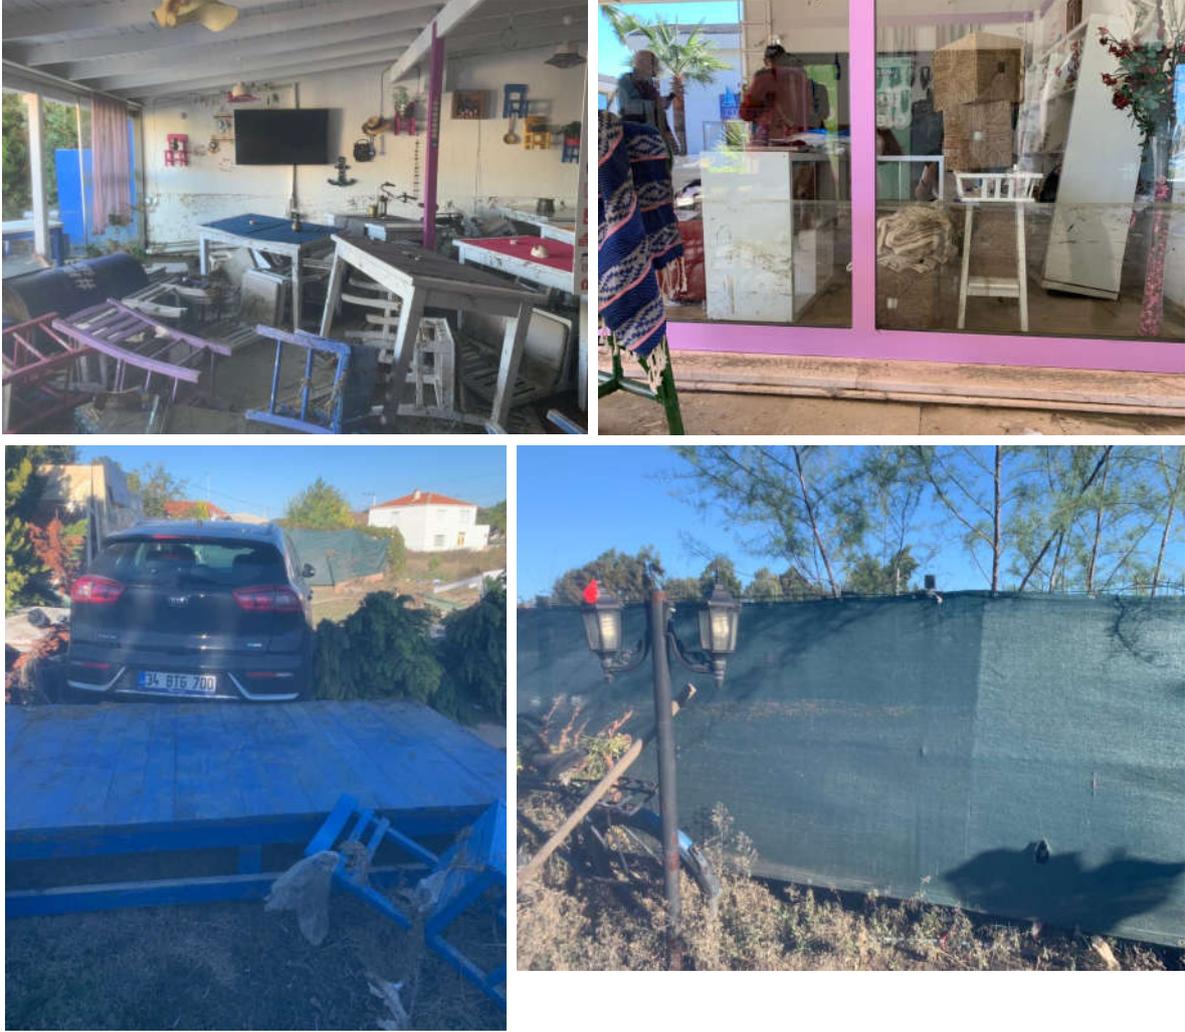
Fig 4.5 Damage and tsunami traces in cafes and shops in Sığacık

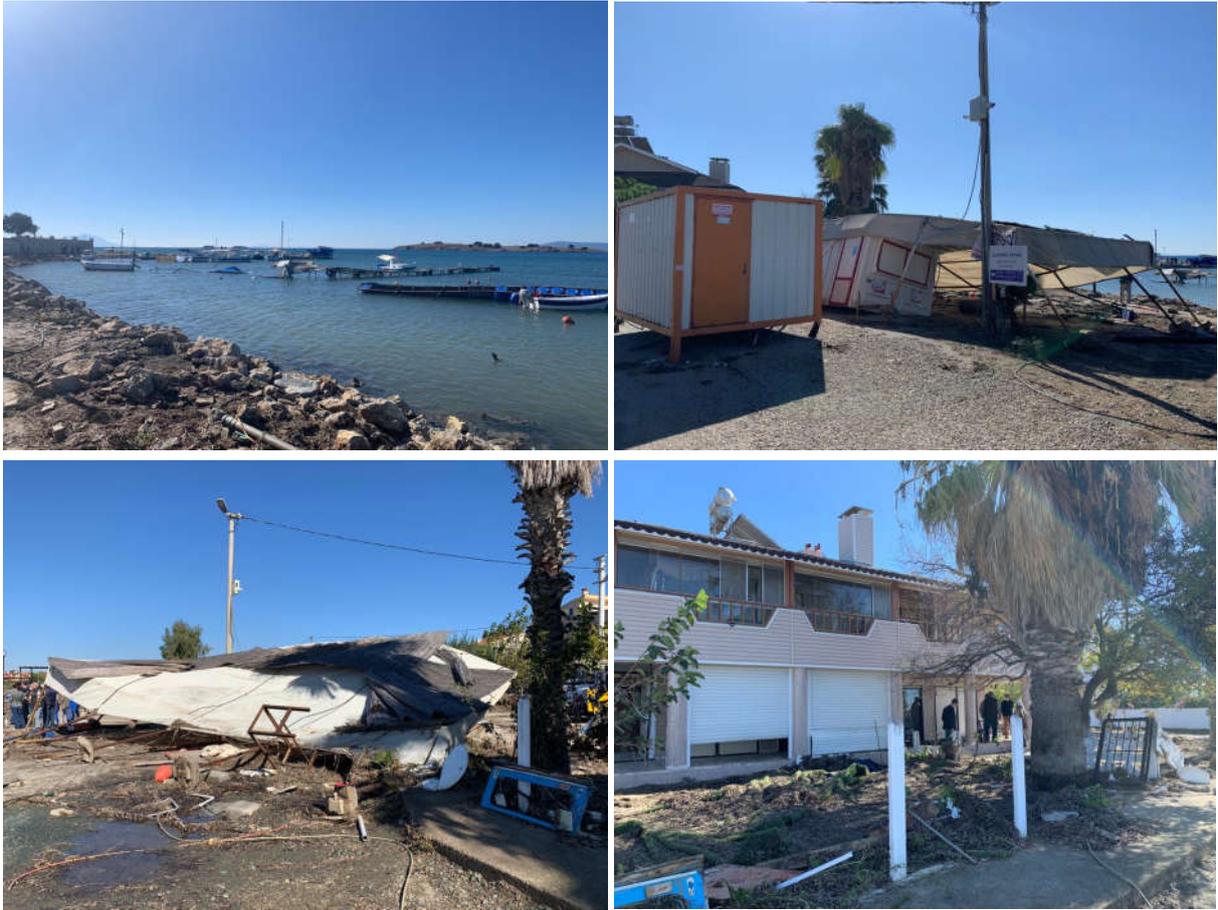
Fig 4.6 Damaged fishery port piers, boats and small structures in Akarca due to tsunami

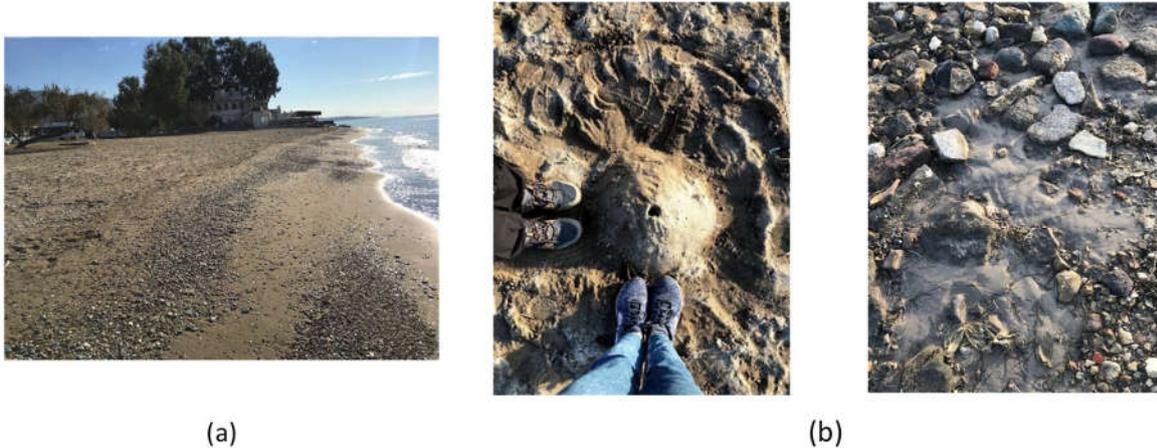
Fig 5.7 a) No surface manifestation (38.057442, 27.011747) b) Surface manifestations of seismic soil liquefaction in the form of sand boils (38.338447, 26.647494 and 38.310372, 26.679756)

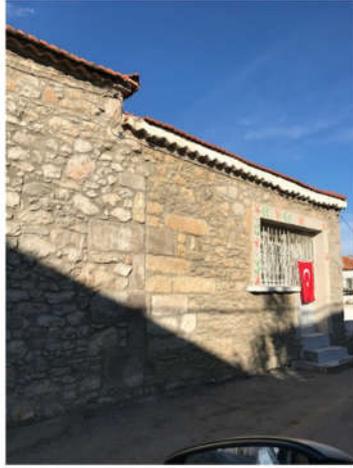
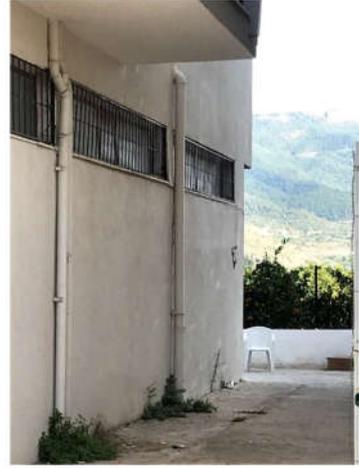
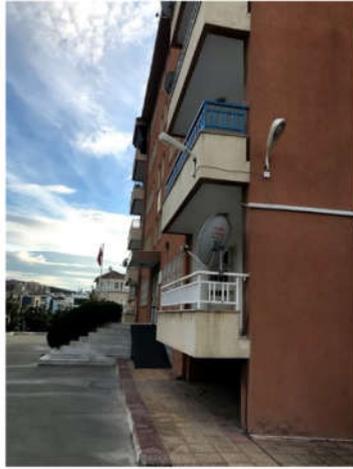
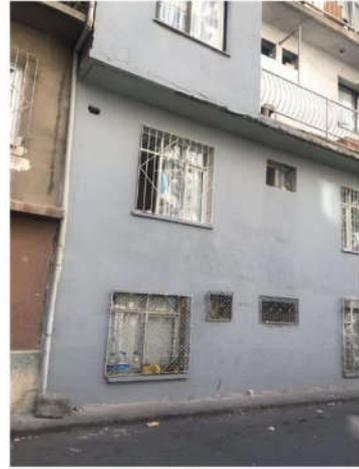
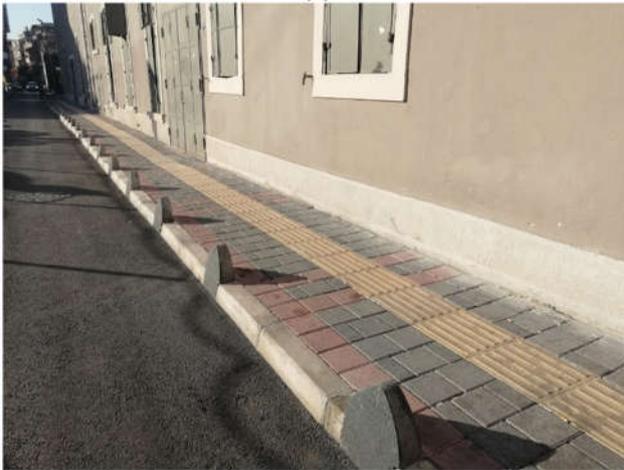
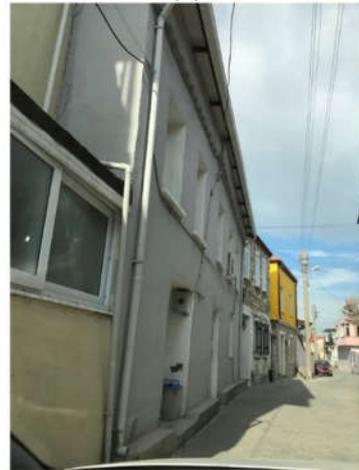
A number of structurally damaged residential buildings were also documented with special emphases on their foundation performances. Commonly, 1-2 story reinforced concrete beach houses were documented by the coastal region of Aegean Sea, starting from Çeşme in the north, to all the way down to Didim in the south. No apparent heavy structural damages were observed at these low-story light weight buildings. At downtowns of major districts, there exist 3 to 7 story reinforced concrete buildings founded on shallow, strip footings or individual footings with strapped beams. Again, no apparent evidence, suggesting excessive total or relative settlements, bearing capacity failures was mapped. A sample of illustrative pictures is presented in Fig 5.8.

Fig 5.8 Illustrative foundation performances at selected sites: a) Germiyan (38.315925, 26.464742), b) Gümüldür (38.071206, 27.016639), c) Kuşadası (37.859711, 27.265708), d) Bayraklı (38.454033, 27.180125), e) Alsancak (38.439888, 27.145748) and f) Urla (38.321289, 26.770333)

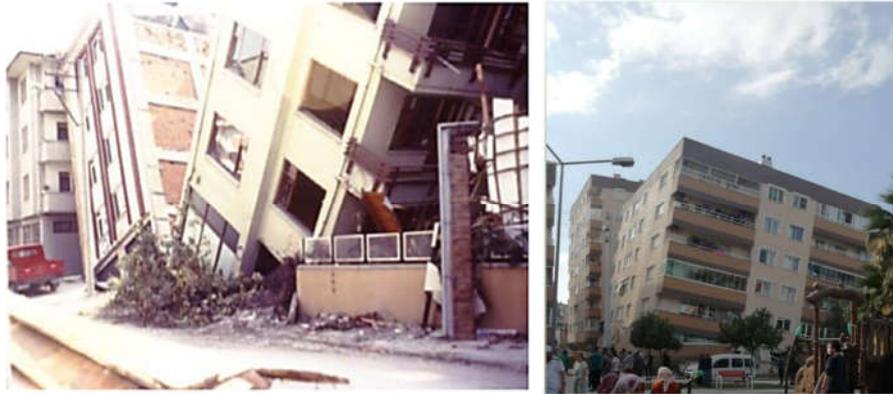
due partial collapse of entrance floor columns and shear walls, were erroneously attributed to soil liquefaction and induced bearing capacity problems, which could not be verified in the field. A comparative illustration of “true” liquefaction-induced bearing capacity failures documented in Adapazarı after 1999 Kocaeli earthquake, is shown in Fig 5.9 along with tilted buildings from this event in Bayraklı district.

Fig 5.9 Liquefaction-induced bearing capacity failure in Adapazarı (on the left) after 1999 Kocaeli earthquake vs. tilted buildings due to partial failure of entrance floor columns and shear walls after İzmir-Seferihisar earthquake (on the right, coordinates:38.461689, 27.180669)

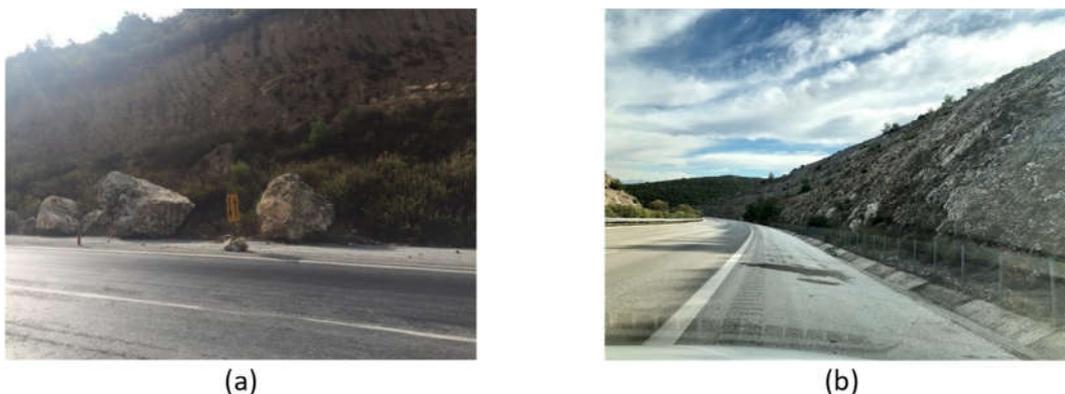
A limited number of rockfalls were observed by the benches of highways, one of which is illustrated in Fig 5.10a. Some potential landslide sites were also visited, but no signs of seismically induced movements were documented as also shown in Fig 5.10b.

Fig 5.10 a) Fallen rock blocks (37.897341, 27.368394, b) A view from a highway cut with potential for slope instability (38.292119, 26.670731)

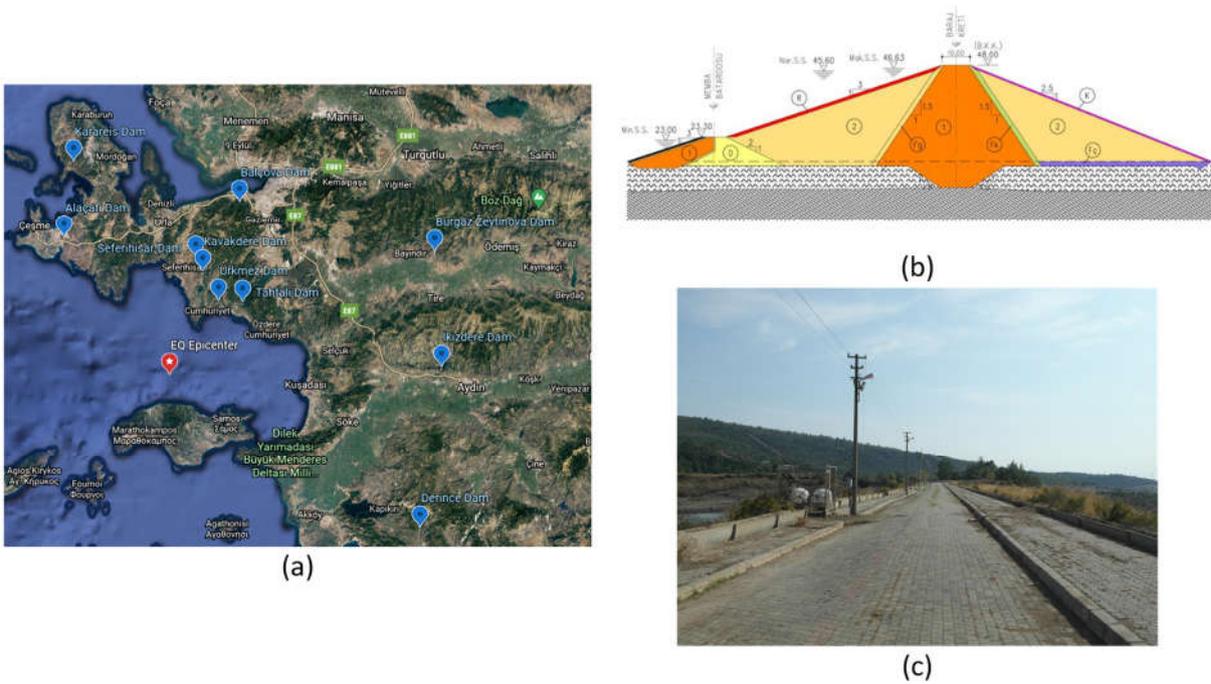
Fig 5.11 Location of earthfill and rockfill dams, b) Ürkmez Dam Typical Cross-section and c) crest view of Ürkmez Dam

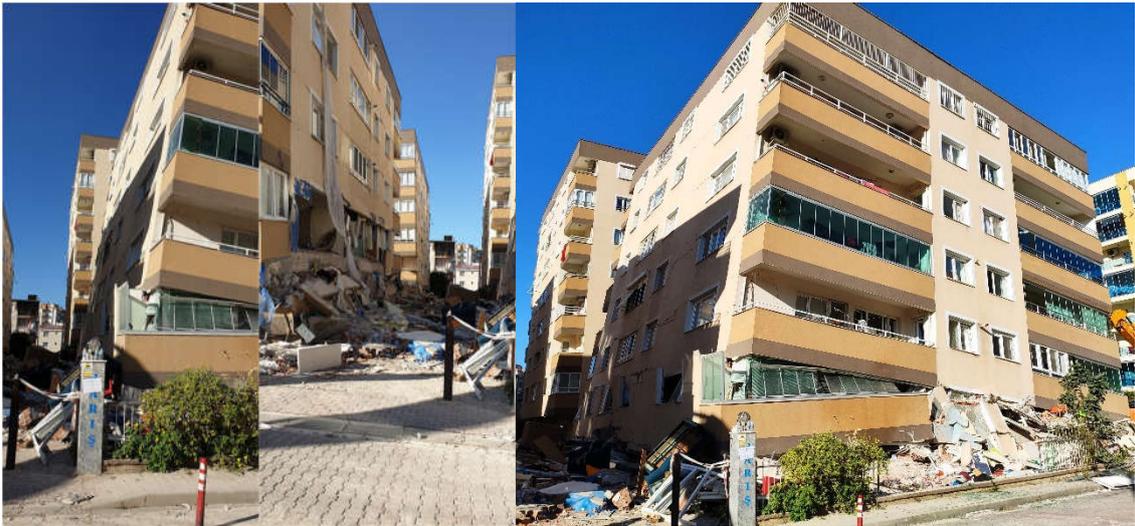
Examination of the ground motion records presented earlier in this report shows that the spectral acceleration measured at the soft soils in Bayraklı is around 0.35g in the period range of 0.8-1.4 seconds. According to Turkey's current seismic hazard map, these values are above the spectral accelerations corresponding to a ground motion level of service earthquake (72-year return period). Still, they are around 30-40 percent of the design level earthquake ground motion (475-year return period). For this reason, it appears that the earthquake led to heavy damage for 7-10 story buildings designed between 1990-1994 with major inadequacies. These types of damages were observed in Barış Building Complex (4 buildings with 9 stories, Fig 6.6), Cumhuriyet Building Complex (3 buildings with 8 stories, Fig 6.7), and Adalet Building Complex (2 buildings with 9 stories, Fig 6.8). Although the buildings within each of these complexes have identical plan properties (area, plan drawings), different damage levels were observed. Two buildings in Barış Apartment Complex had experienced total collapse, one building suffered heavy damage, and the fourth building survived the earthquake with minimal structural damage and significant infill wall damage. The two main reasons for the building to survive the earthquake are; 1) unlike three other buildings, this building had a significant amount of infill walls in the ground floor allocated for management office and superintendent flat, 2) this block was constructed by a different contractor with most probably a better construction quality. Our assessments revealed that the presence of infill walls and the difference in the quality of construction had increased the base shear capacity of the building by approximately 20-30 percent. The past observation that infill walls help the buildings survive small to medium size earthquakes by contributing to their lateral load carrying capacity was confirmed. A similar observation can be made in Cumhuriyet complex, where the level of damage in one building is limited but in the other two buildings are more significant.

Fig 6.6 Damage observed in Barış Building Complex

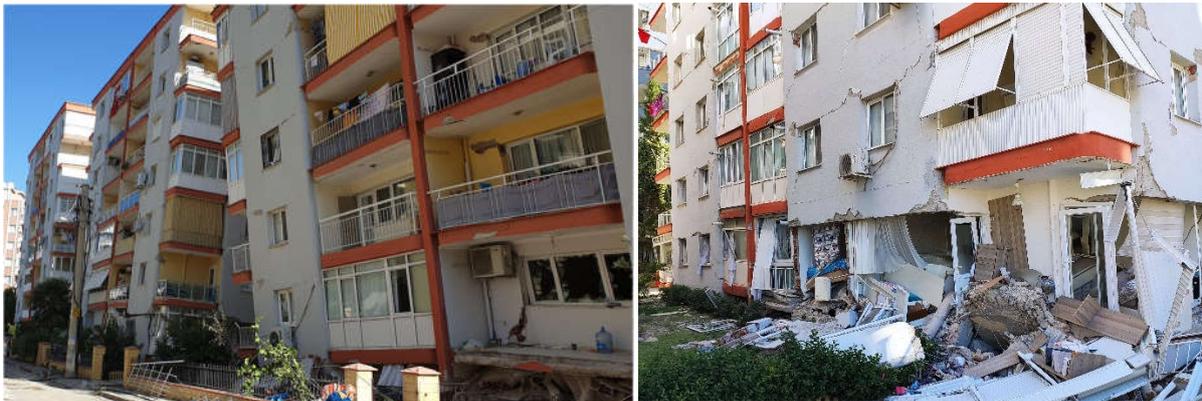
Fig 6.7 Damage observed in Cumhuriyet Building Complex

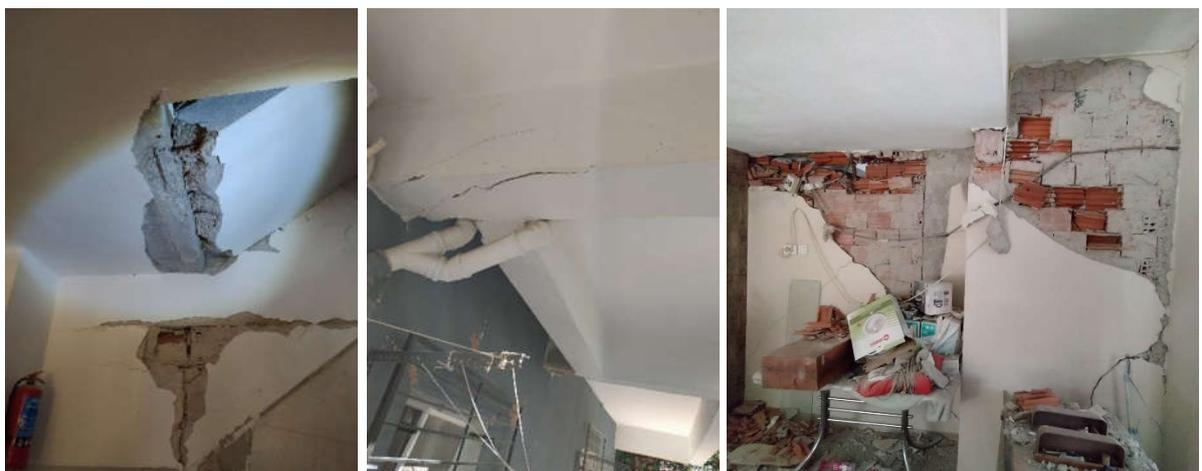
Fig 6.8 Damage observed in Adalet Building Complex

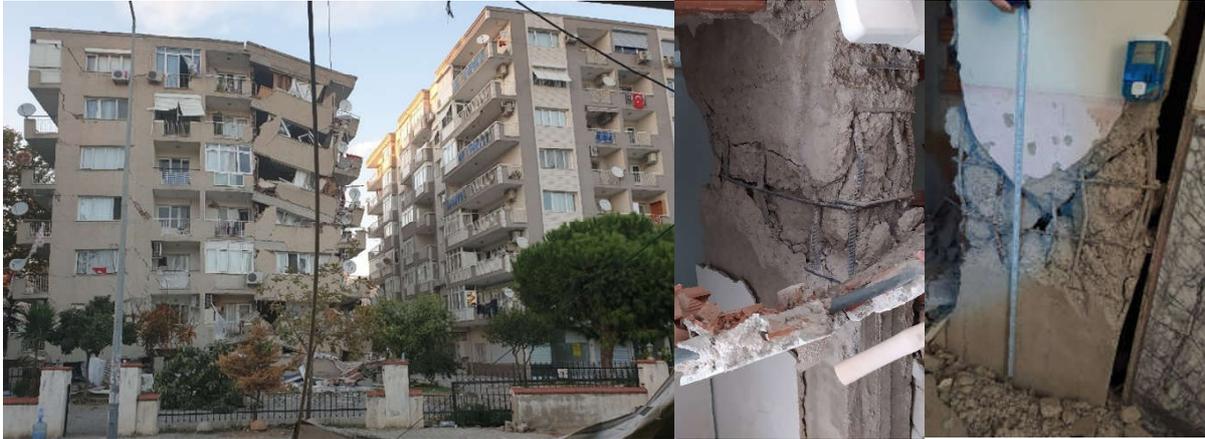
Another case where our observations focused was the Egemen Building Complex with two similar buildings. Although the first two floors of one of the buildings collapsed, almost no damage was observed from the street survey. The building's assessment from inside revealed heavy shear damage and significant corrosion in columns (Fig 6.9). This observation clearly shows that damage assessment based on building examination without entering inside may lead to quite misleading results.

Fig 6.9 Egemen Building Complex, collapsed and undamaged looking buildings

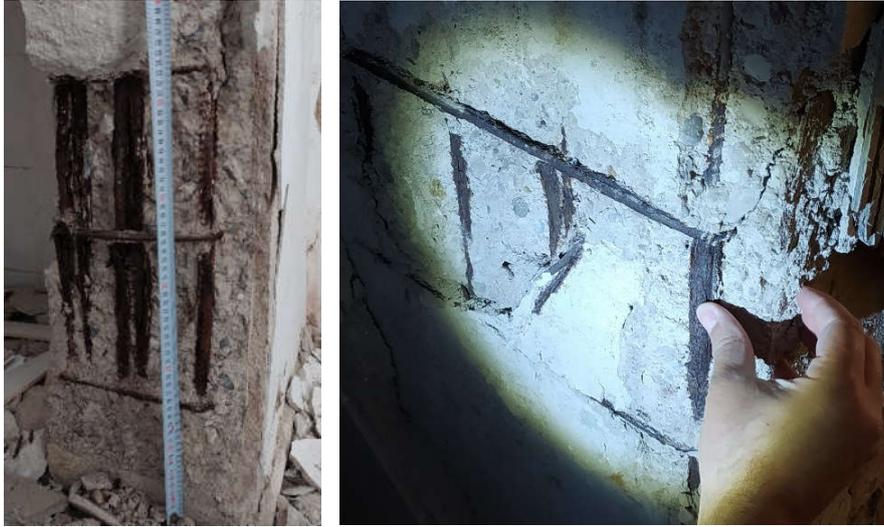
Our investigations showed that corrosion in reinforcement is a widespread problem in İzmir (Fig 6.10). Excessive corrosion was especially observed at the lower end of columns located in the basement of ground floors. The loss in the cross-sectional area of reinforcement due to corrosion was significant in some instances reaching values from 25 to 65 percent.

Fig 6.10 Columns suffering excessive corrosion

- 8- Excessive level of corrosion was observed in bottom ends of columns located at the basement and ground floors of examined buildings in Bayraklı, İzmir.

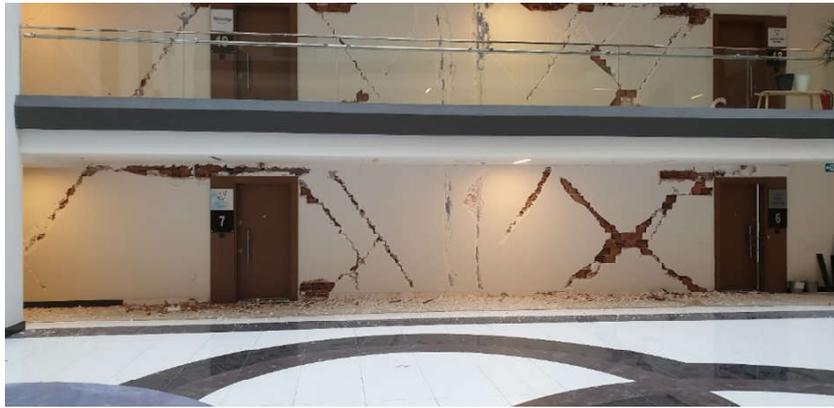
The widespread nonstructural damage observed in a recently constructed commercial center points out some design mistakes (Fig 6.11). This 10-story commercial center has a shear wall core and a large opening in the center of the slab. All offices are located around the opening. Although no damage was observed in the shear wall, heavy shear cracks were observed in the infill walls. It is surprising to see such heavy level of infill wall damage in a recently constructed building under an earthquake ground motion well below the design earthquake level. We believe that due to lack of diaphragm action, the core wall was unable to restrain the interstory drift. It appears that improper modelling and inadequate design led to excessive drift of office areas, and the infill walls around offices suffered heavy damage. This observation emphasizes the importance of slab openings (slab discontinuity) and ways for developing proper load transfer mechanisms to the shear walls.

Fig 6.11 Damage in the commercial center

- 6- Inadequate stiffness and strength of slabs and tie-beams, transferring the load to shear walls led to high drift demands in the building resulting in a concentration of damage in nonstructural members.

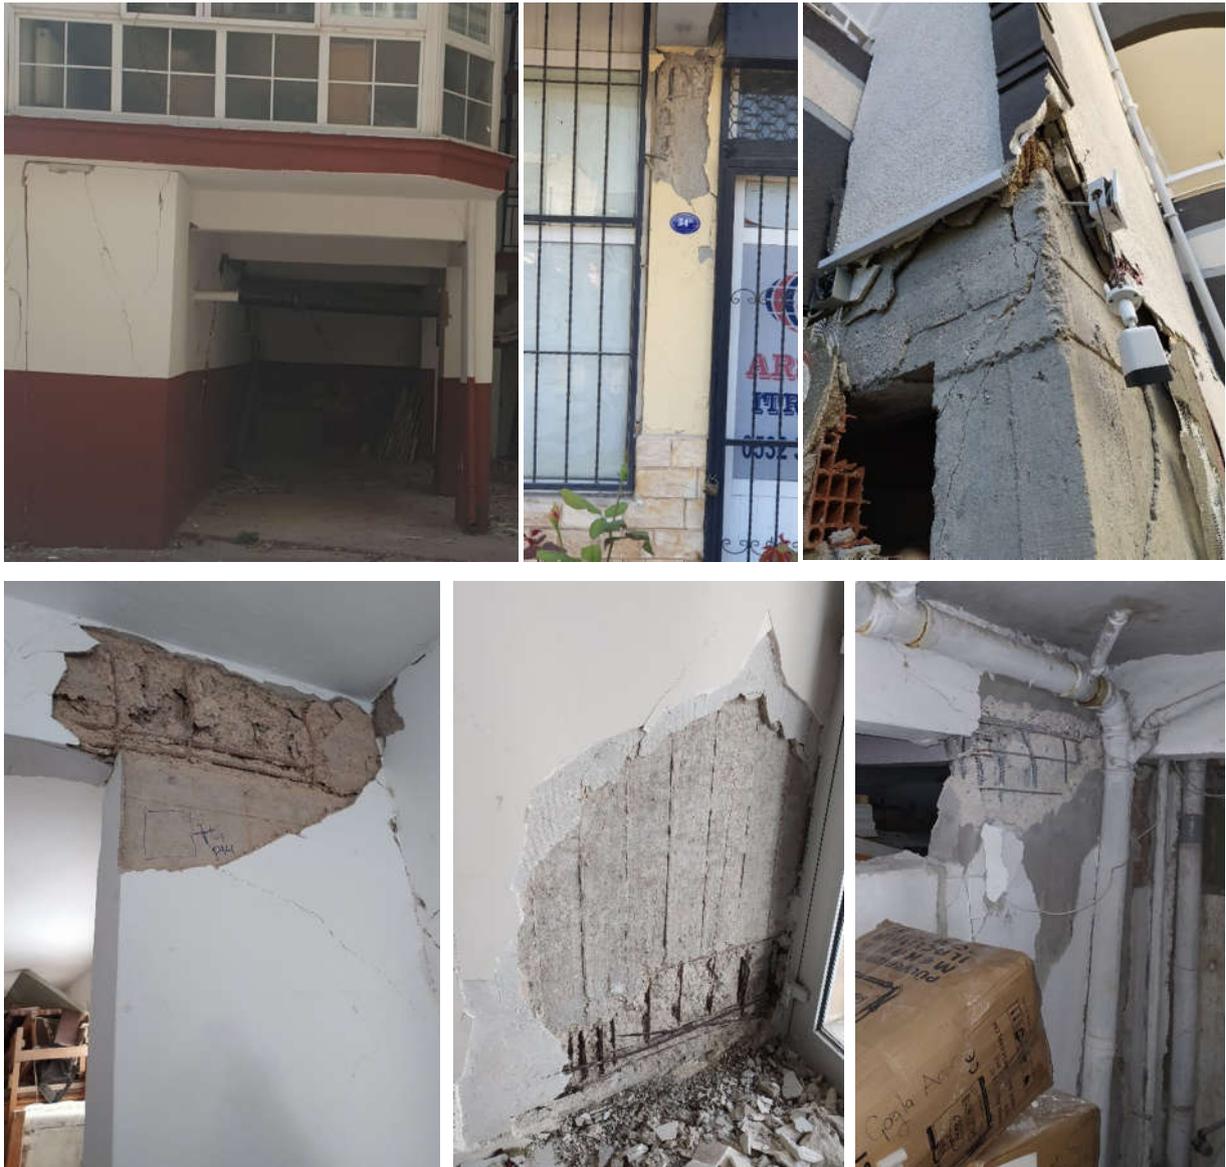
Fig 6.12 Localized heavy damage

- 9- Local overhang-column connection and ground floor column damages observed at the cantilevers of 7-10 story buildings are so high that the retrofit and re-occupation of the buildings was impossible.

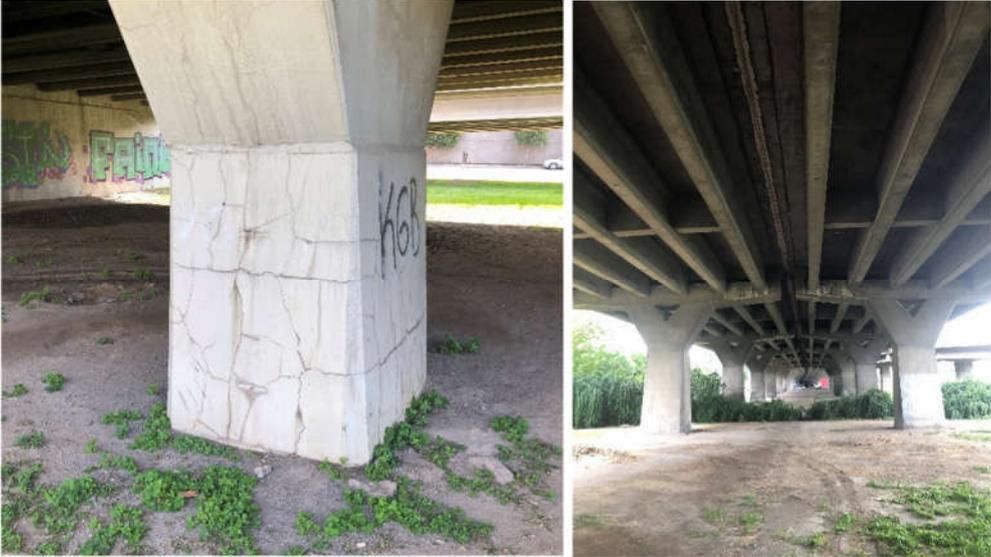
Fig 6.16 ASR based cracks (non-seismic) and general view

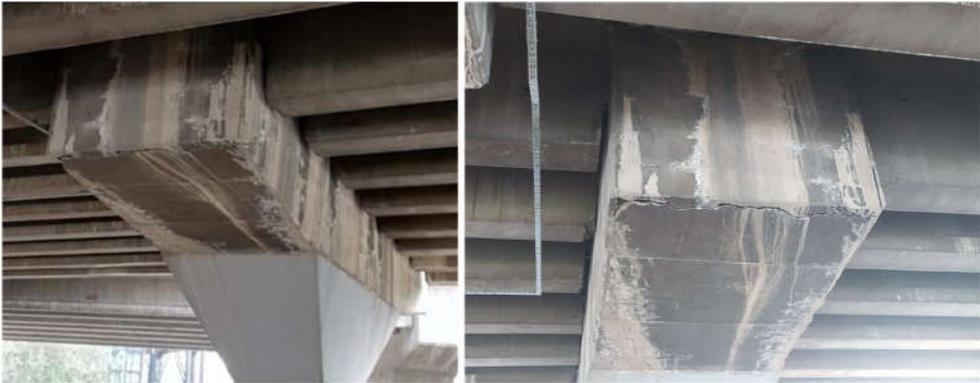
As is known, the bridges are approximately 70 km from the earthquake epicenter. No permanent movement has been observed in the superstructure beams and supports. The bending or shear capacity of the bridge columns and foundations has not been exceeded and no cracks have occurred due to the recent earthquake. There was no settlement on the foundation over soft soil. No movement was observed at the bridge expansion joints. No loss of function such as rupture or fracture has been observed in non-structural bridge elements (precast panels, pedestrian railings, lighting poles, etc.). The earthquake performances of longitudinal joints between twin bridges are adequate as expected and some small concrete pieces not more than 2-3 cm fall on the ground only at some very local zones. After the examination of the superstructure and infrastructure of the bridges, no earthquake-related damage was detected.

Fig 6.17 Typical before and after earthquake photo (December, 2019) & (November 2020)

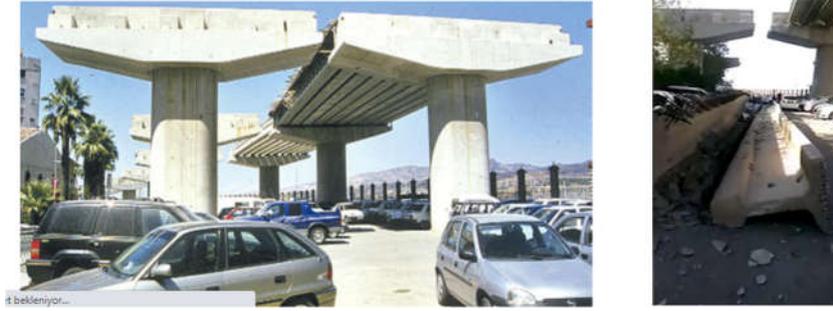
Fig 6.18 Stopped construction of bridges 20 years ago without lateral girder stability (10 years ago and now)
