## THE ELÂZIĞ-SİVRİCE EARTHQUAKE [24 JANUARY 2020 M<sub>w</sub>=6.8] FIELD OBSERVATIONS ON SEISMIC AND STRUCTURAL DAMAGE

REPORT NO: METU/EERC 2020-01

MARCH 2020 ANKARA

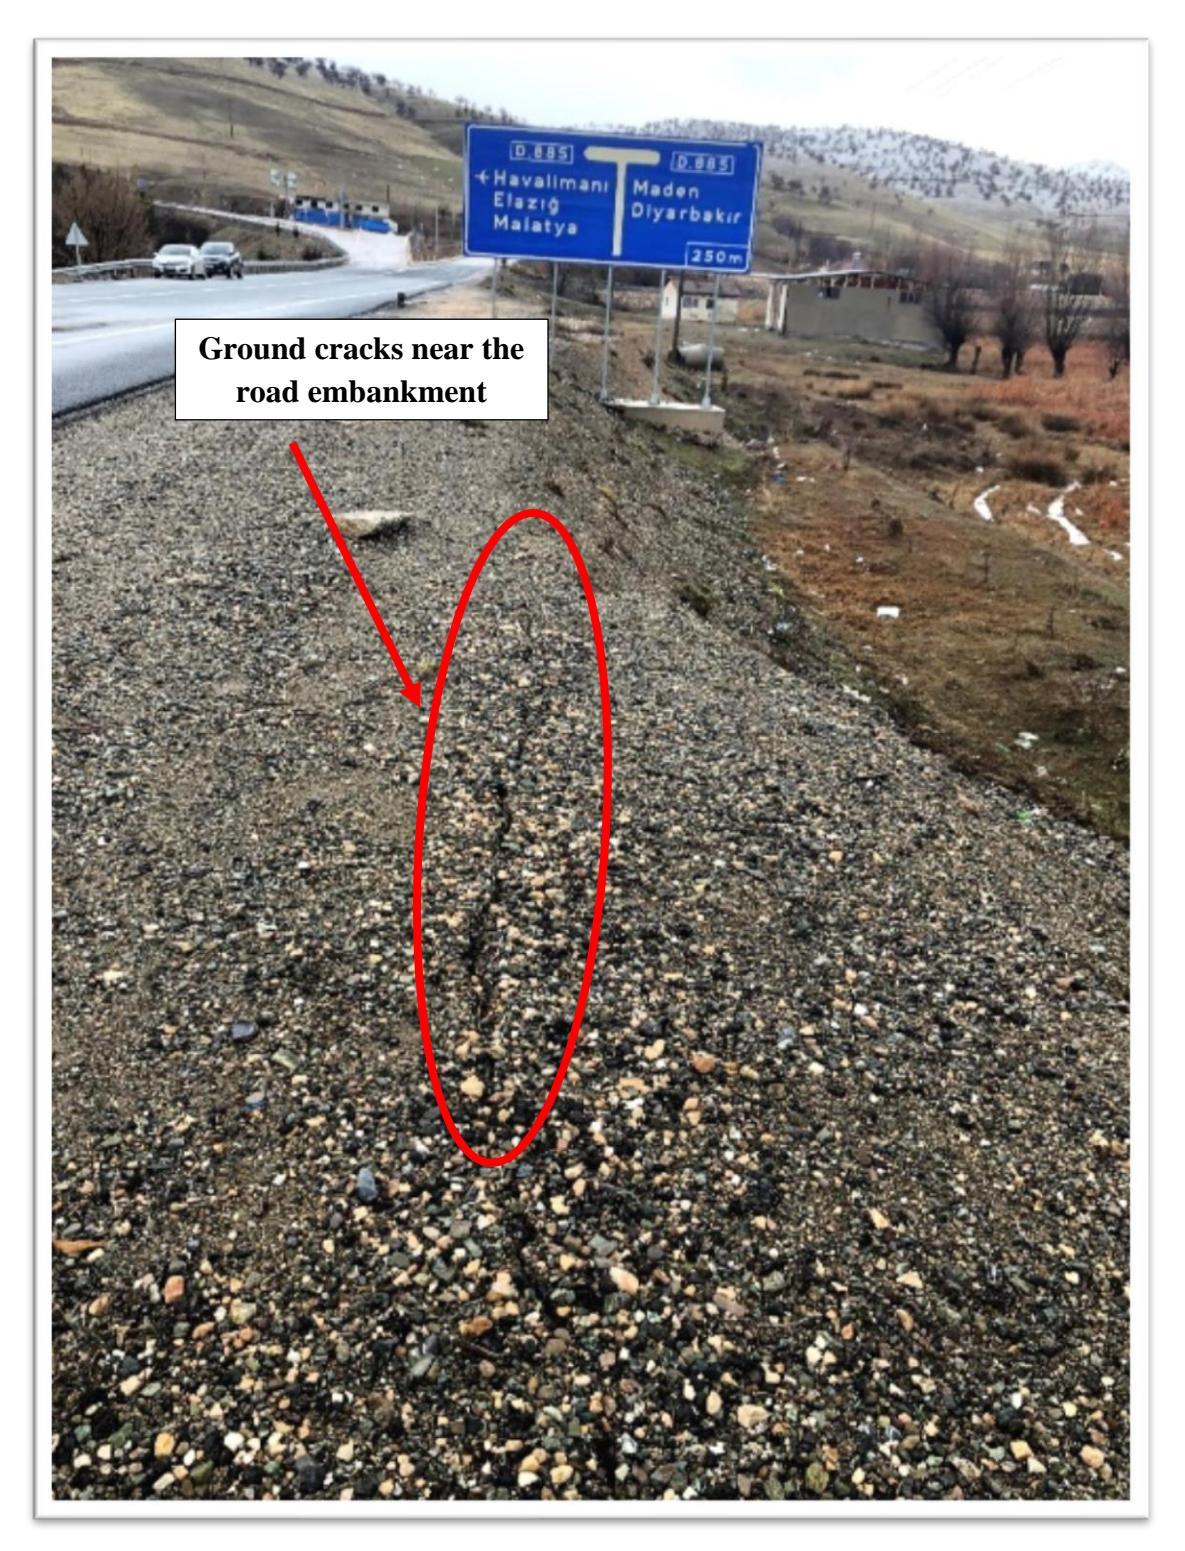
A small crack indicating a local bench failure was observed near the Sivrice road embankment, as shown in Figure 4.9. The crack is examined and presumed as a sign of a local small-scale slope instability problem.

Figure 4.9 A small crack observed near the highway embankment (38°28'08.0"N 39°16'38.7"E / 31.01.2020 / 11:50)

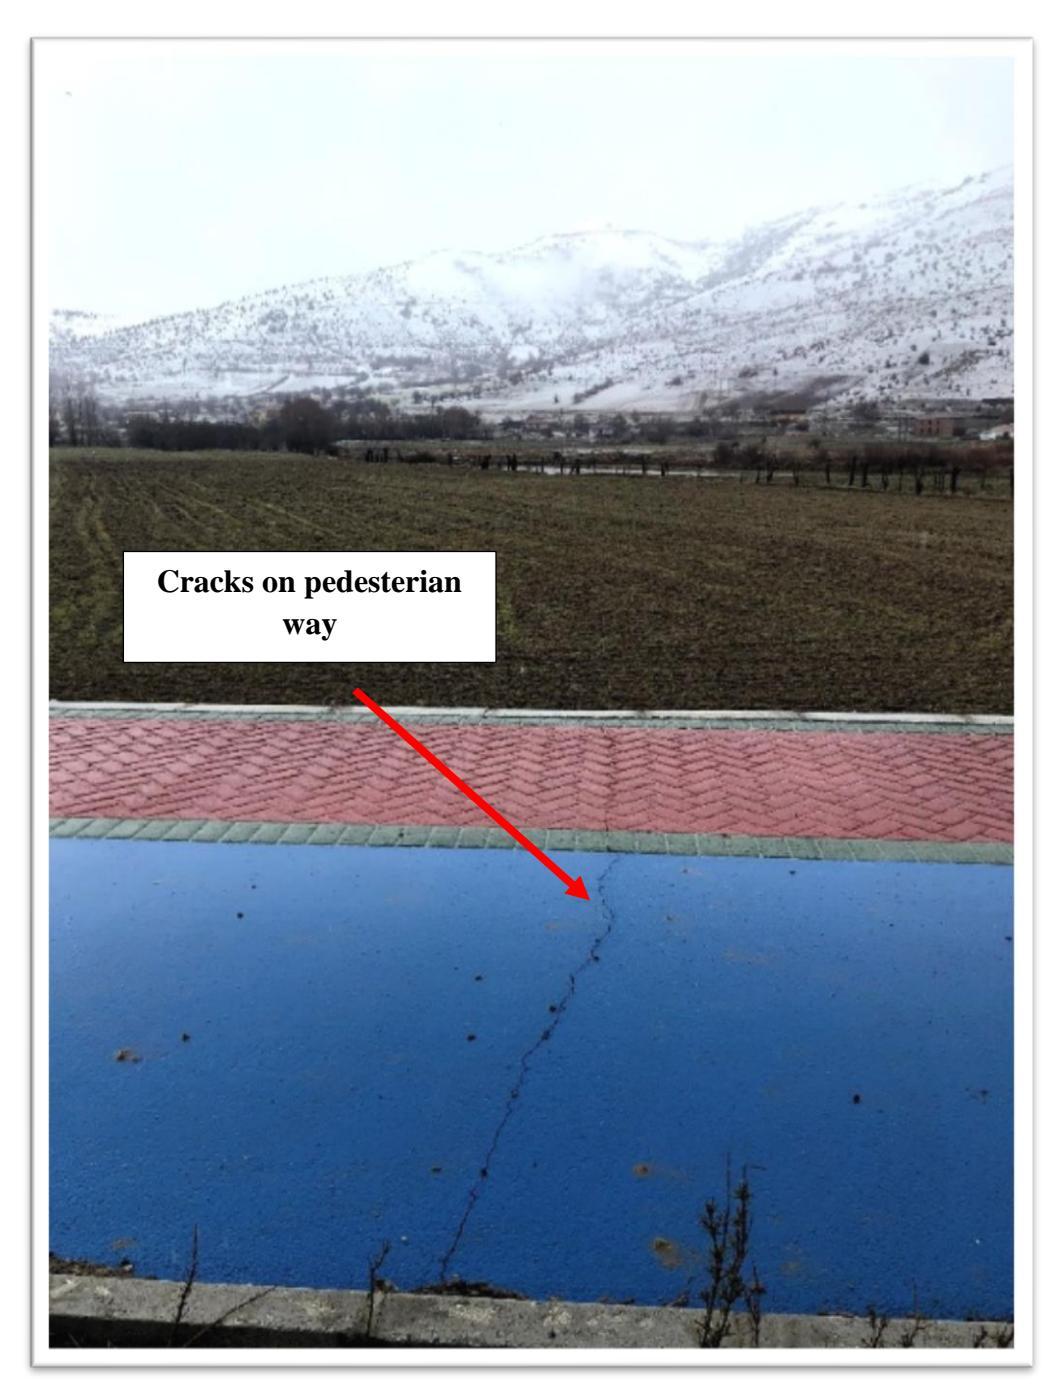
A crack was observed on the sidewalk near to Sivrice road as presented in Figure 4.11. The orientation of the cracking does not support a slope instability problem, which may be interpreted as an old crack existing before the earthquake.

Figure 4.11 Clayey site, no signs of failure (38°28'10.0"N 39°17'03.6"E / 31.01.2020 / 11:56)

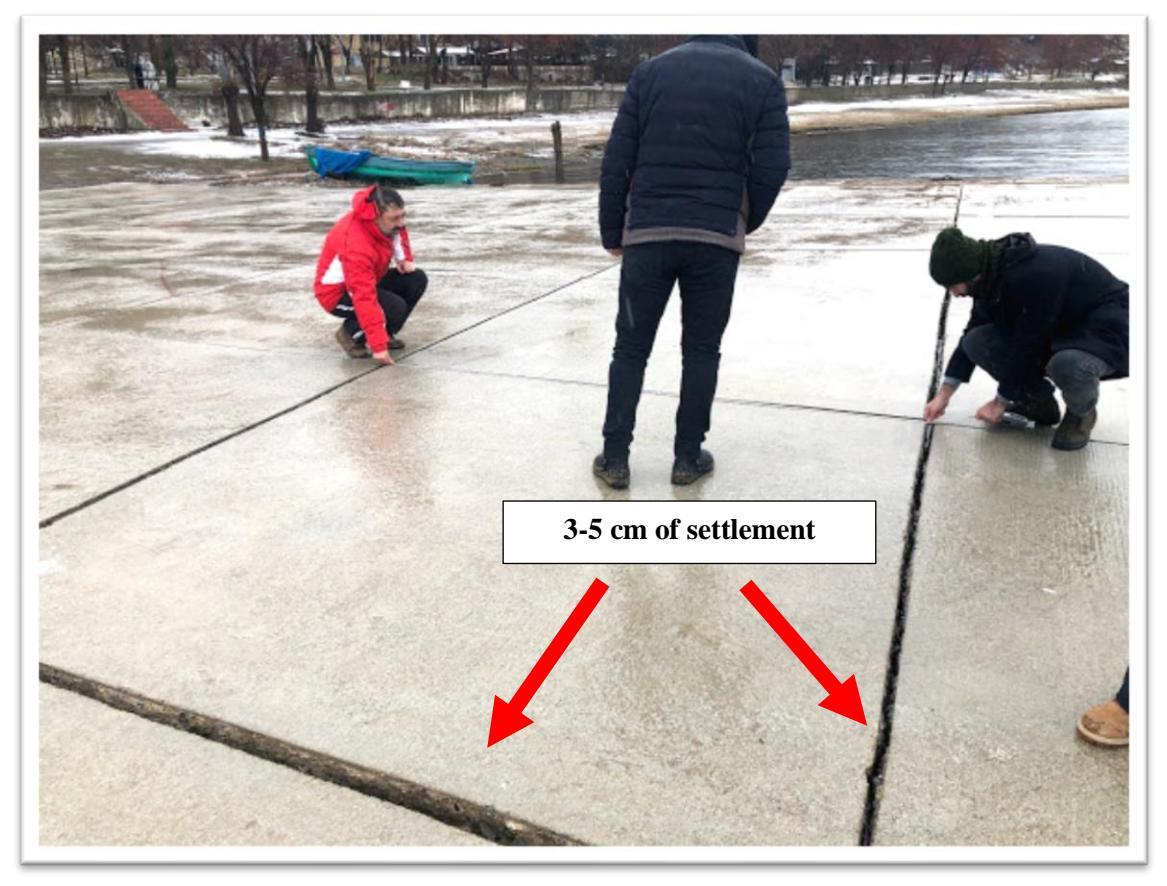
Figure 4.12 Seismically-induced volumetric settlement in the dock of Hazar Lake (38°28'10.0"N 39°17'03.6"E / 31.01.2020 / 12:11 & 38°26'53.2"N 39°18'53.4"E / 31.01.2020 / 12:14)

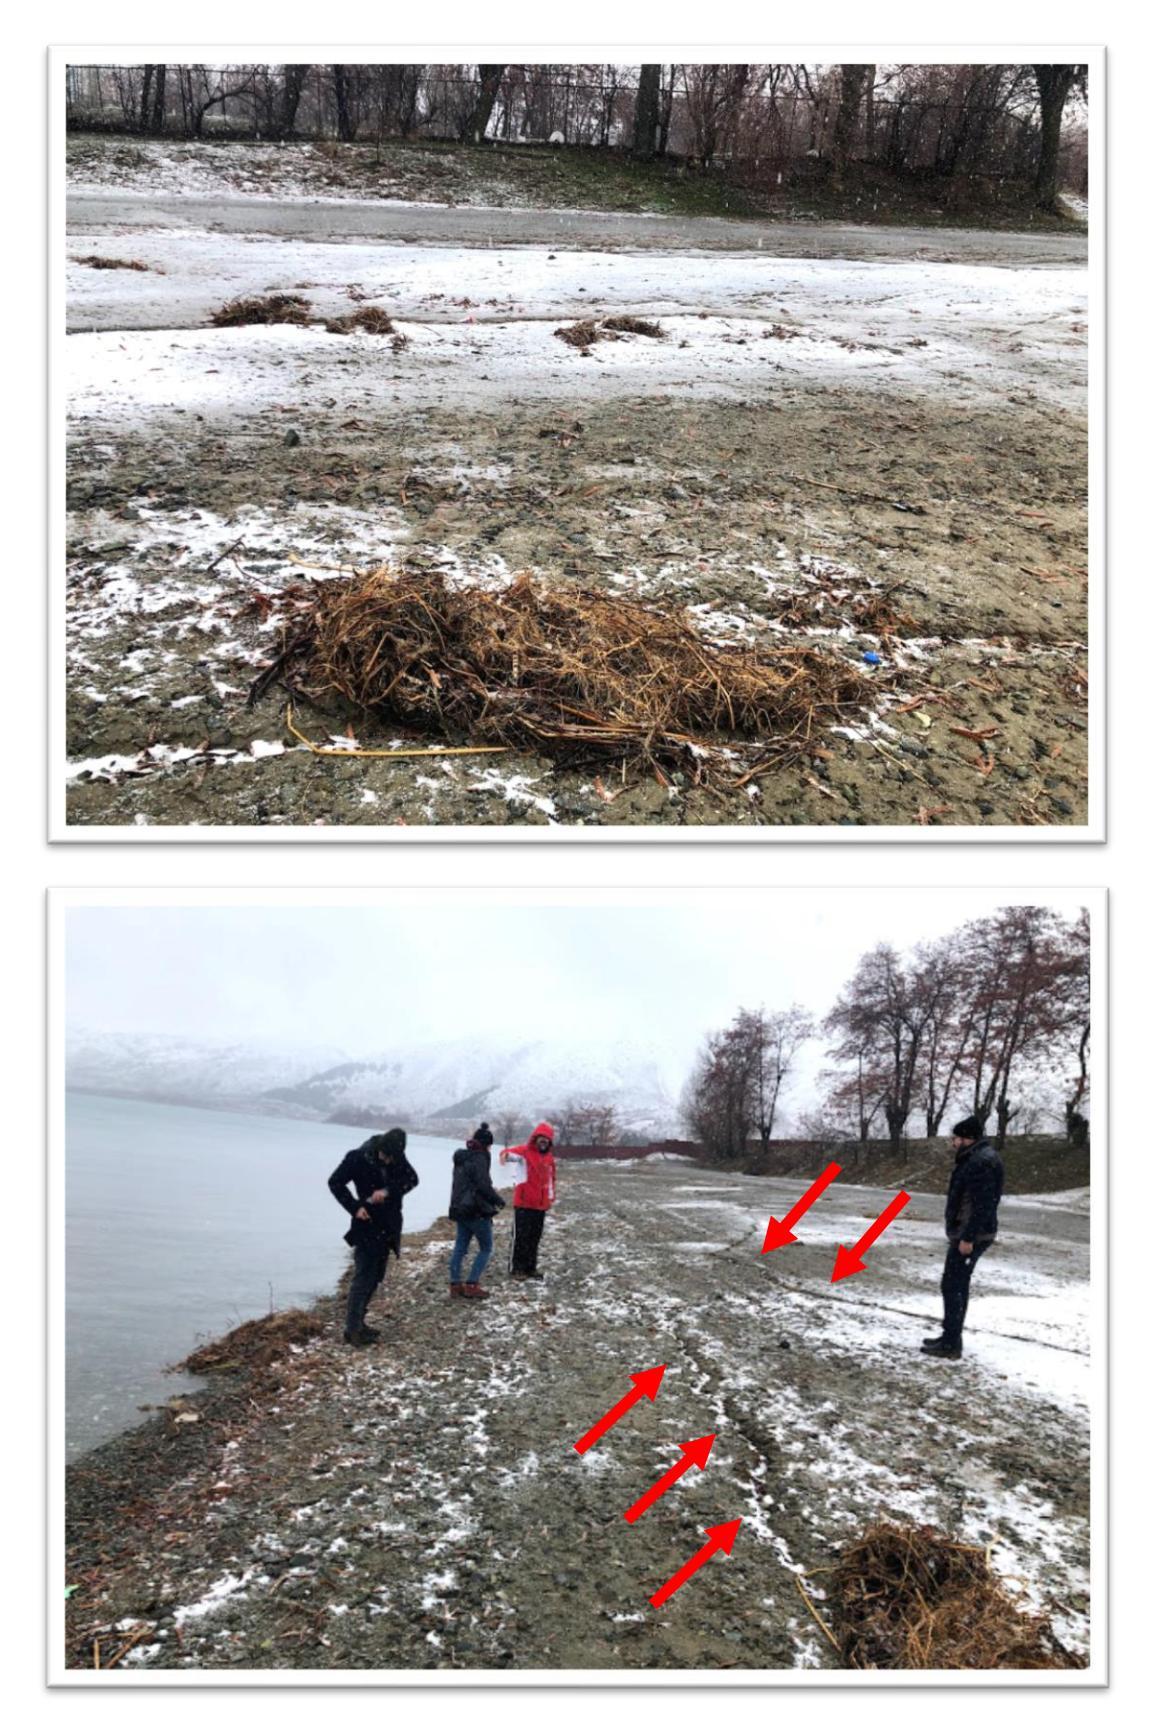
Figure 4.15 **S**eismically-induced lateral spreading on the beach of Hazar Lake (38°26'53.7"N 39°18'54.2"E / 31.01.2020 / 12:21 & 38°26'50.7"N 39°18'56.9"E / 31.01.2020 / 12:21)

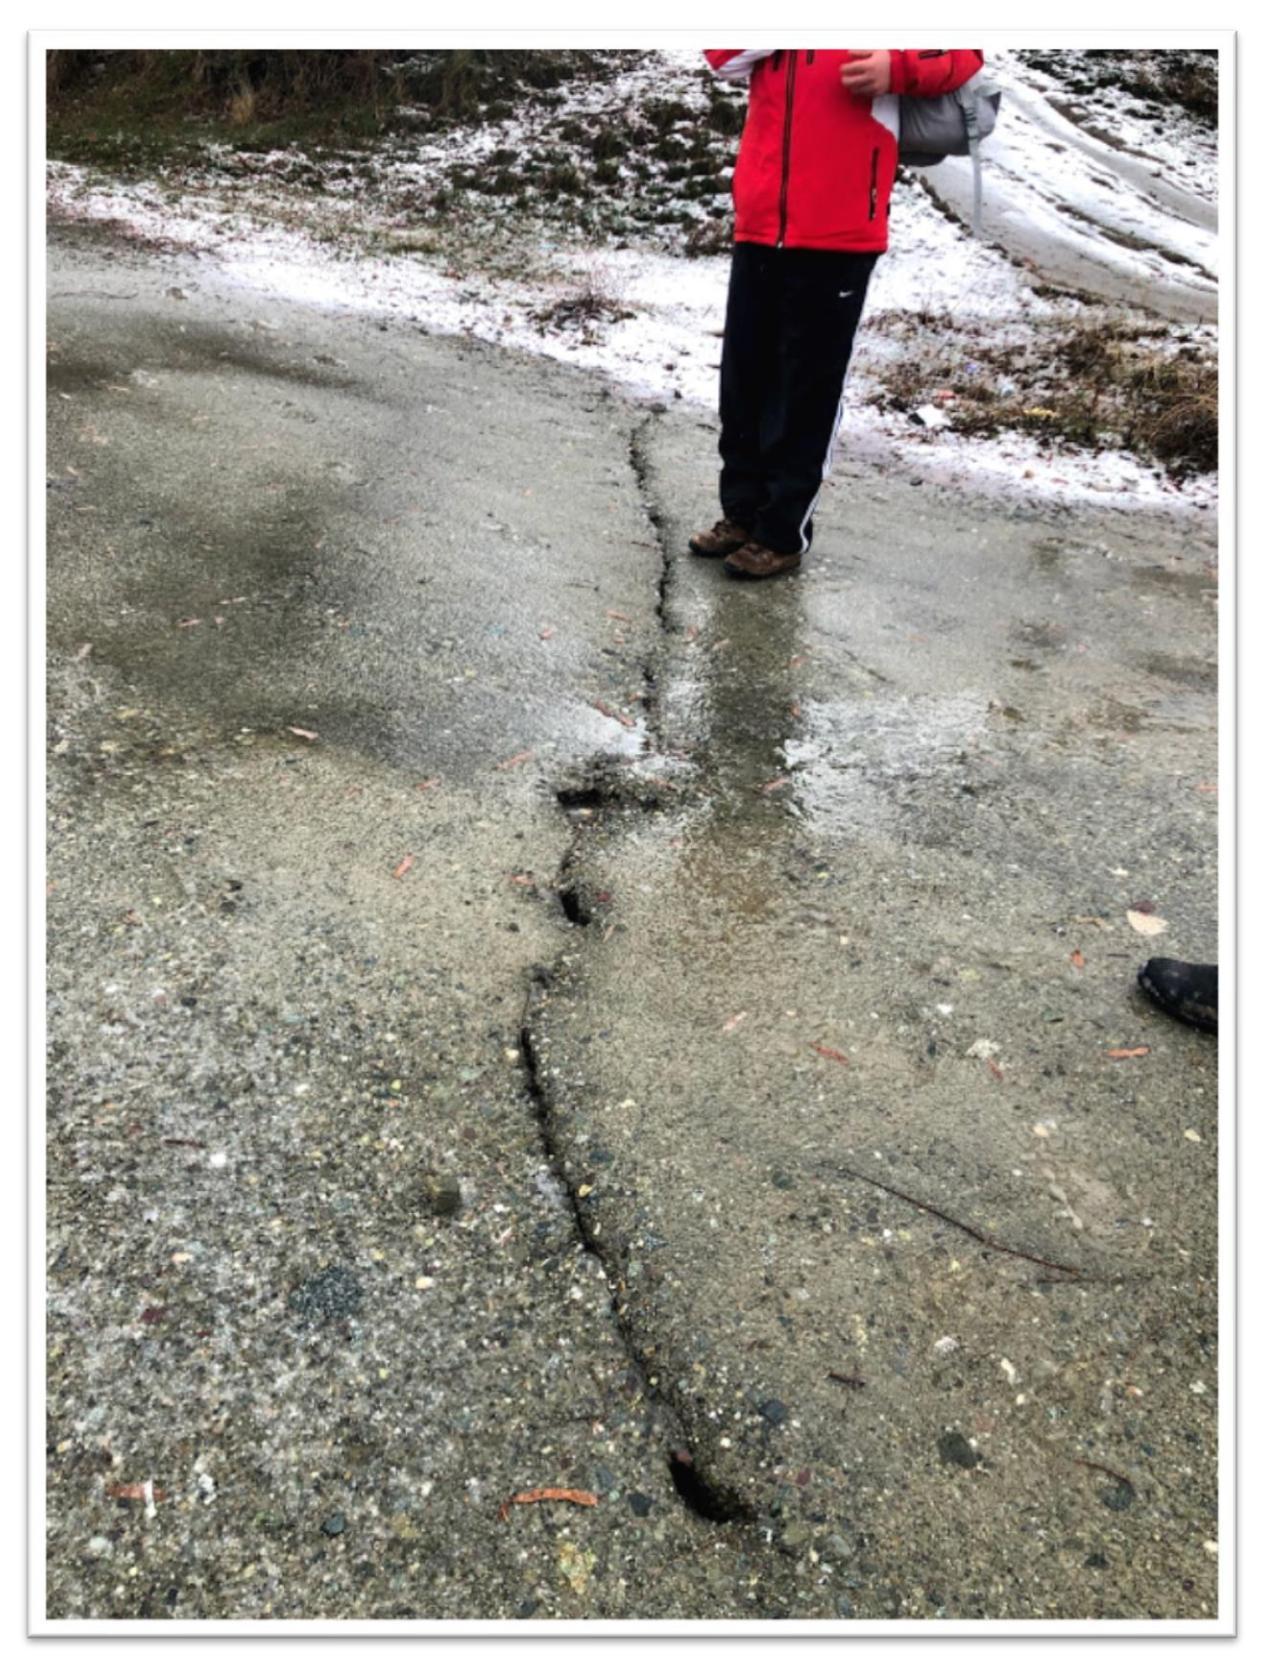
Figure 4.18 Another view of seismically-induced lateral spreading cracks (38°26'50.7"N 39°18'55.4"E / 31.01.2020 / 12:36)

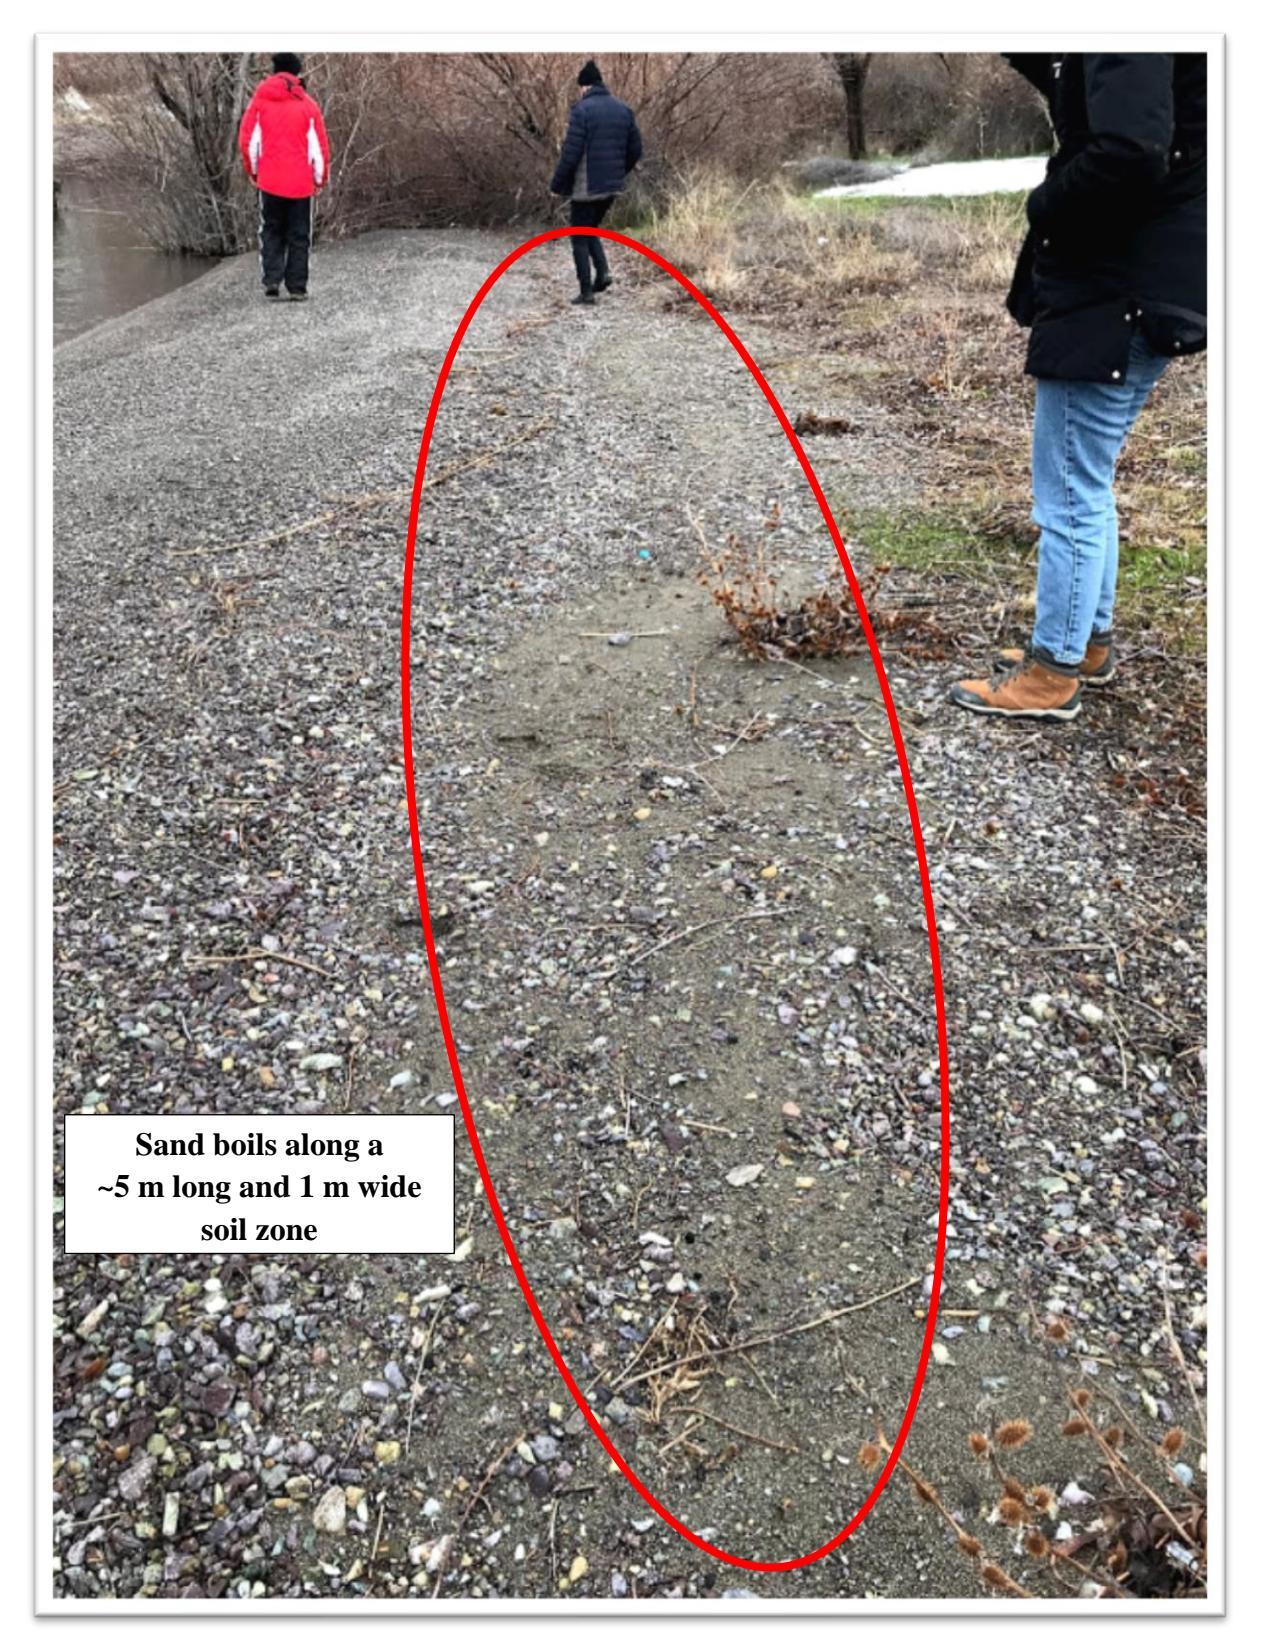
Figure 4.32 Sand boils observed in Stop 8 (38°27'49.8"N 39°24'03.0"E / 31.01.2020 / 14:14)

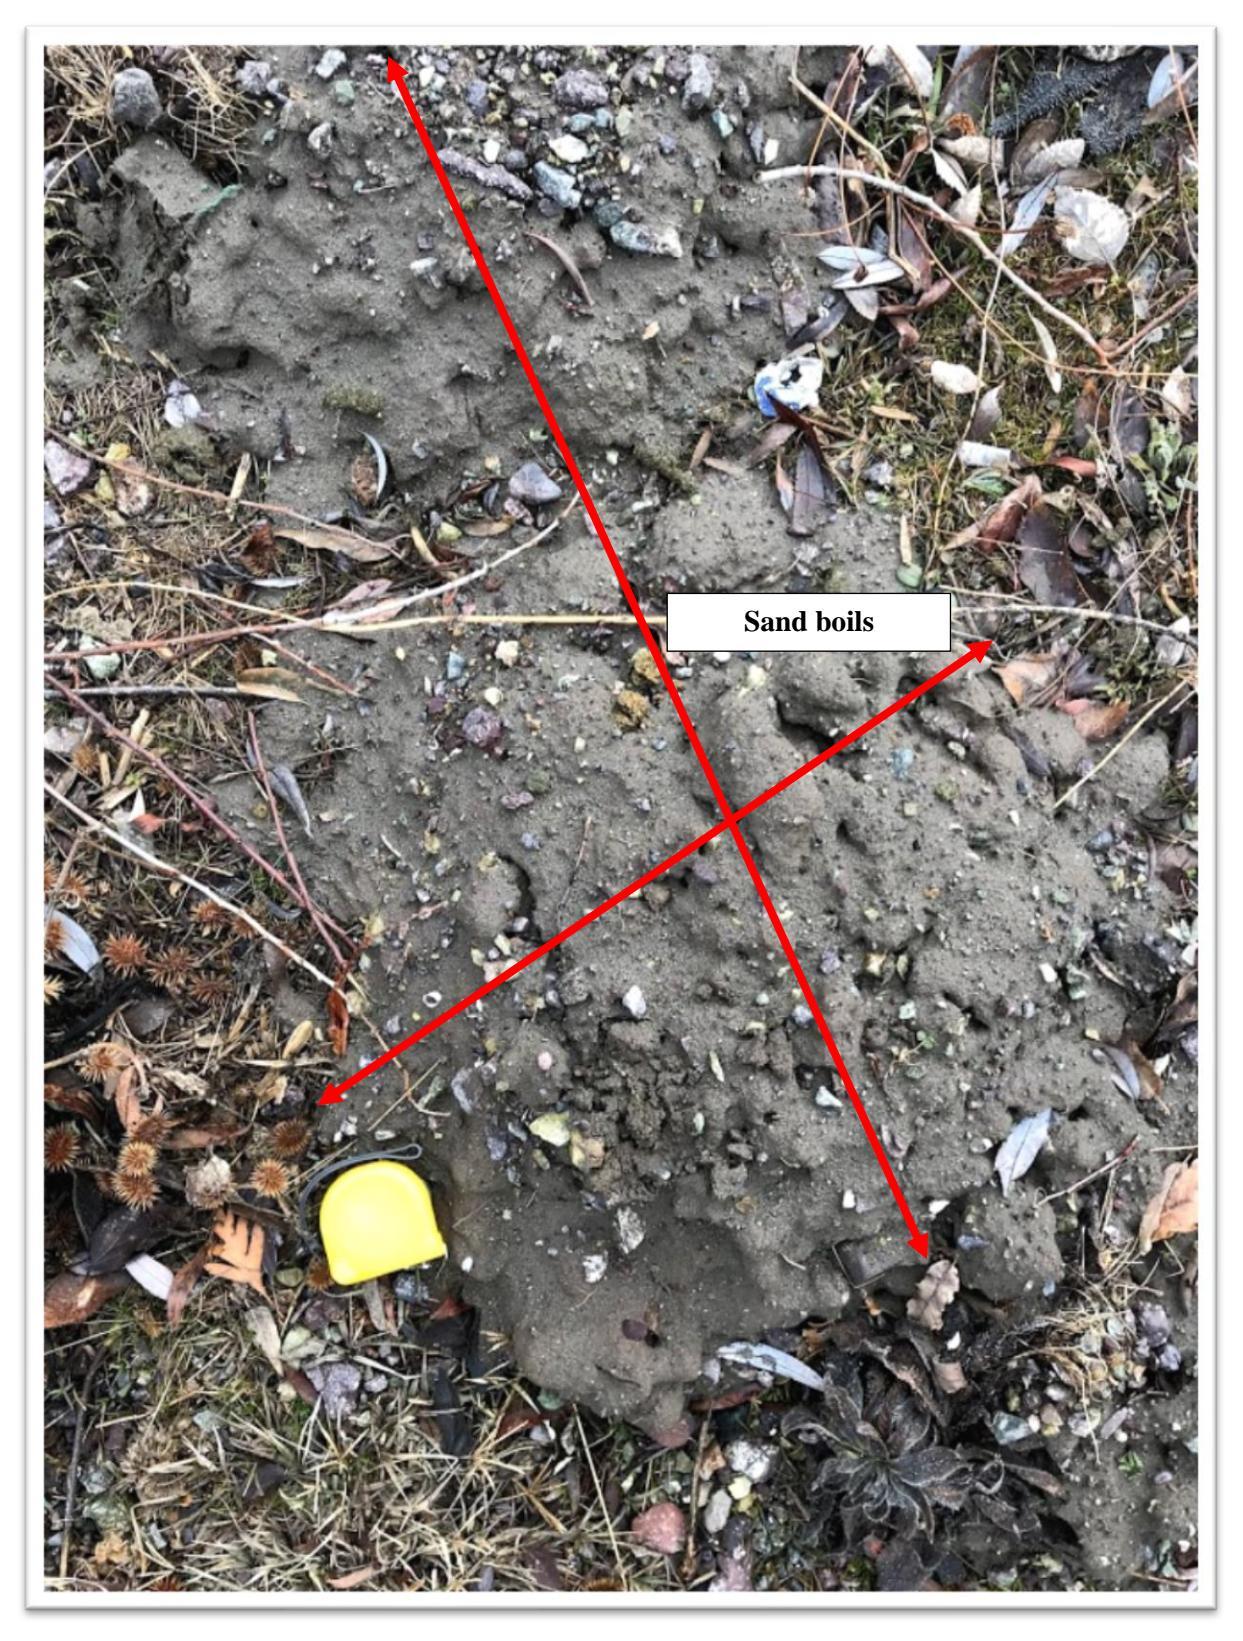
Figure 4.33 Sand boils observed in Stop 8 (38°27'49.9"N 39°24'02.8"E / 31.01.2020 / 14:17)

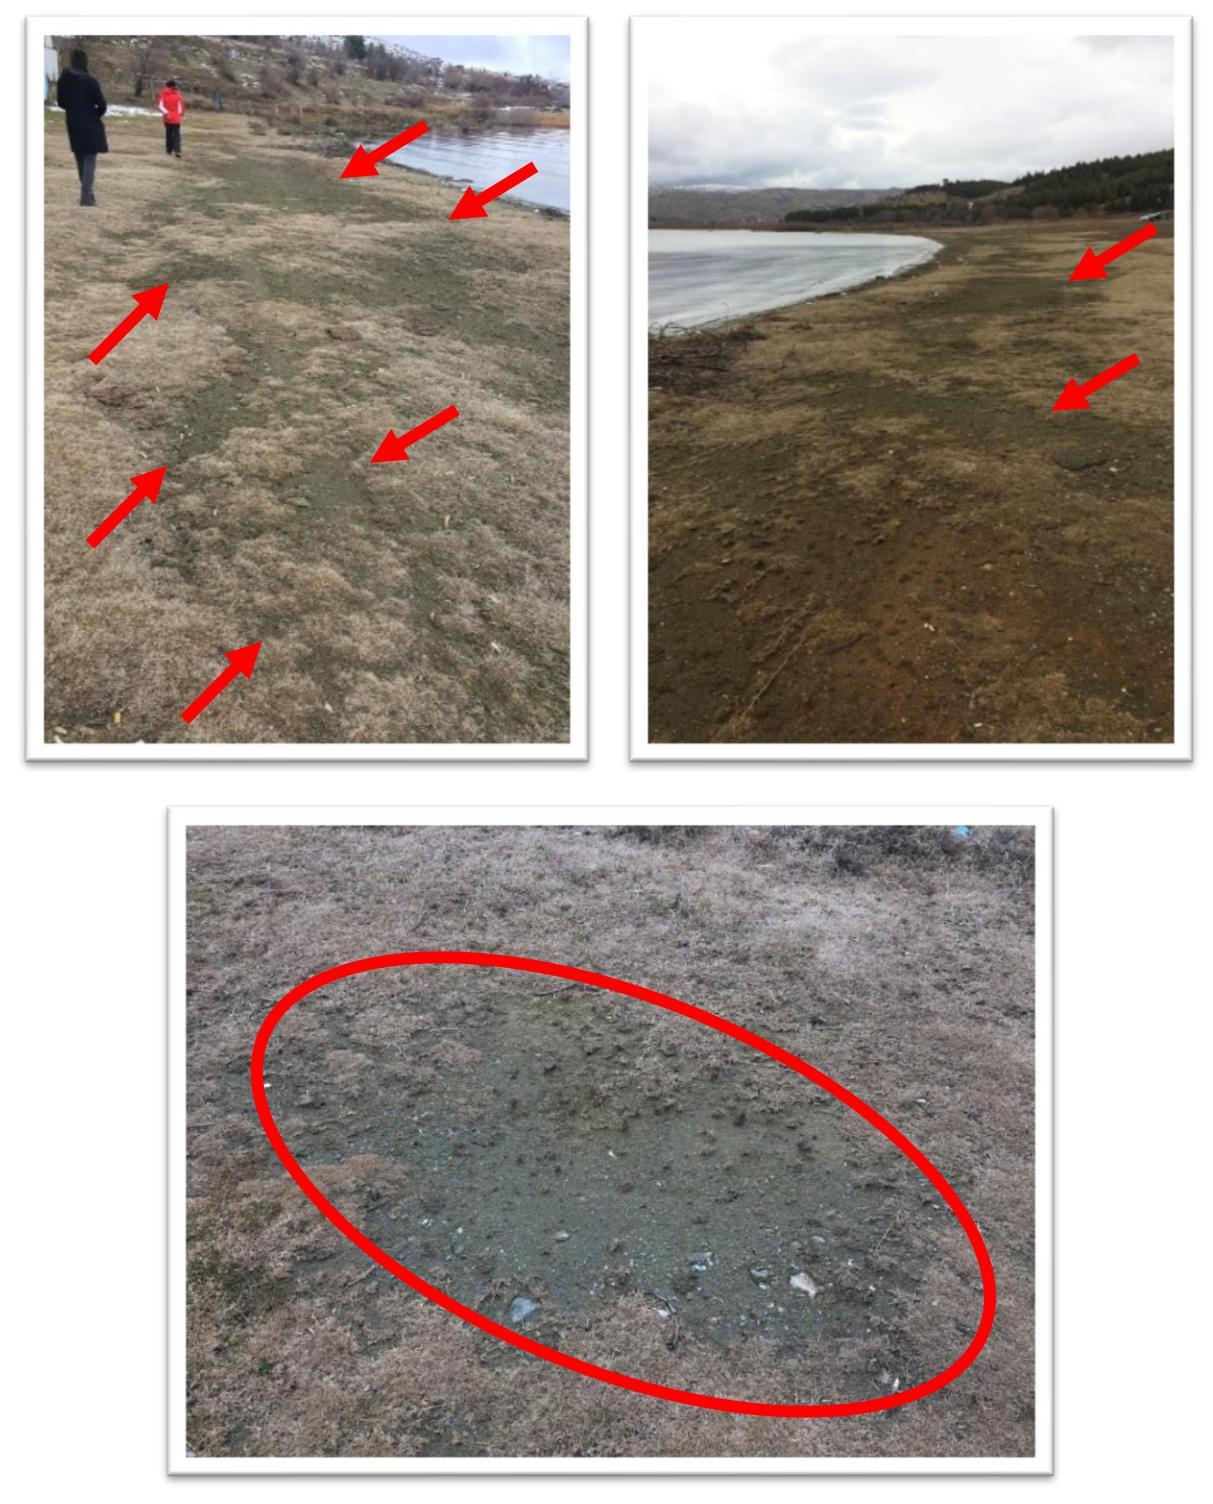
Sand boils were observed at 12<sup>th</sup> stop. These surface manifestations are shown in Figure 4.44.

Figure 4.44 Sand boils observed (38°29'58.5"N 39°30'24.6"E / 31.01.2020 / 15:29 & 38°29'57.6"N 39°30'23.9"E / 31.01.2020 / 15:30 & 38°29'57.7"N 39°30'24.0"E / 31.01.2020 / 15:30)

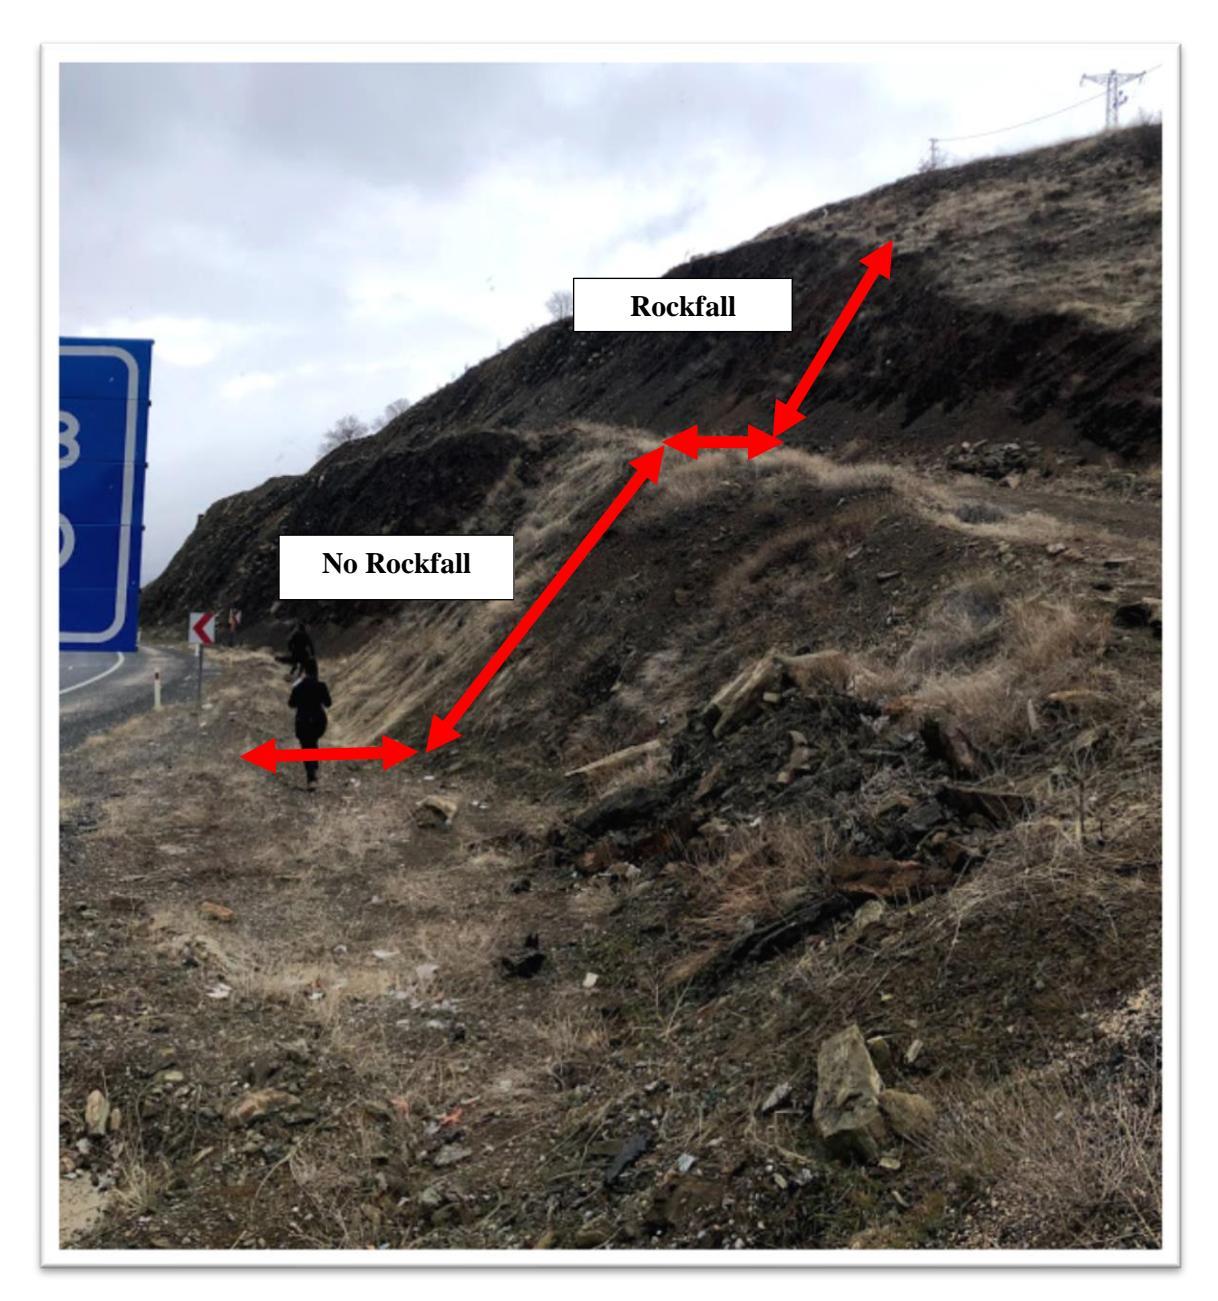
Rock falls were mapped at 13<sup>th</sup> stop as shown in Figures 4.45 to 4.49. Approximate dimensions (length, width, height) of the rocks are measured in the field. A simulation of the rock fall mechanism suggested a peak ground velocity of 4-6 m/s at the region as will be discussed later in the report. Fallen rock blocks horizontal distances from the toe of the first bench were measured as 3-5 m. The details of rockfall assessments will be presented later in the report.

Figure 4.45 Rockfall at 13<sup>th</sup> stop (general view) (38°31'40.3"N 39°28'02.9"E / 31.01.2020 / 16:20)

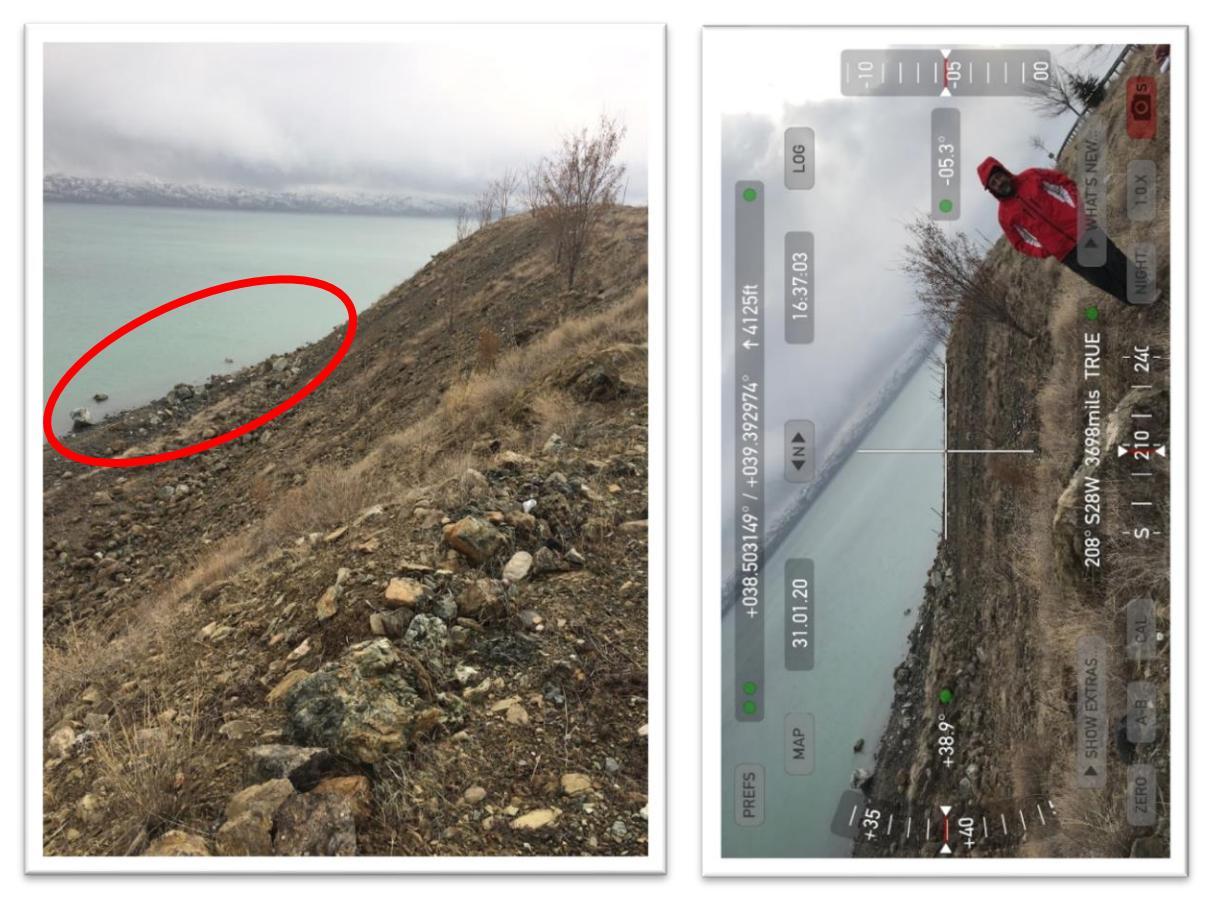
Figure 4.52 Rockfalls at 14<sup>th</sup> stop (38°30'11.4"N 39°23'34.9"E / 31.01.2020 / 16:37 & 38°30'11.3"N 39°23'34.7"E / 31.01.2020 / 16:37)

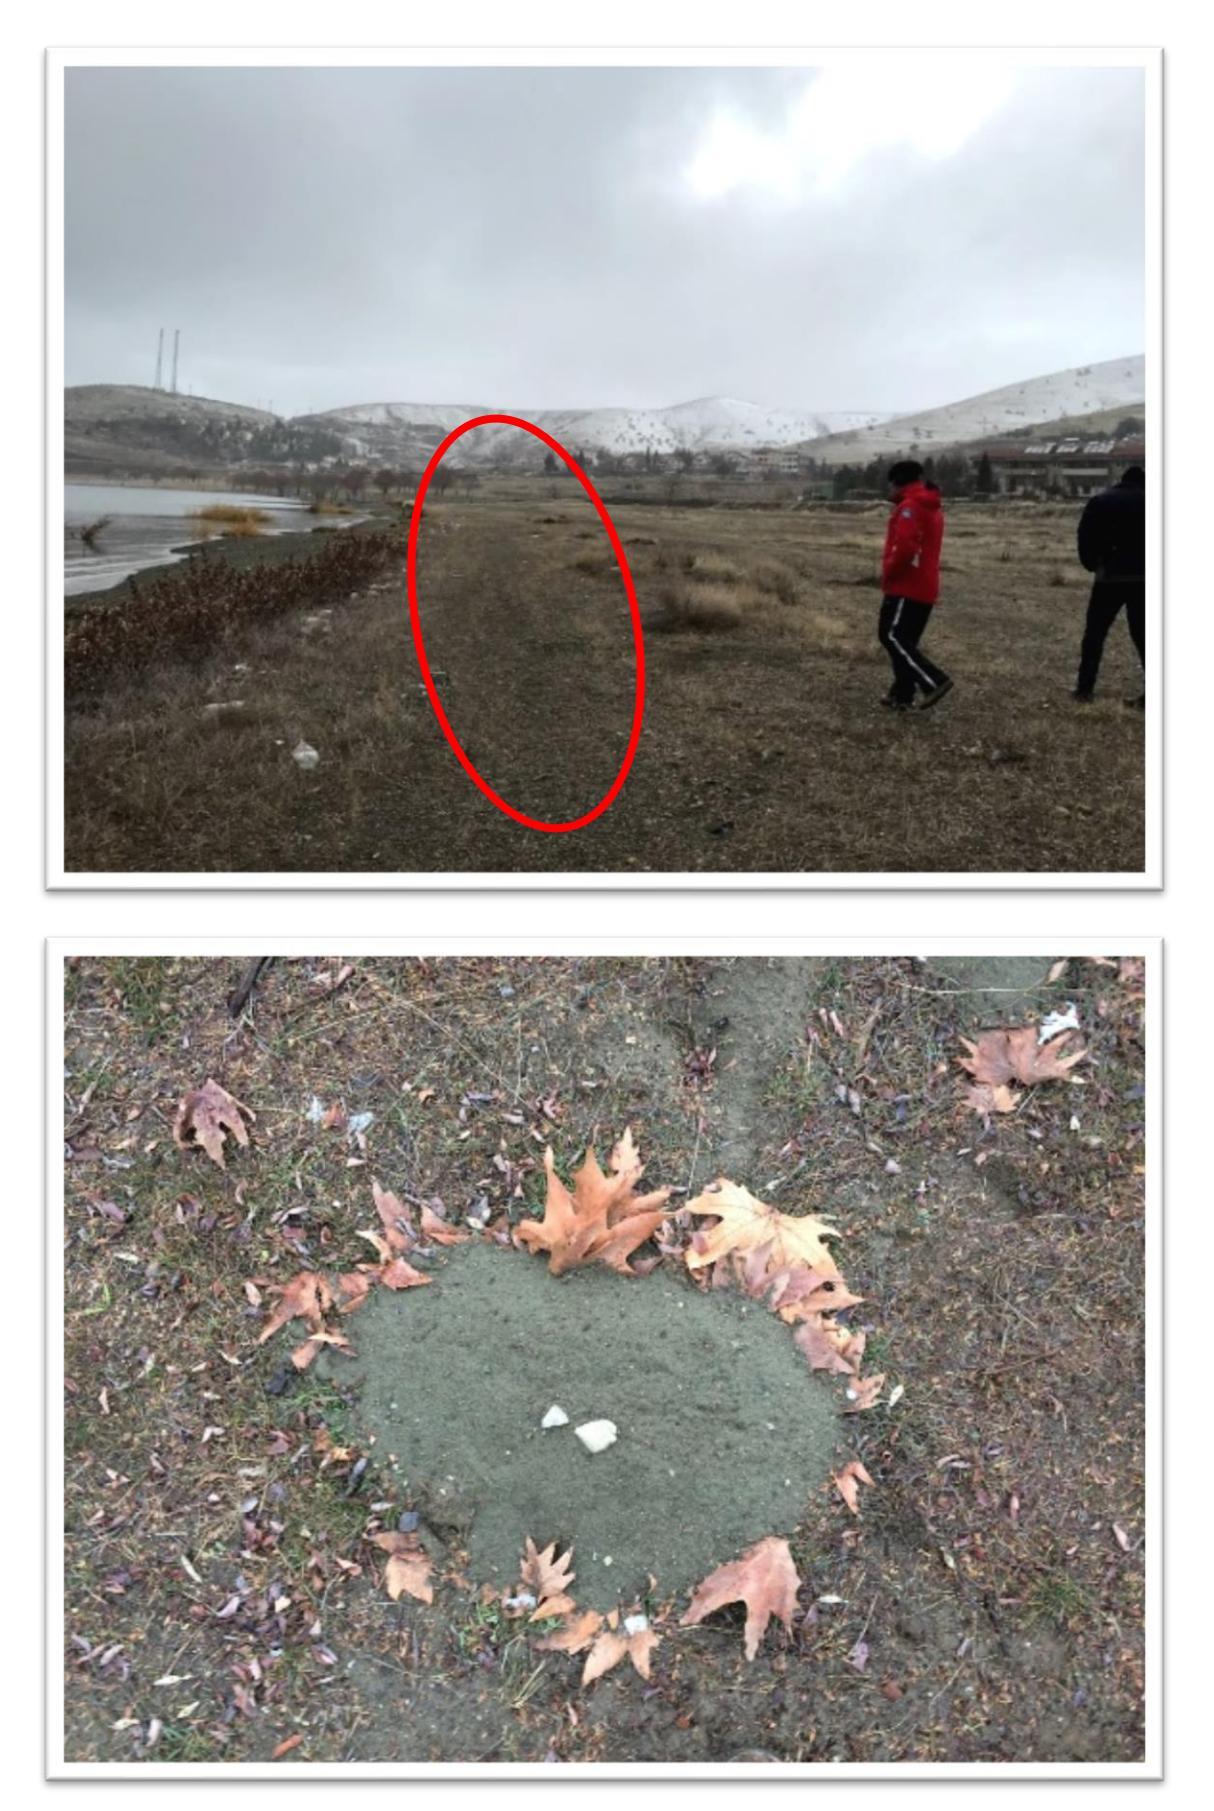
Figure 4.53 Seismic soil liquefaction-induced sand boils at Stop 15 (38°29'32.3"N 39°21'03.8"E / 31.01.2020 / 16:57 & 38°29'34.5"N 39°21'03.6"E / 31.01.2020 / 17:11)

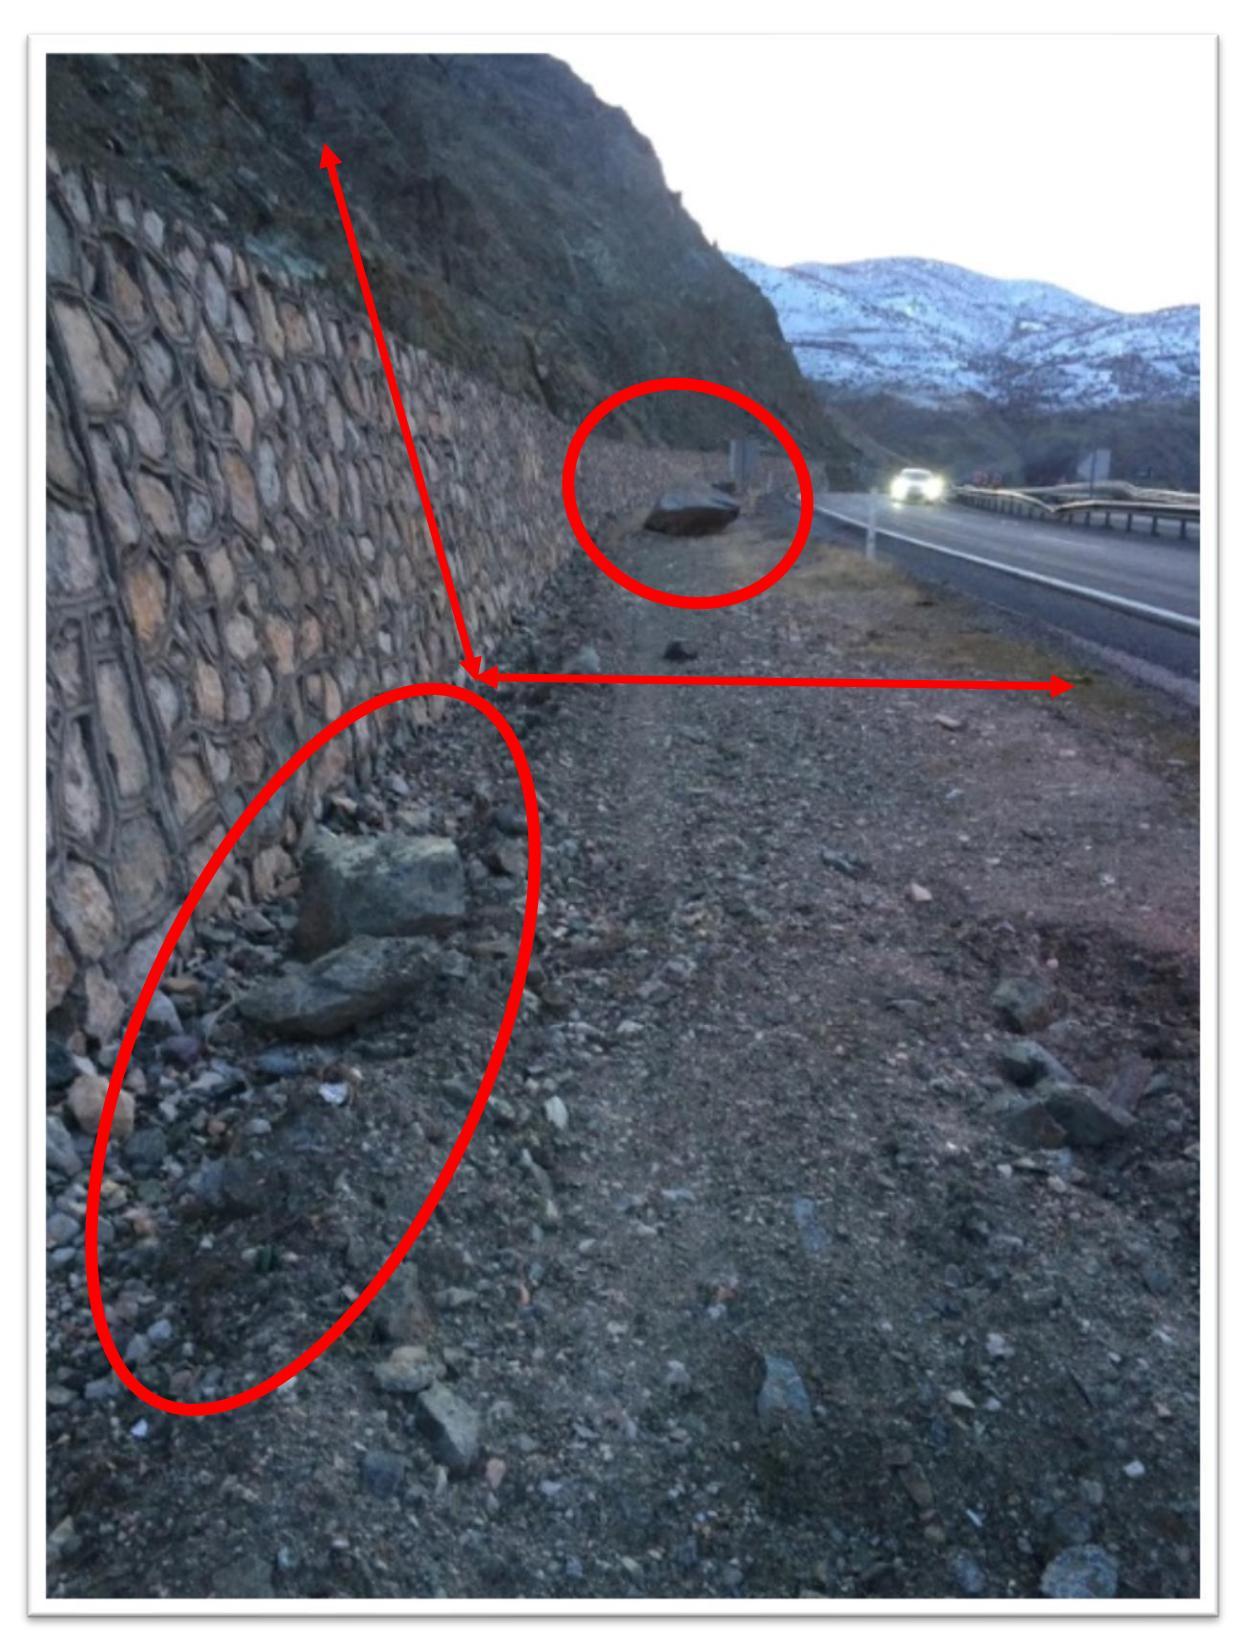
Figure 4.57 Fallen rocks on the highway (38°26'19.8"N 38°49'38.8"E / 01.02.2020 / 7:23)
