## THE ELÂZIĞ-SİVRİCE EARTHQUAKE [24 JANUARY 2020 M<sub>w</sub>=6.8] FIELD OBSERVATIONS ON SEISMIC AND STRUCTURAL DAMAGE

REPORT NO: METU/EERC 2020-01

MARCH 2020 ANKARA

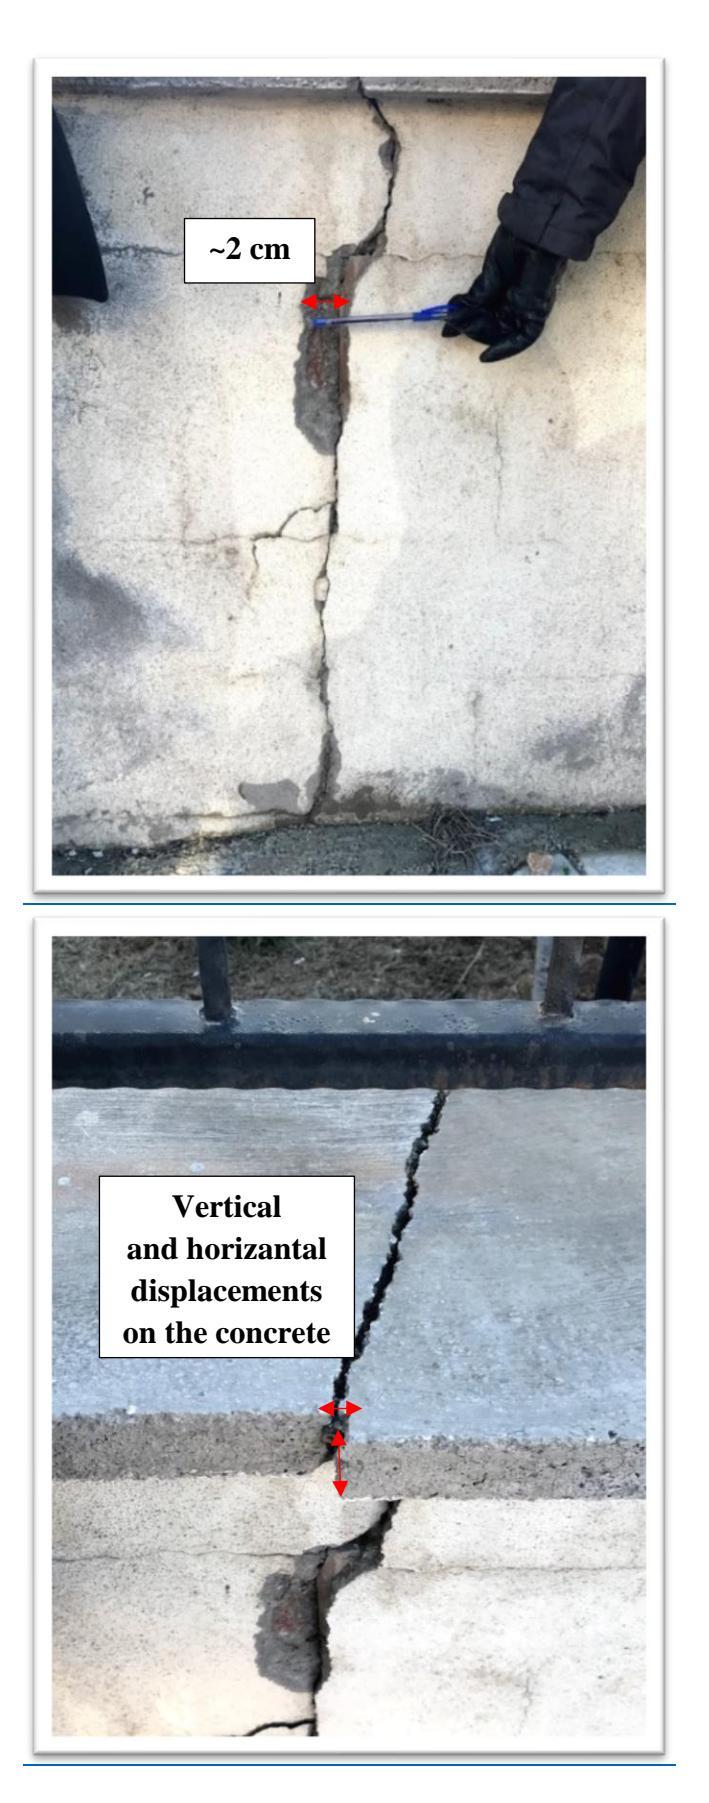
Figure 4.87 A crack on a concrete fence in Sürsürü district of Elâzığ city center (38°40'05.5"N 39°11'12.4"E / 01.02.2020 / 15:28 & 38°40'05.5"N 39°11'12.4"E / 01.02.2020 / 15:28)

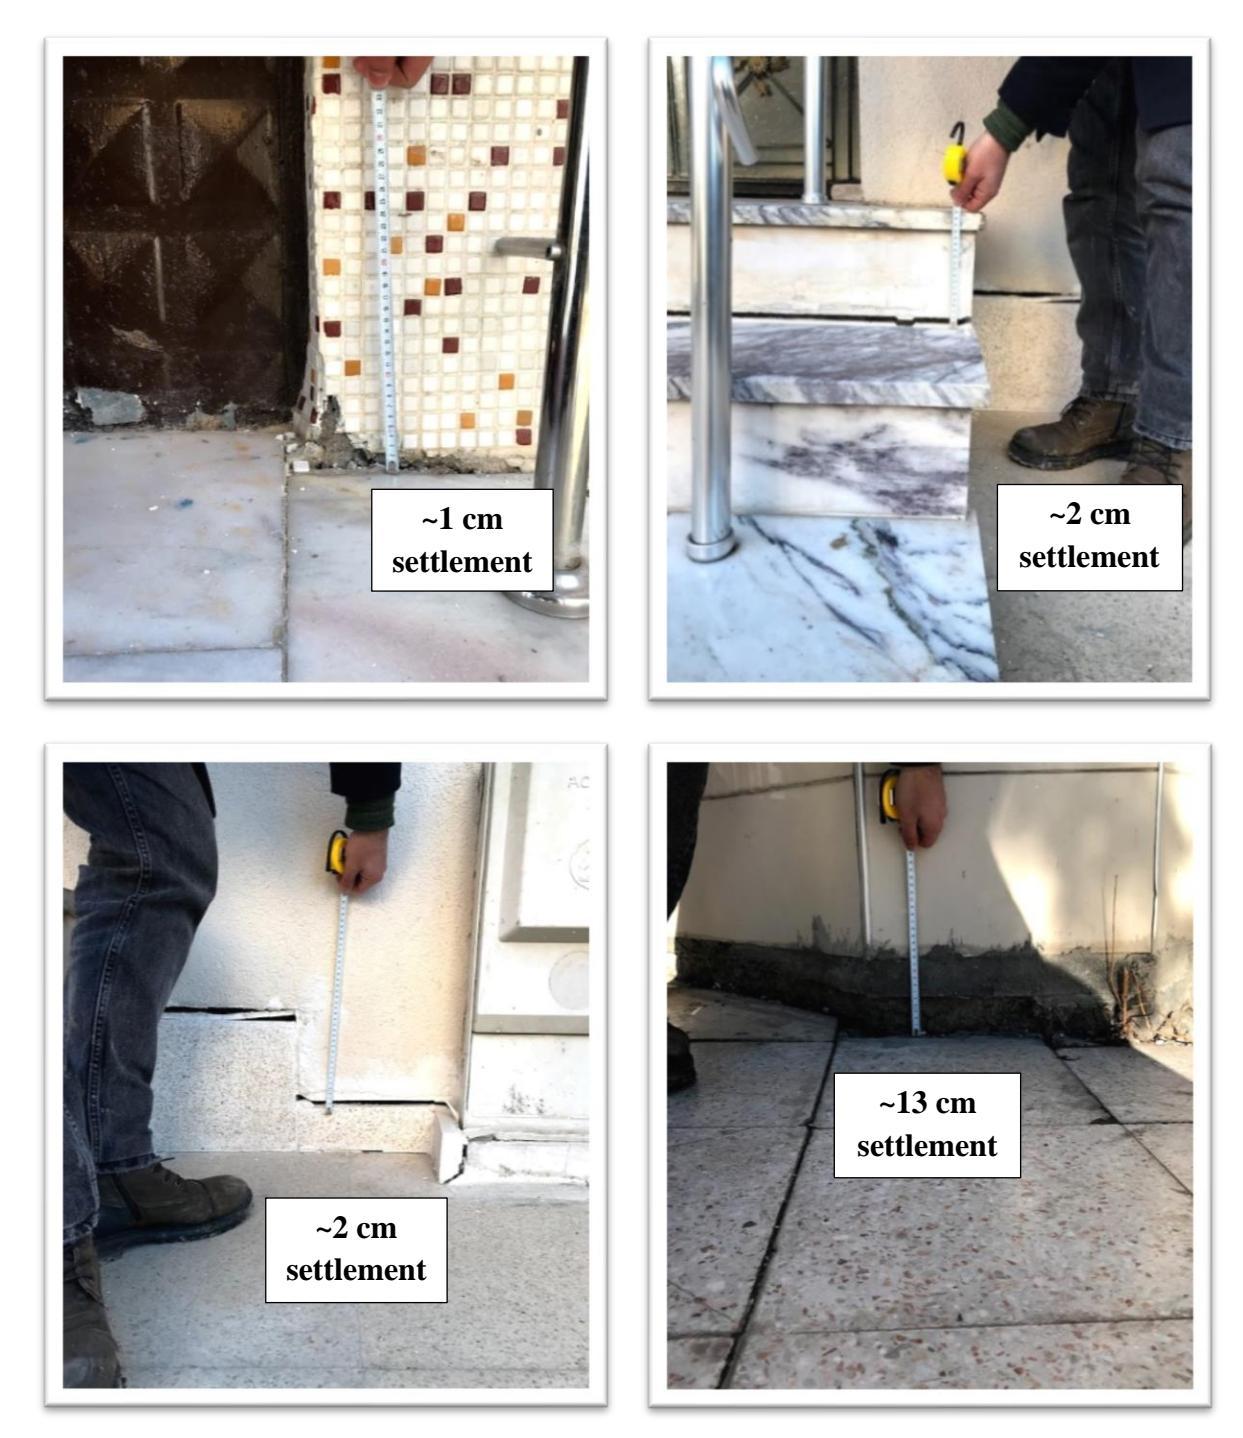
Figure 4.88 Settlement mapped at the entrance of some buildings

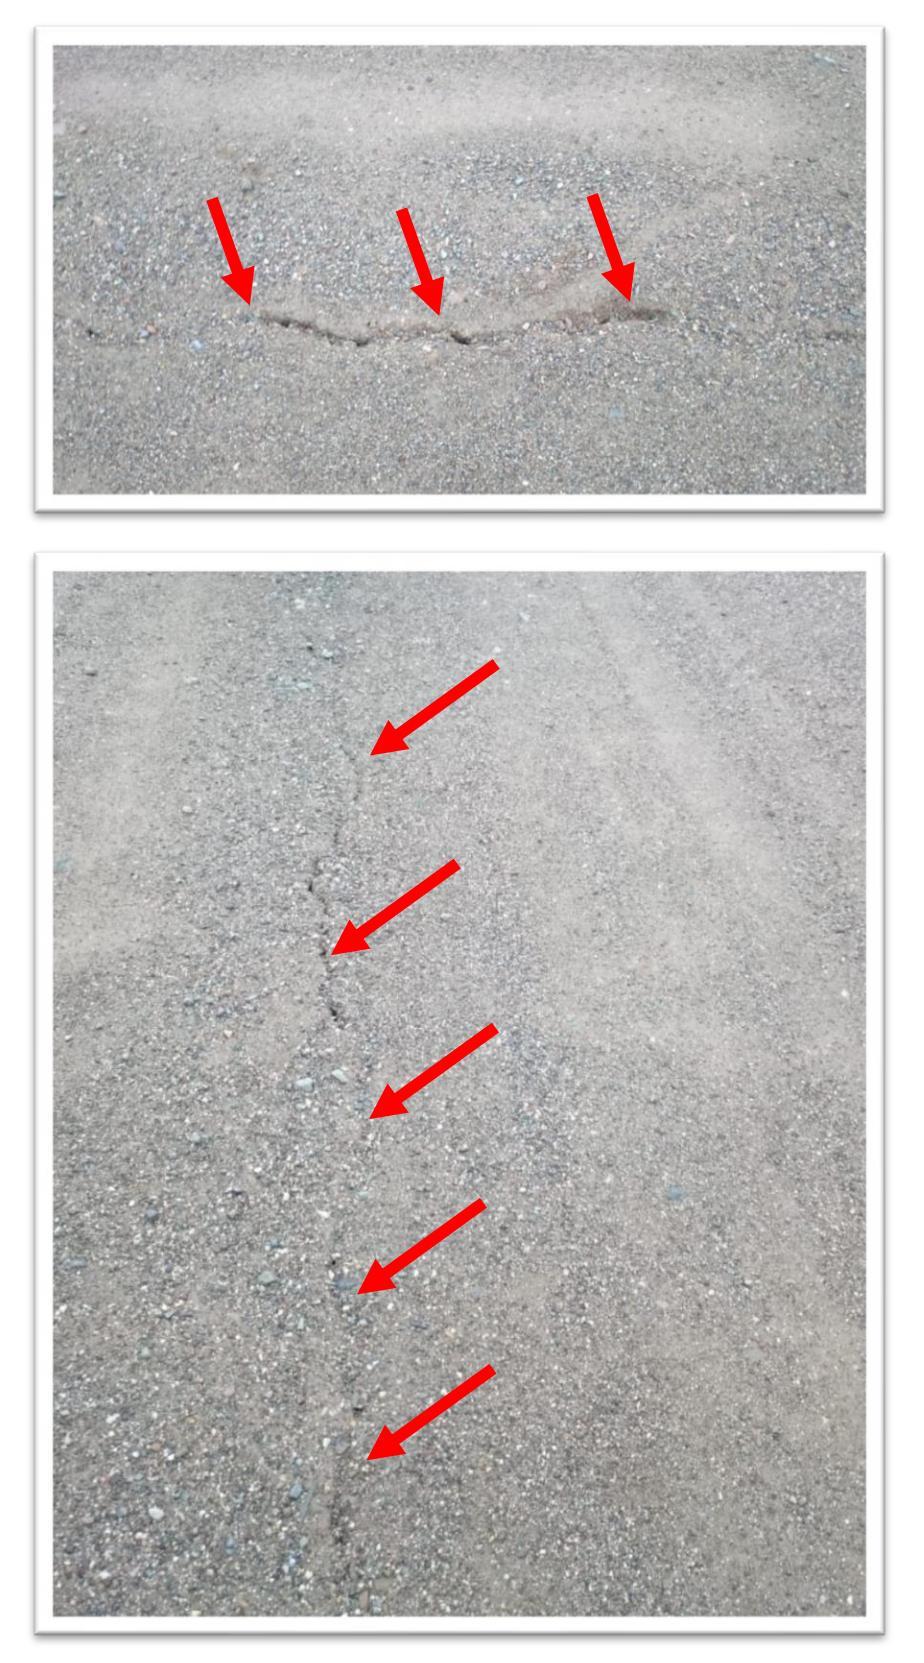
Figure 4.100 Longitudinal cracks on Dedeyolu Dam crest (Courtesy of S. Aydin, DSİ)

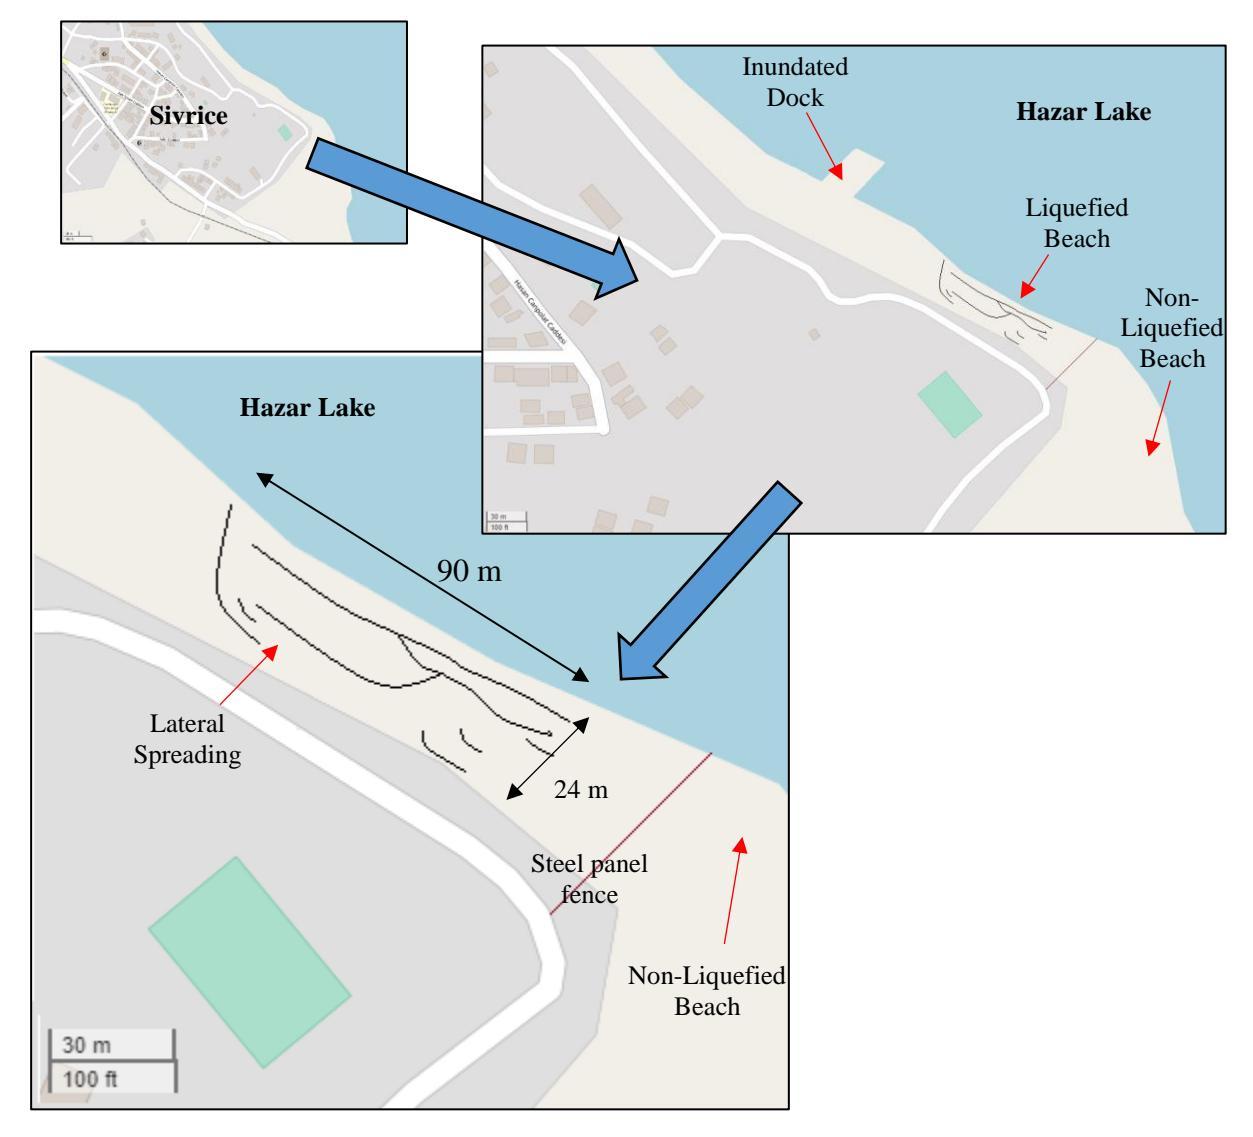
Figure 4.104 A sketch of lateral spread deformations at 2<sup>nd</sup> stop (38°28'10.0"N 39°17'03.6"E / 31.01.2020 / 12:11)

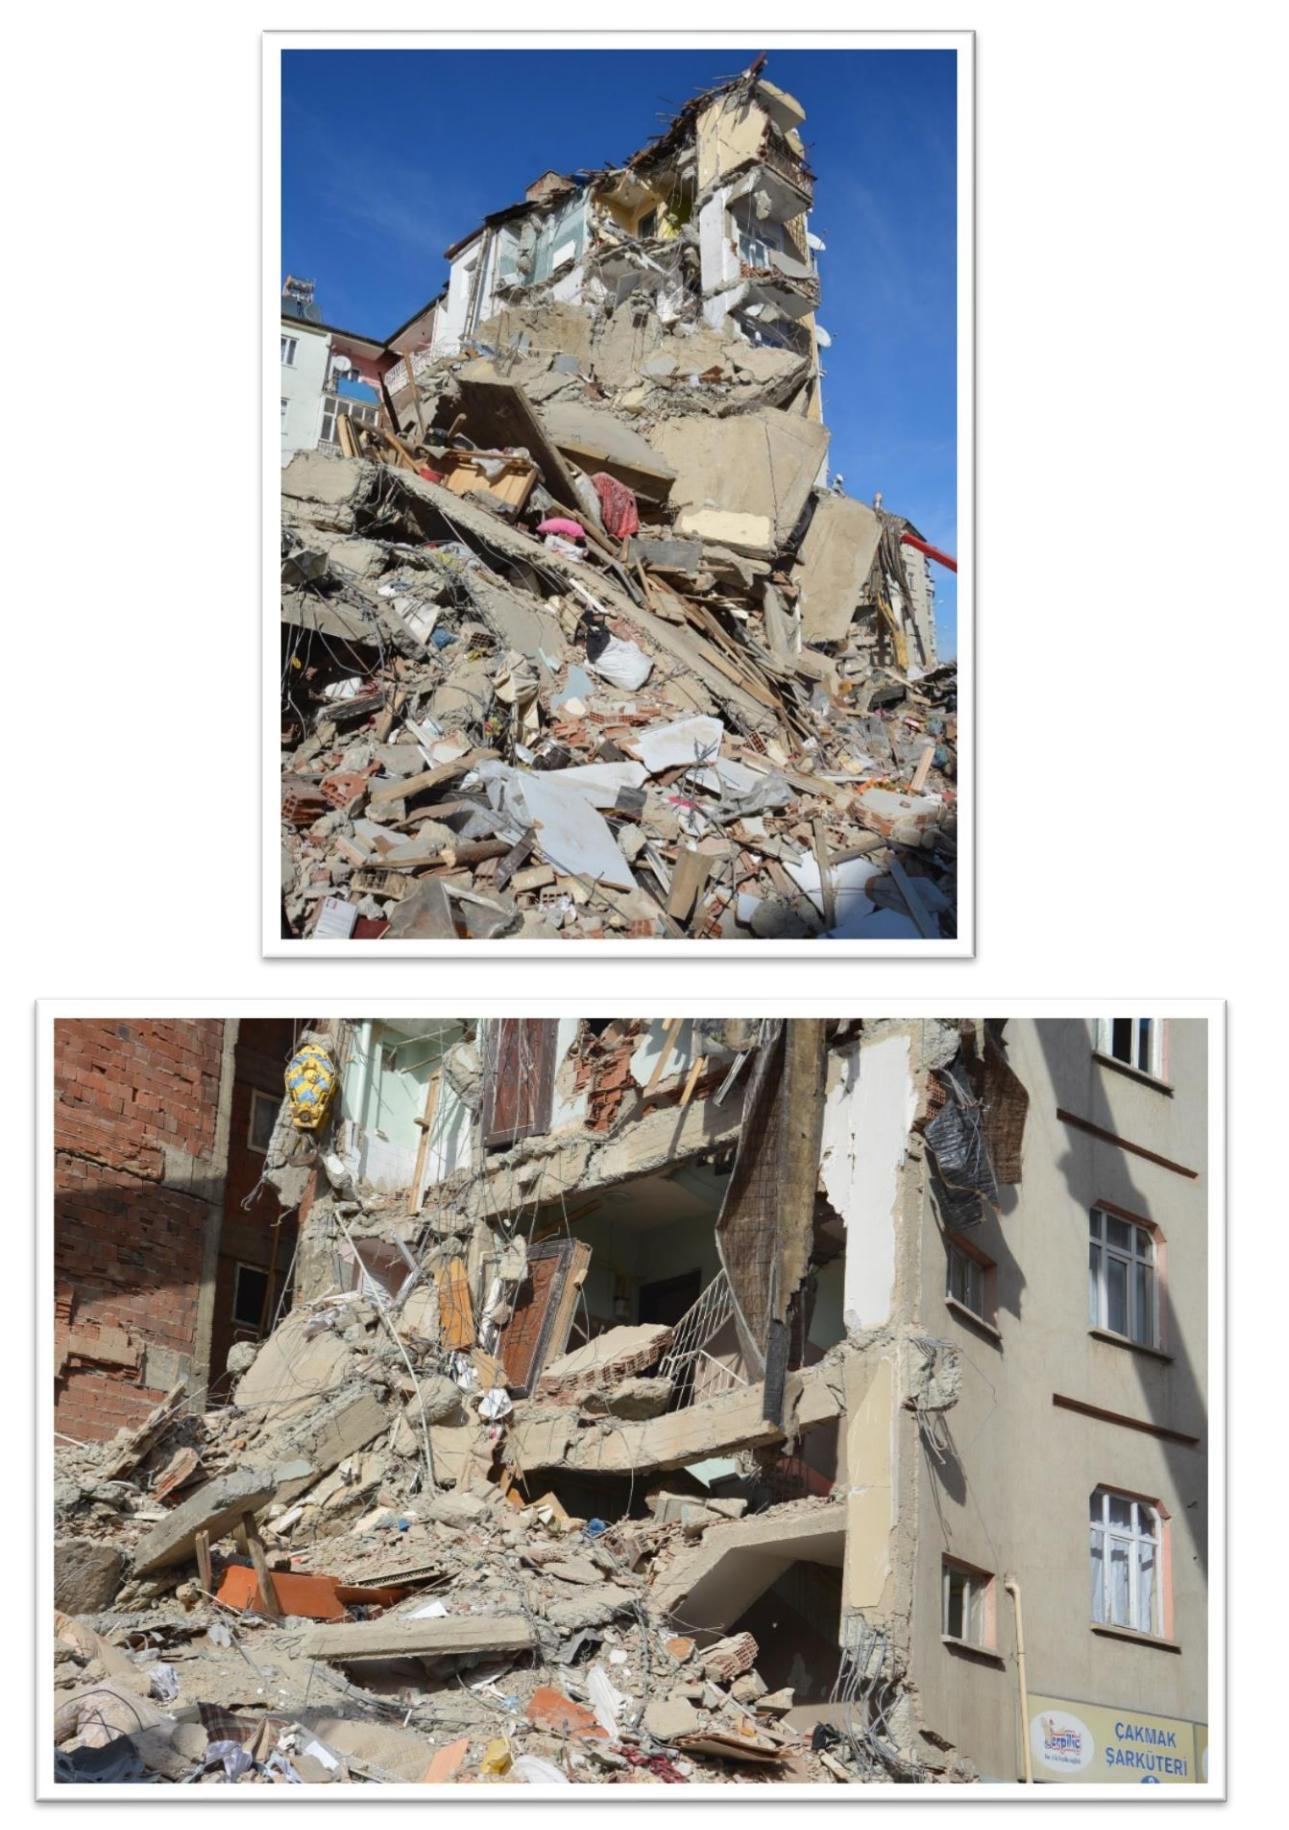
Figure 5.6 Total collapsed buildings in Elâzığ city center

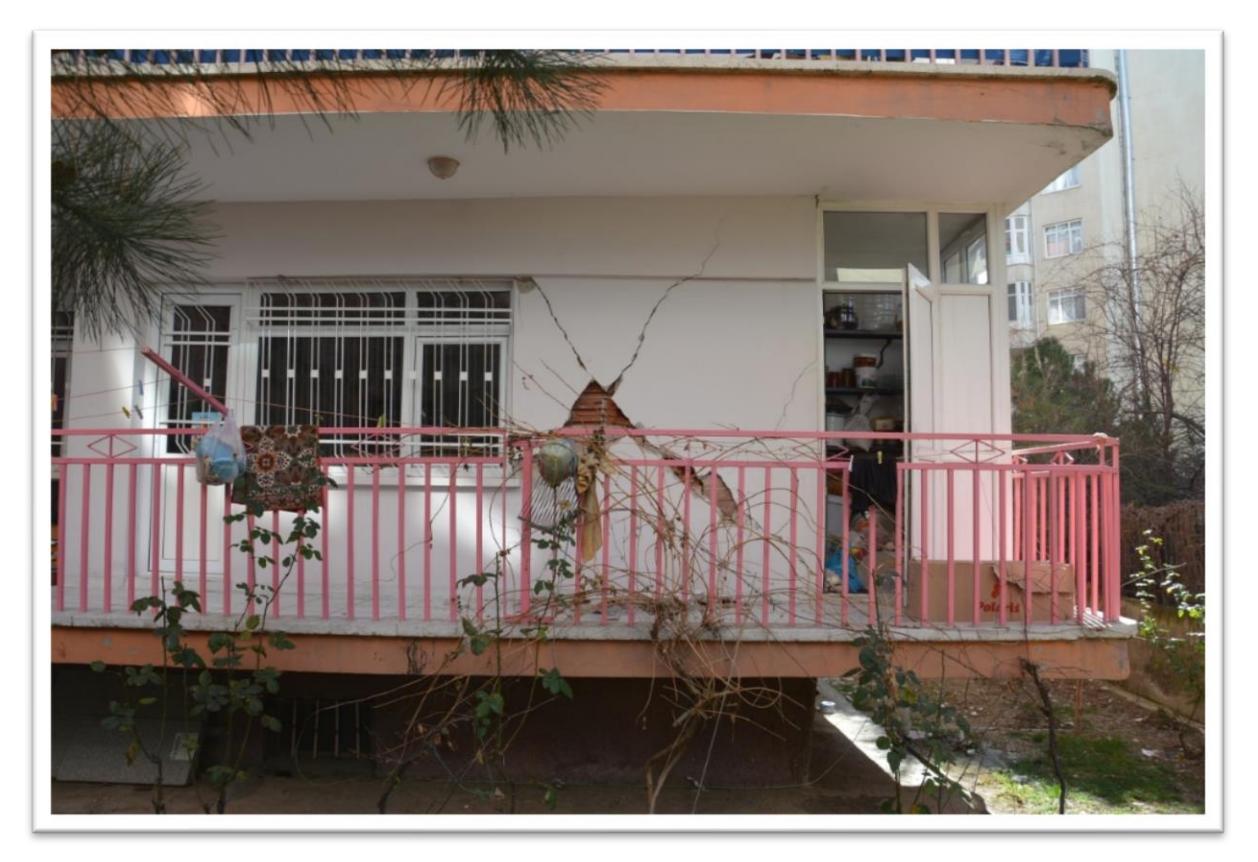
Figure 5.8 Diagonal partition wall crack, exterior

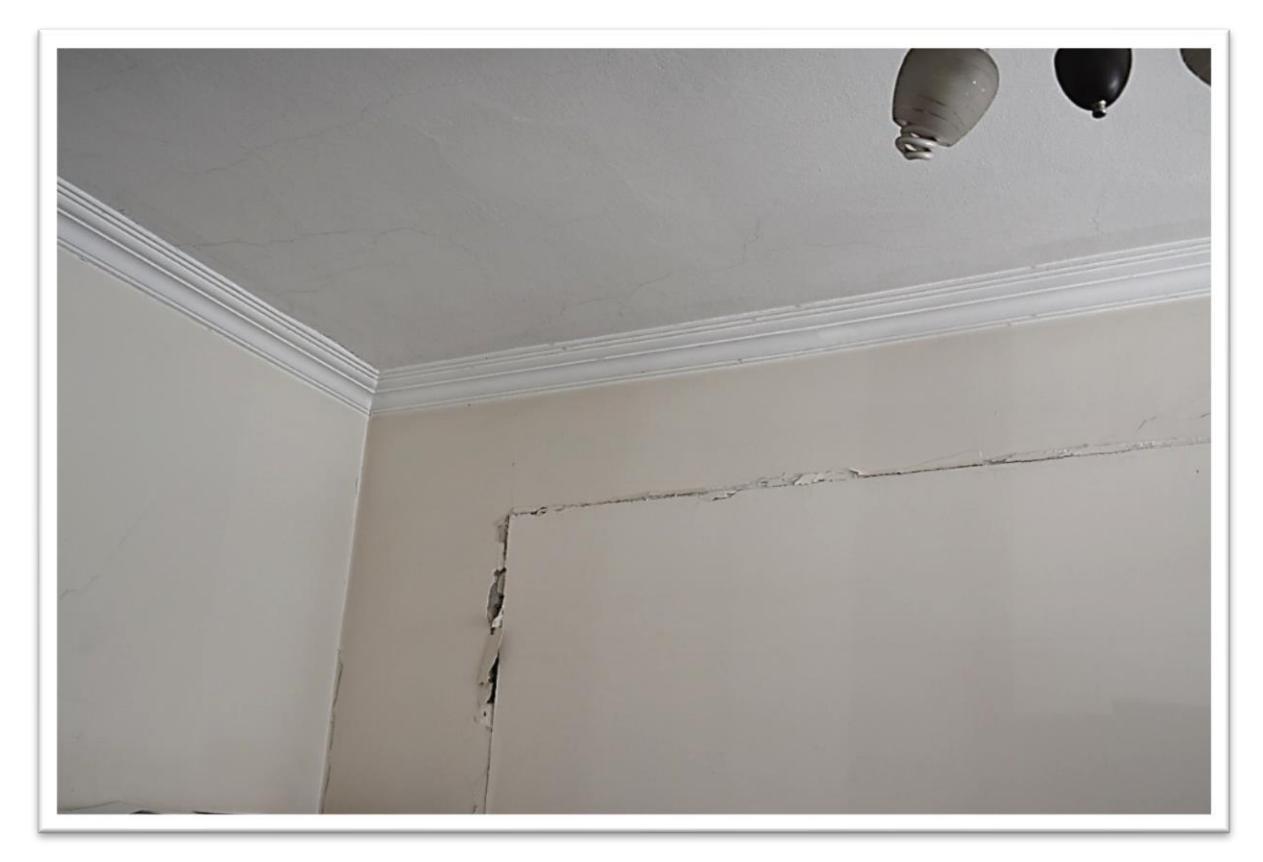
Figure 5.9 Partition wall cracks on the beam-column boundary, interior

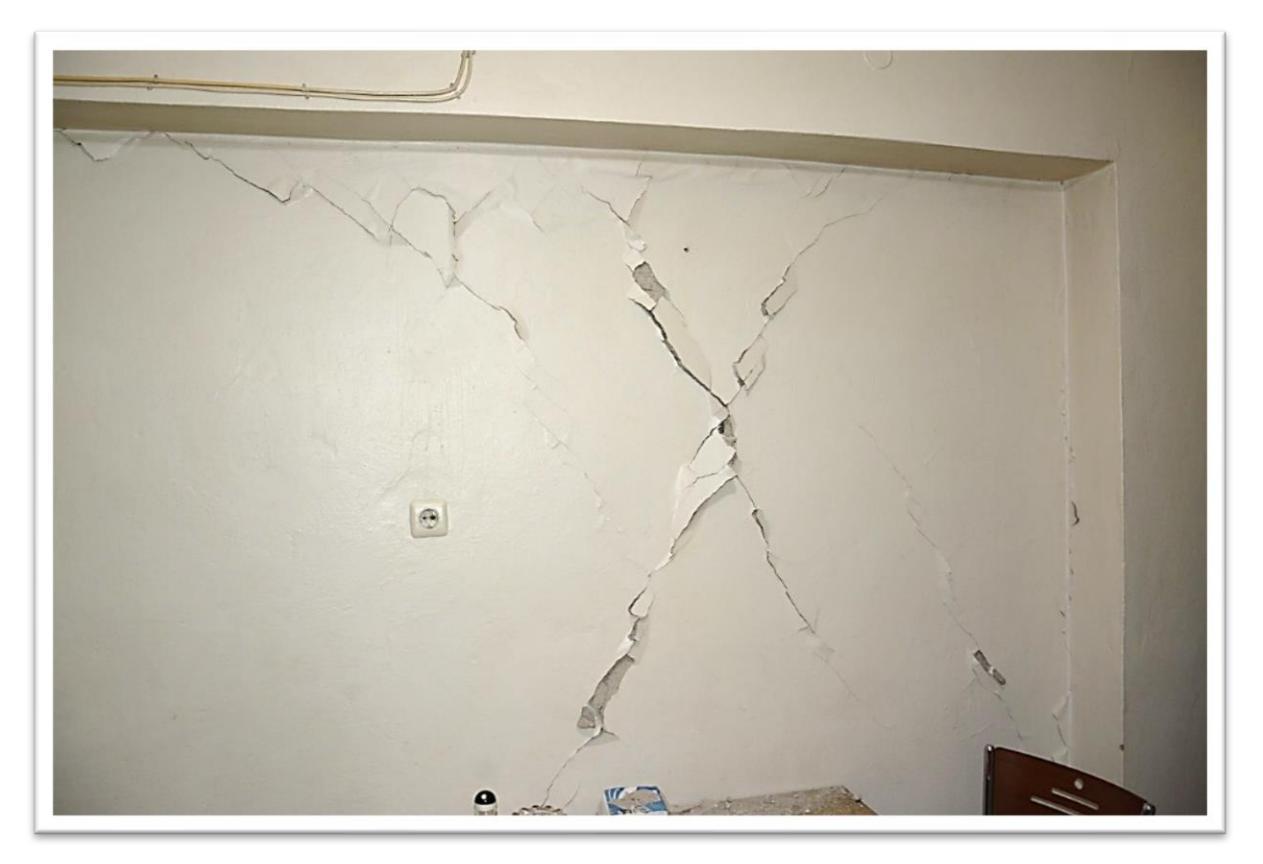
Figure 5.10 Diagonal partition wall crack, interior

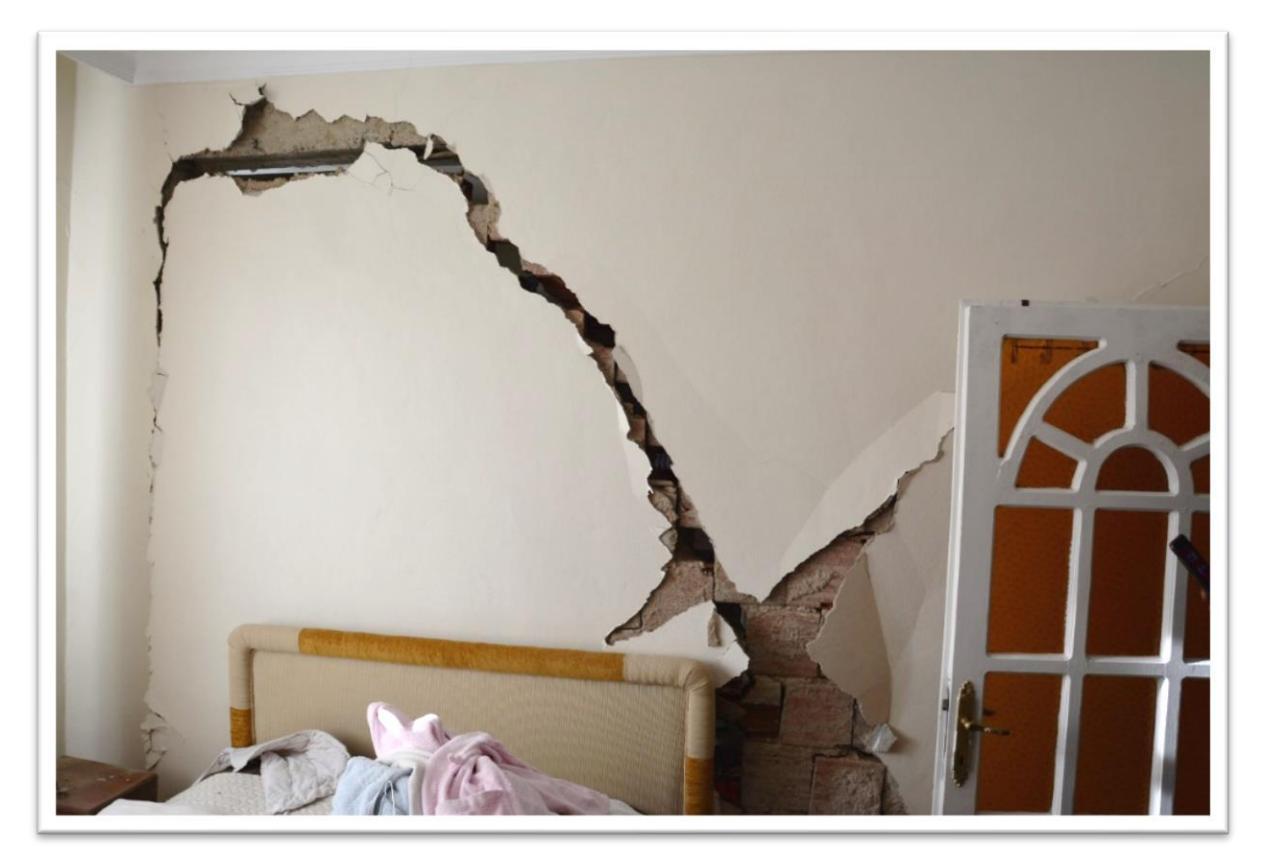
Figure 5.11 Heavy diagonal partition wall crack

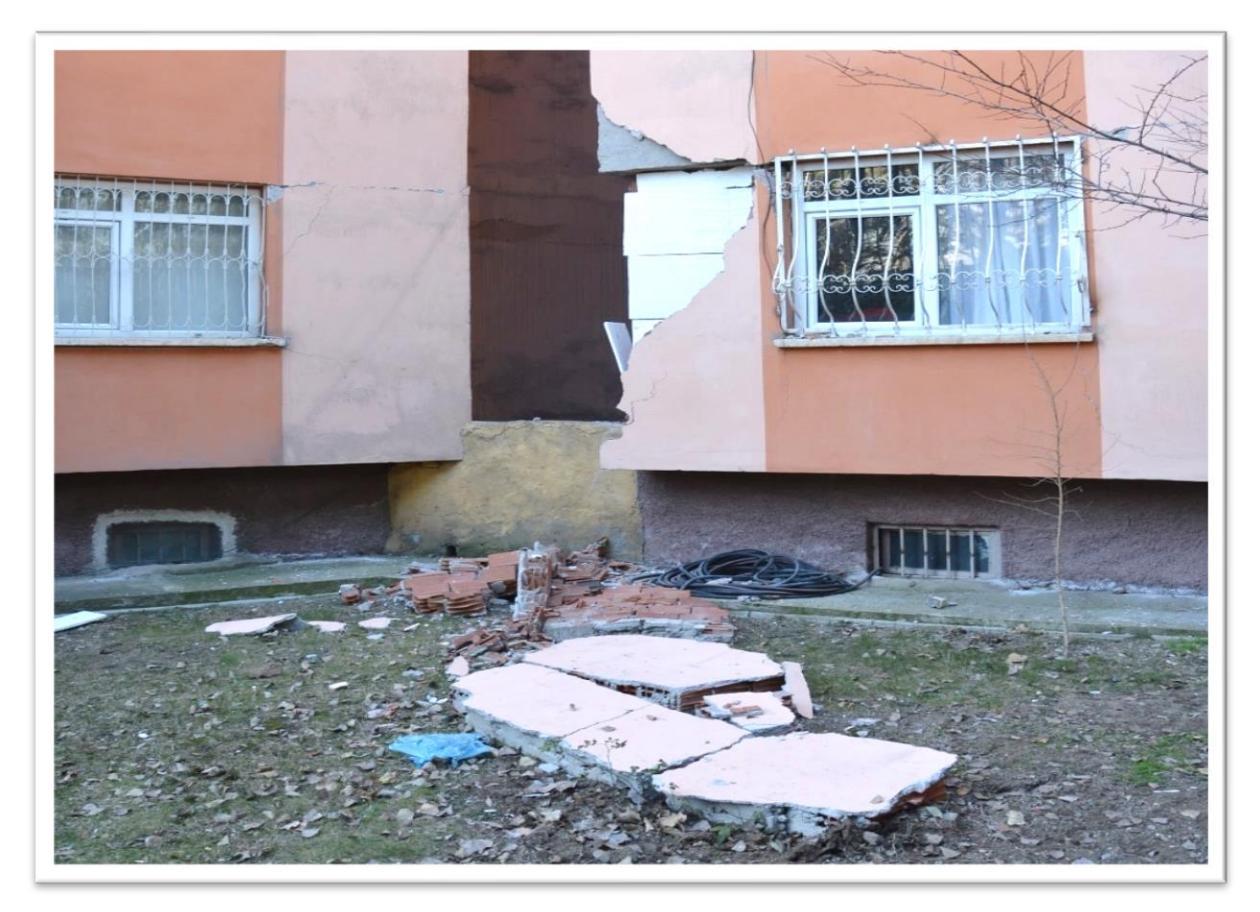
Figure 5.12 Partition wall fall

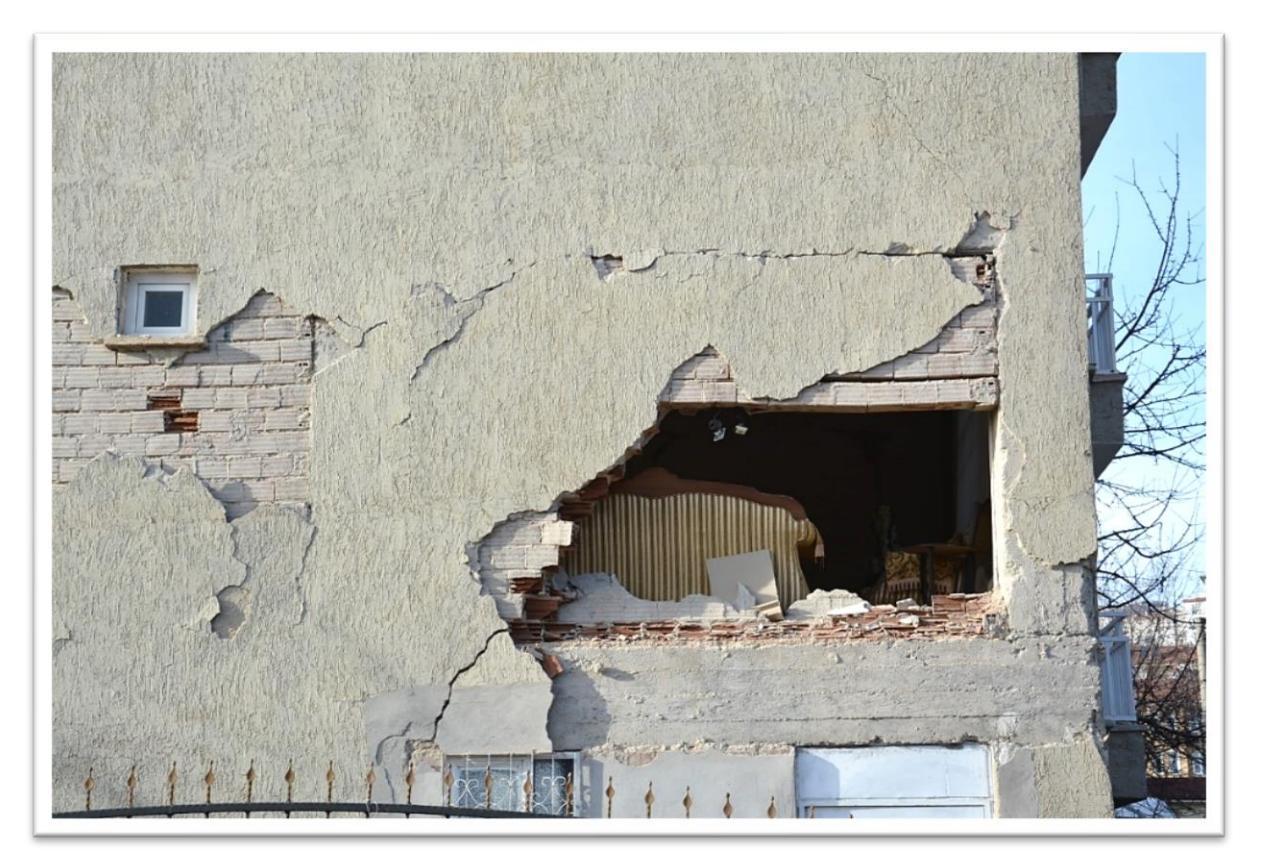
Figure 5.13 Out of plane failure of the partition wall

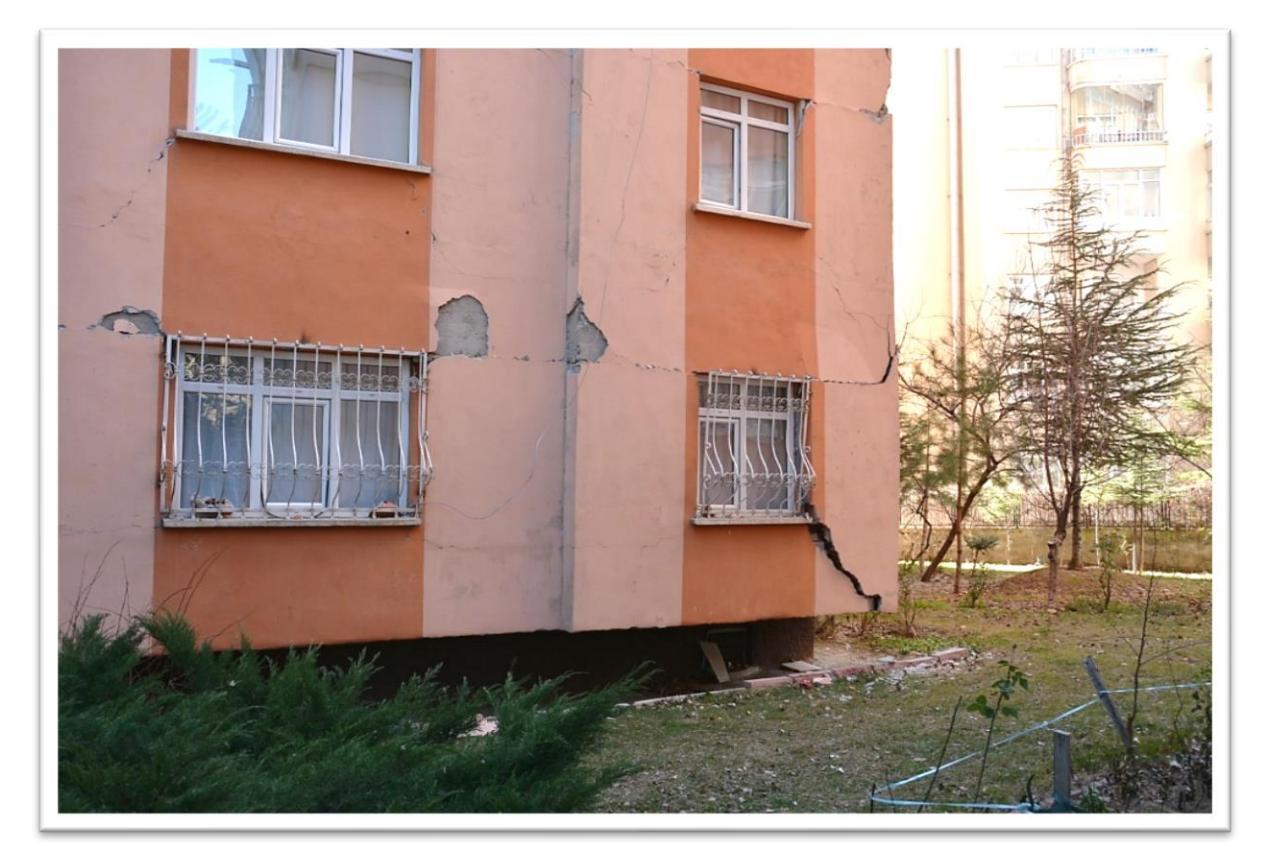
Figure 5.14 Heavy overhang damages

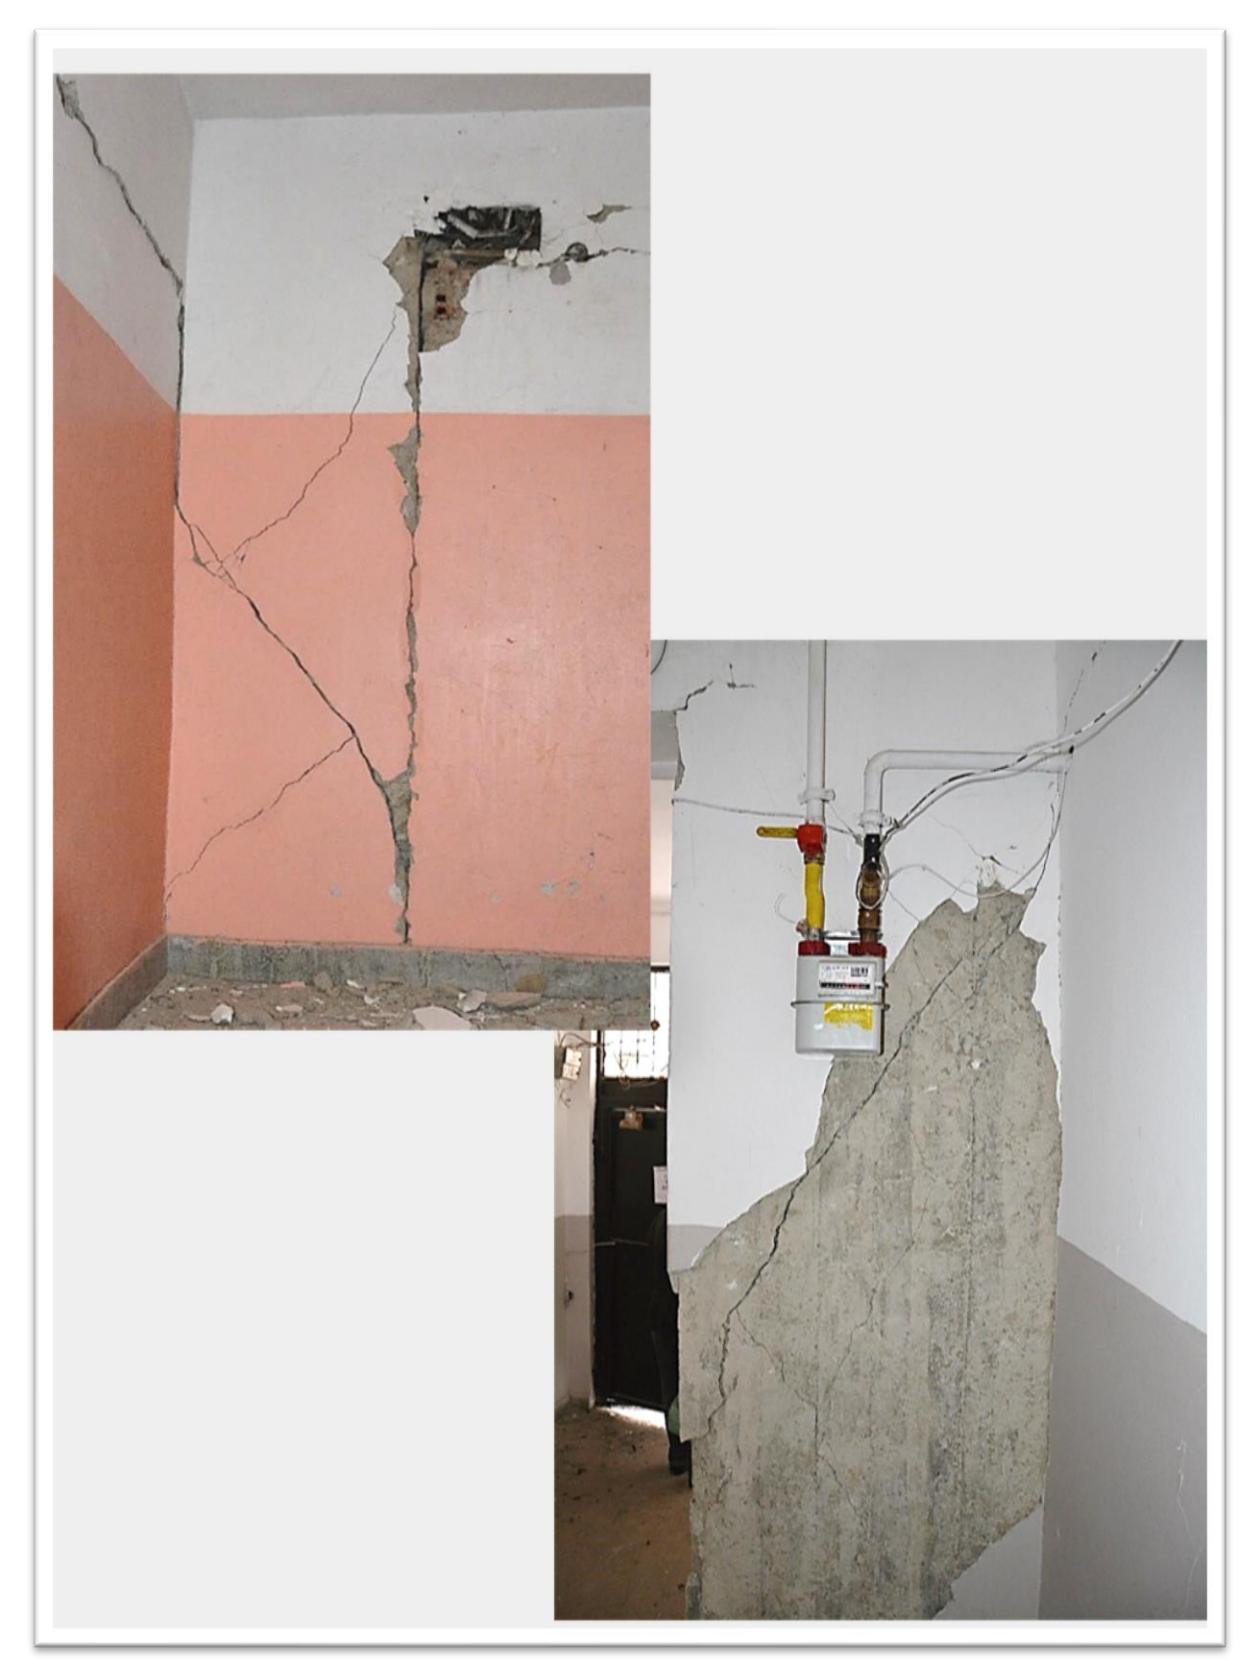
Figure 5.18 Shear failure in columns

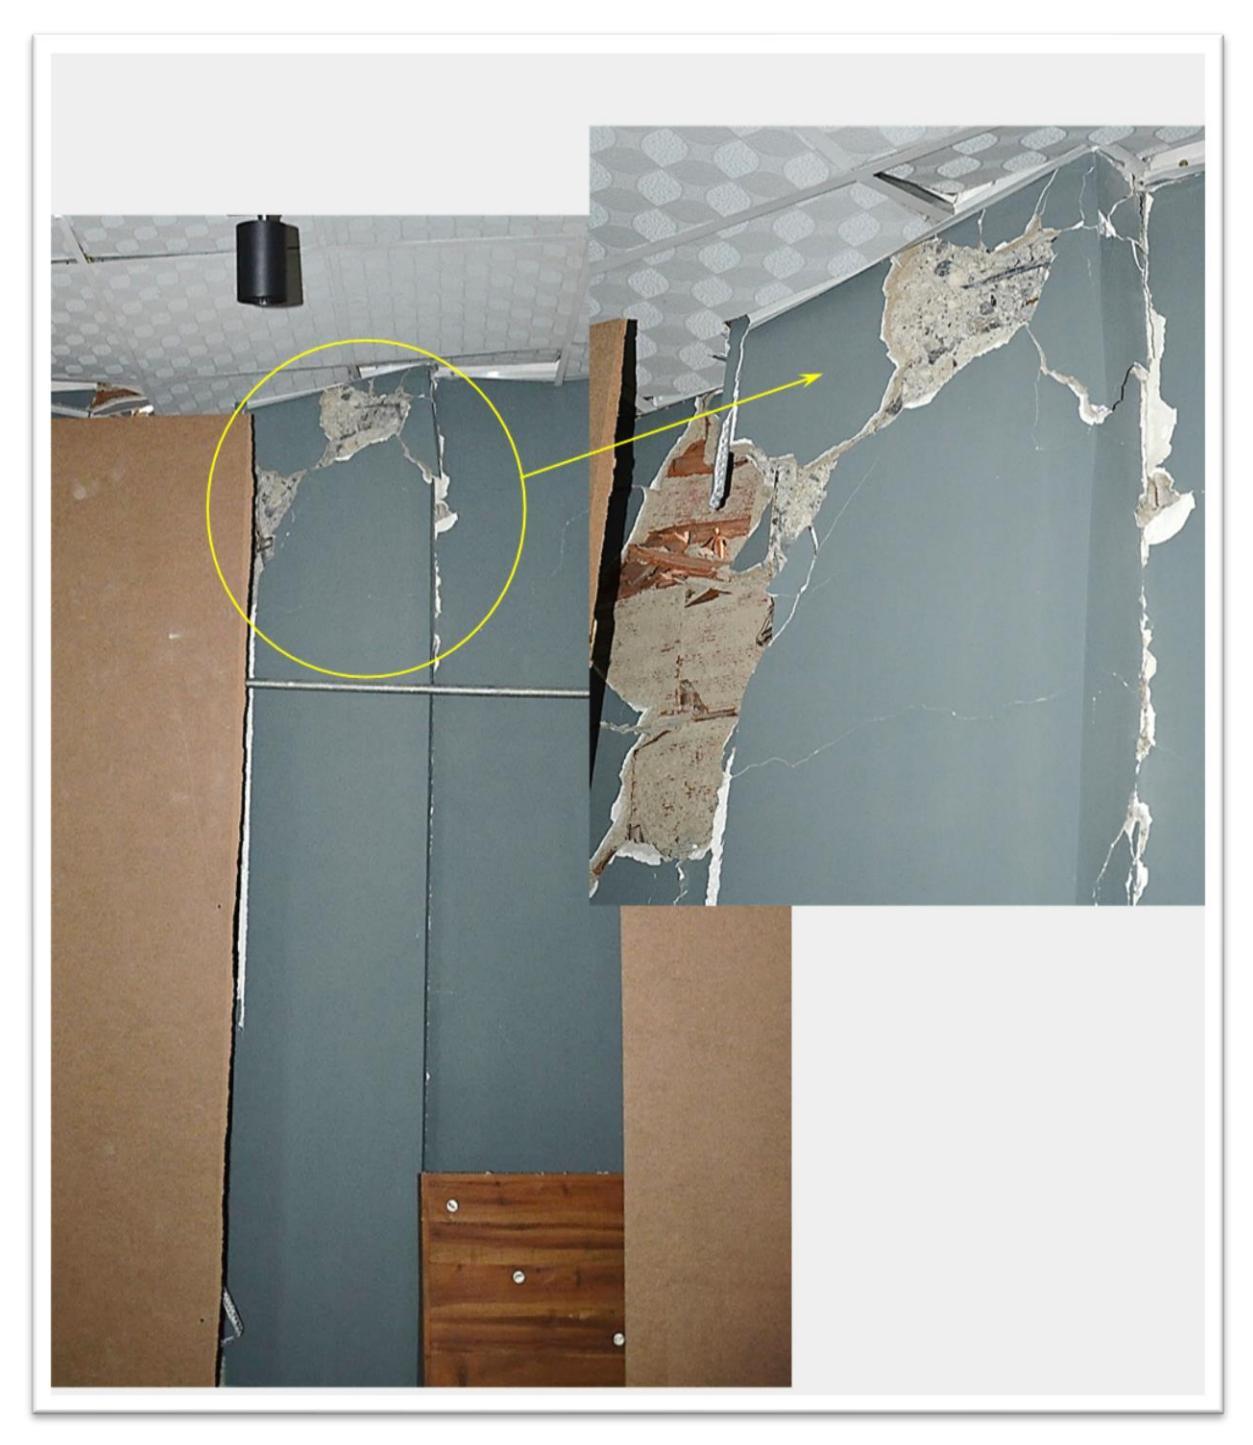
Figure 5.19 Plastic hinging at the top of the column

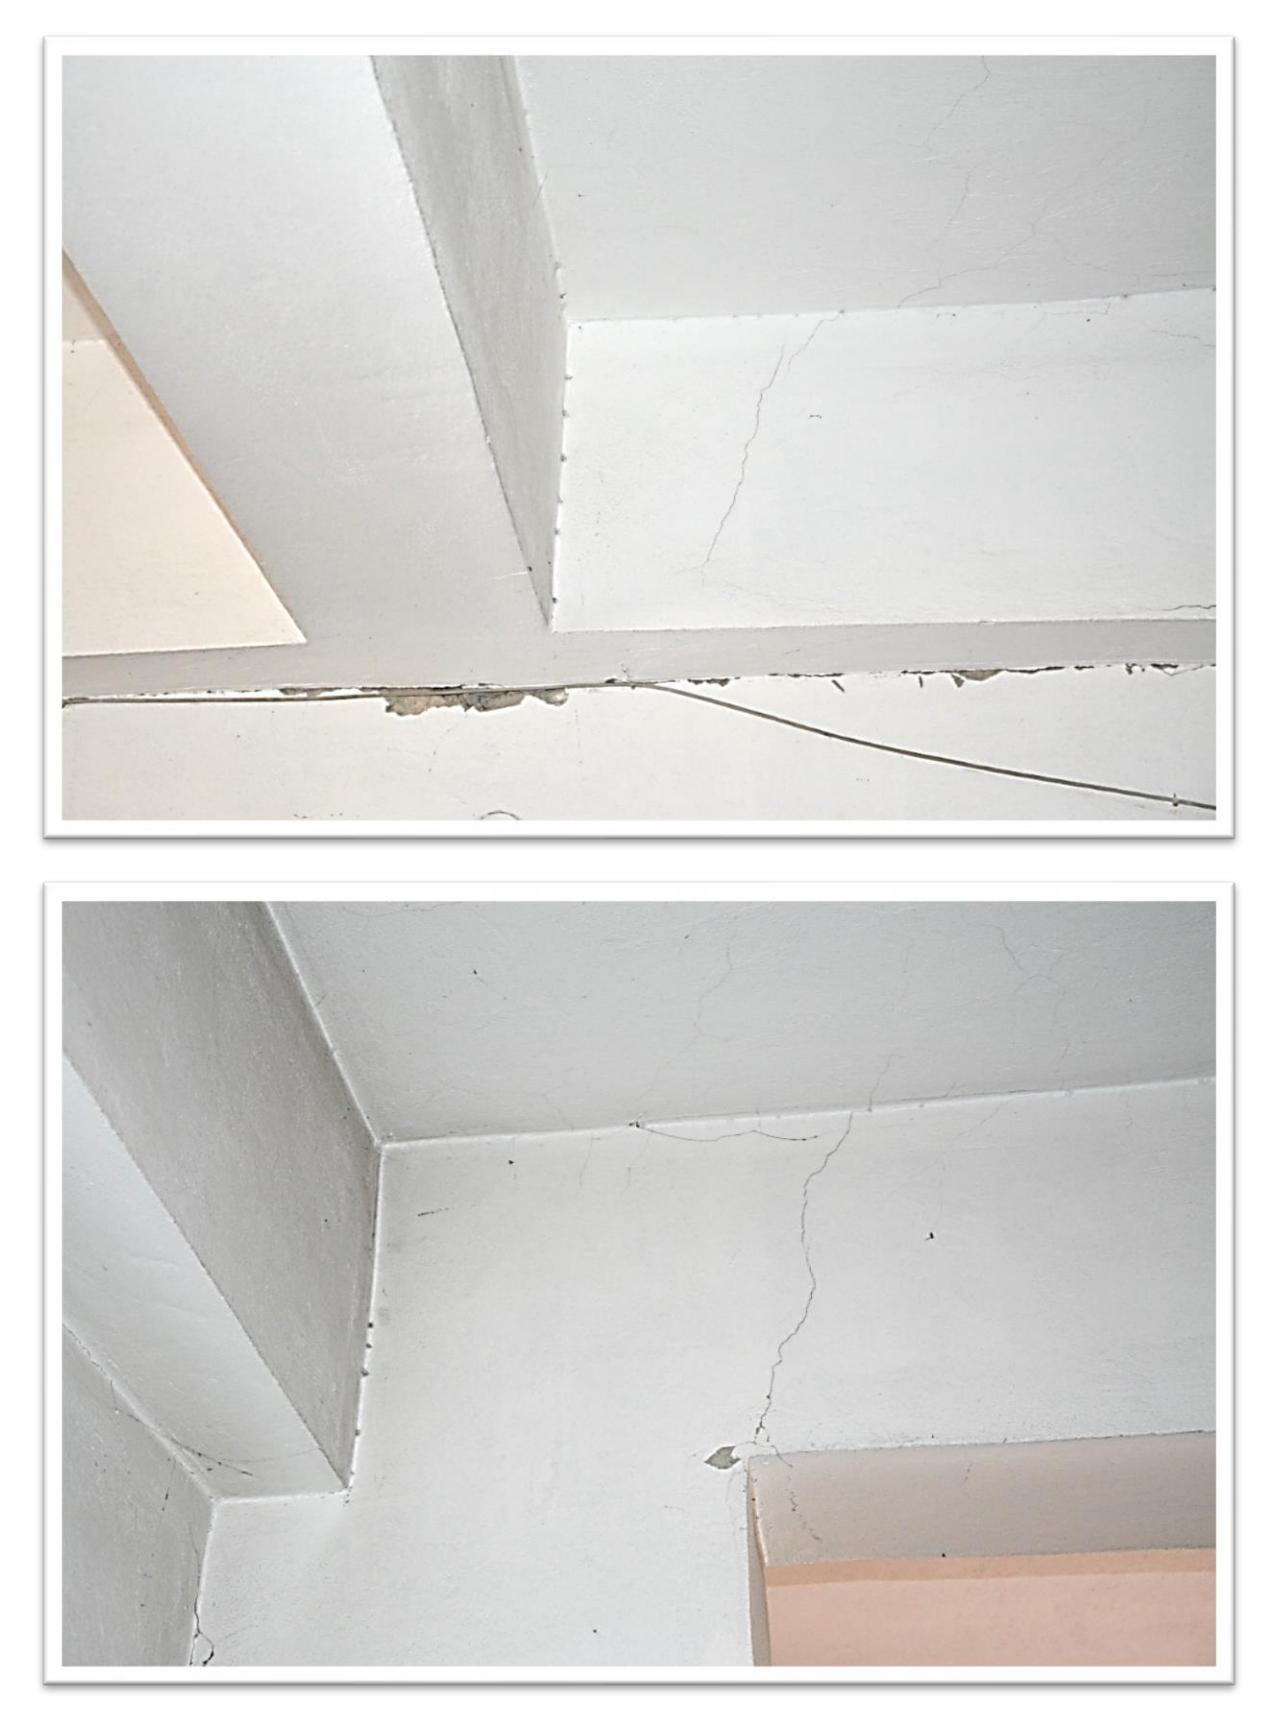
Figure 5.23 Beam shear cracks
