## THE ELÂZIĞ-SİVRİCE EARTHQUAKE [24 JANUARY 2020 M<sub>w</sub>=6.8] FIELD OBSERVATIONS ON SEISMIC AND STRUCTURAL DAMAGE

REPORT NO: METU/EERC 2020-01

MARCH 2020 ANKARA

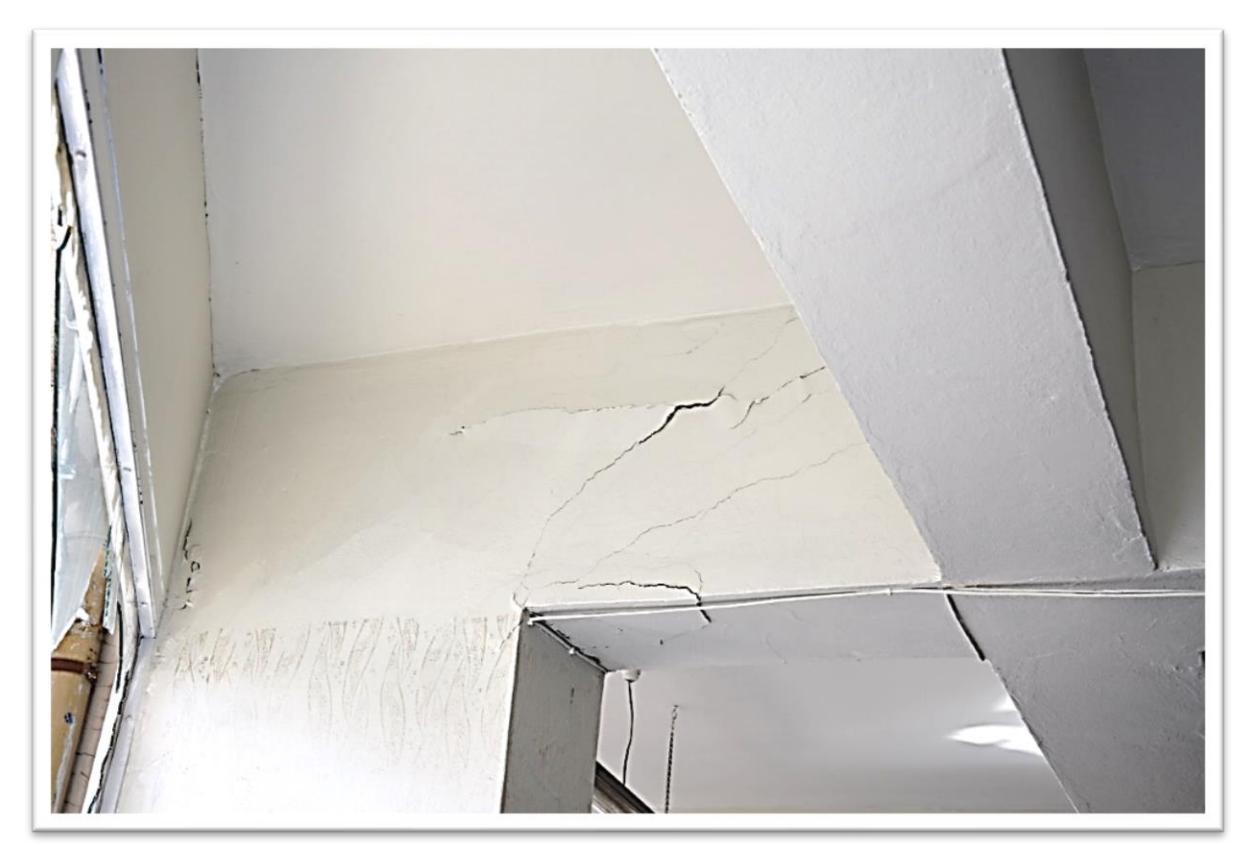
Figure 5.24 Beam shear cracks

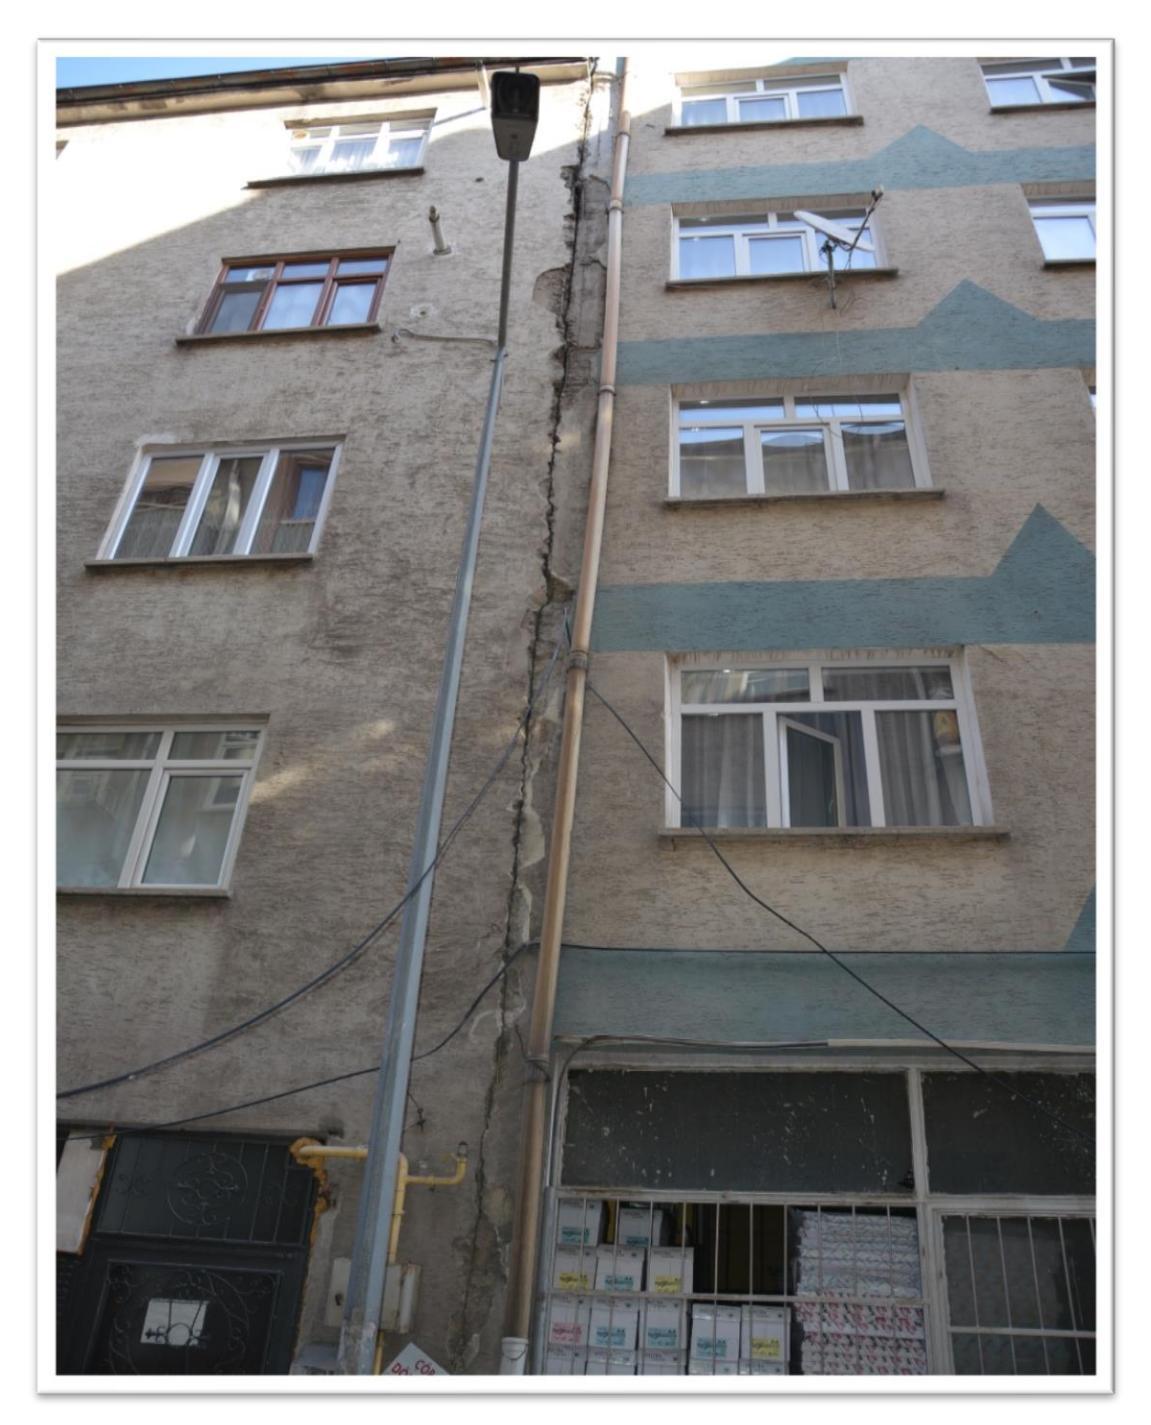
Figure 5.26 Adjacent building damage

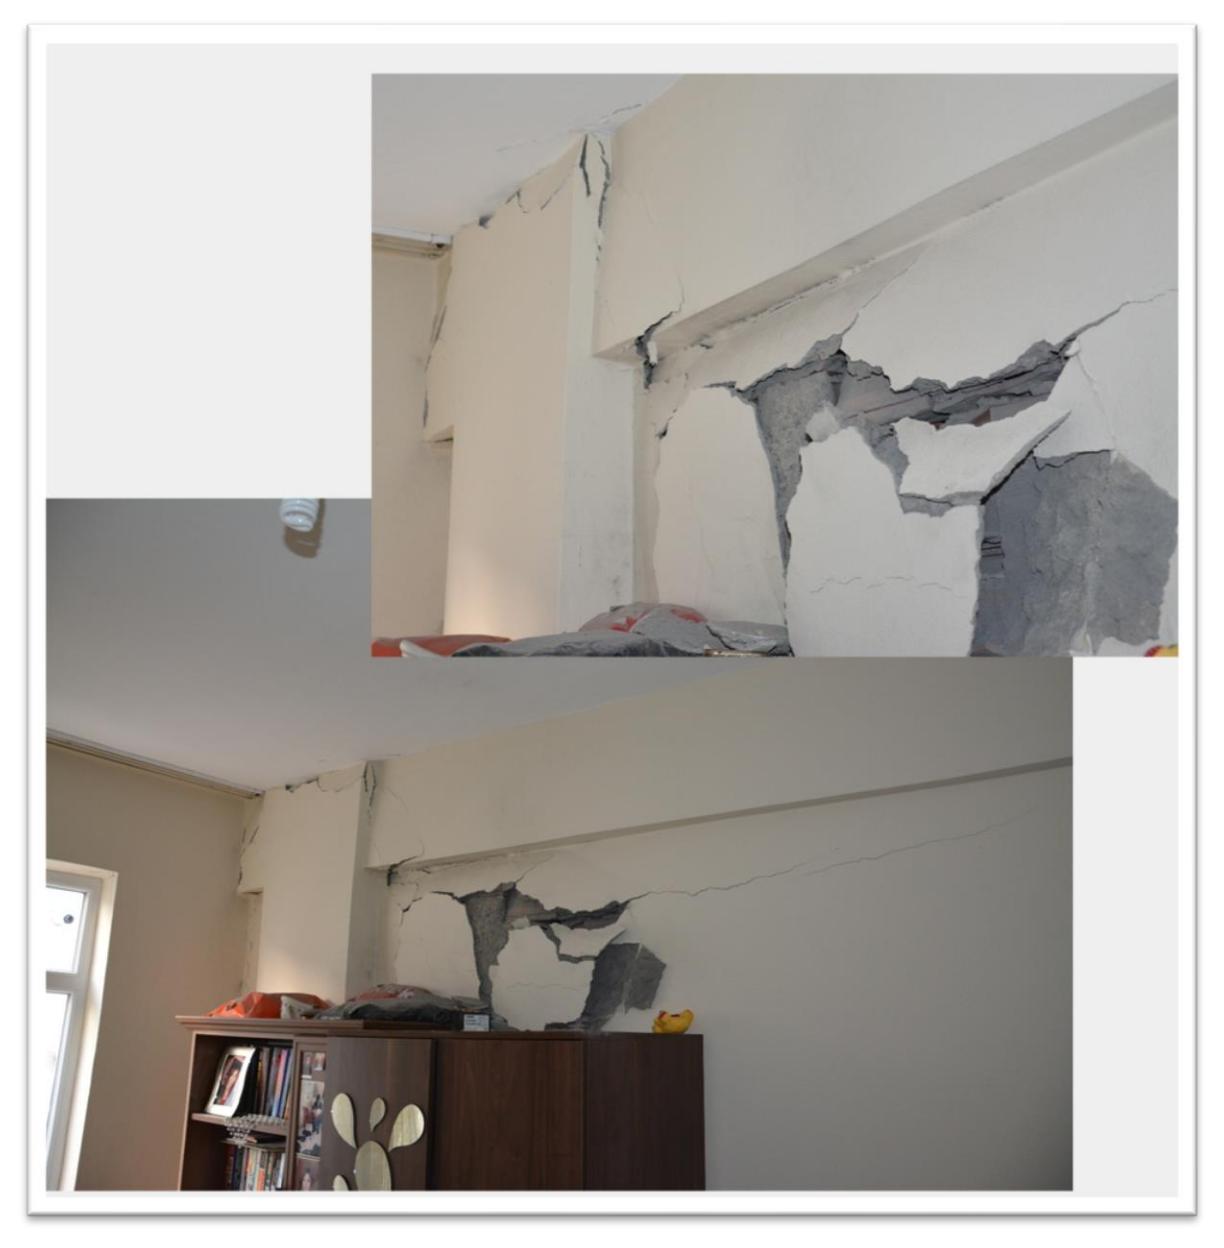
at this level. Pounding damage is seen in Figure 5.27. The impact of pounding damaged the beam-column joint heavily.

Figure 5.27 Pounding damage

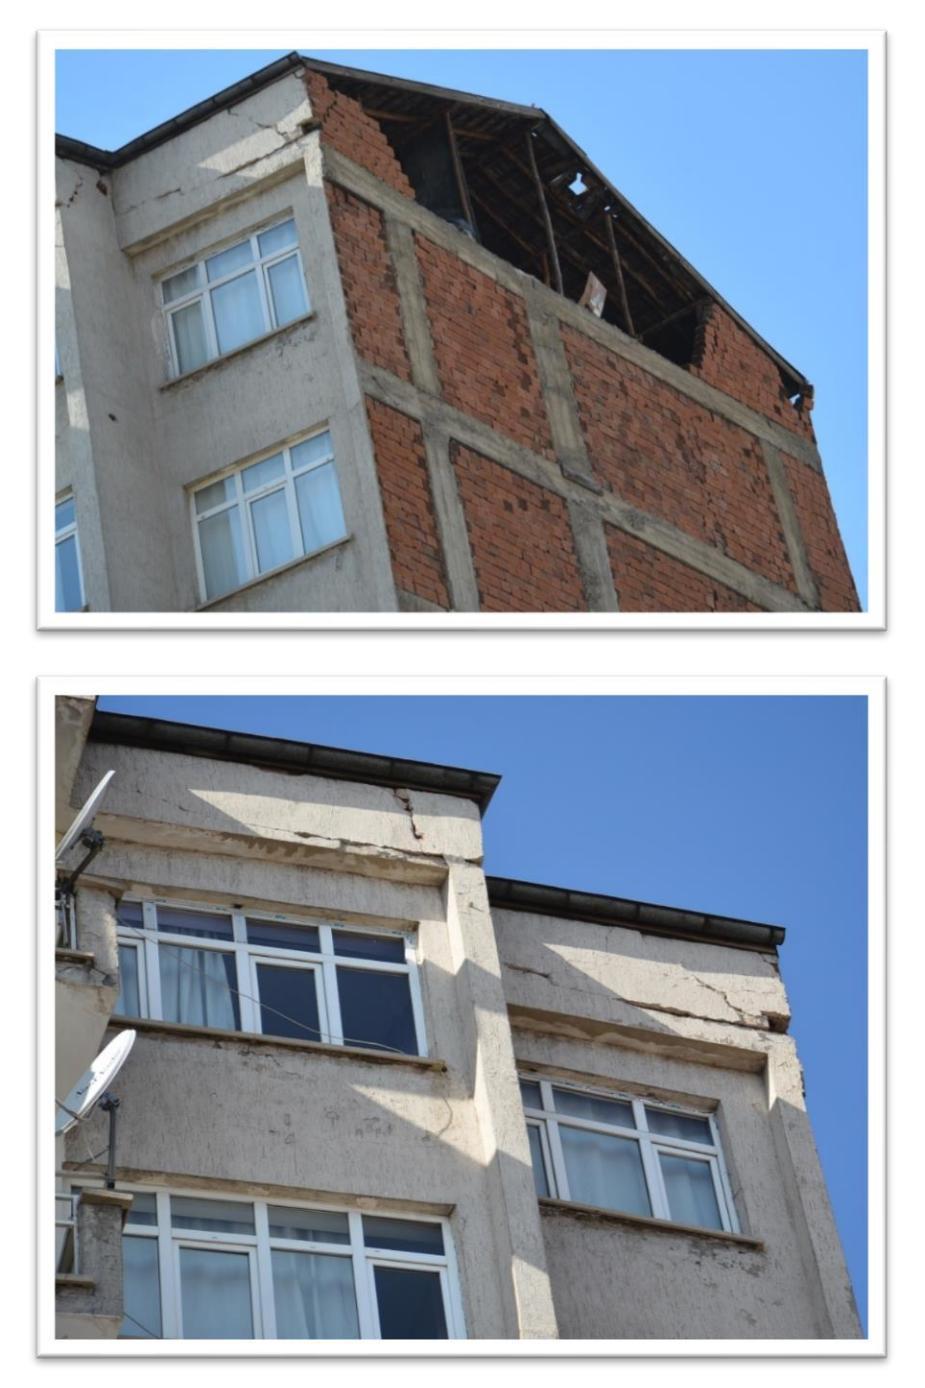
Figure 5.28 Gable and parapet wall damages

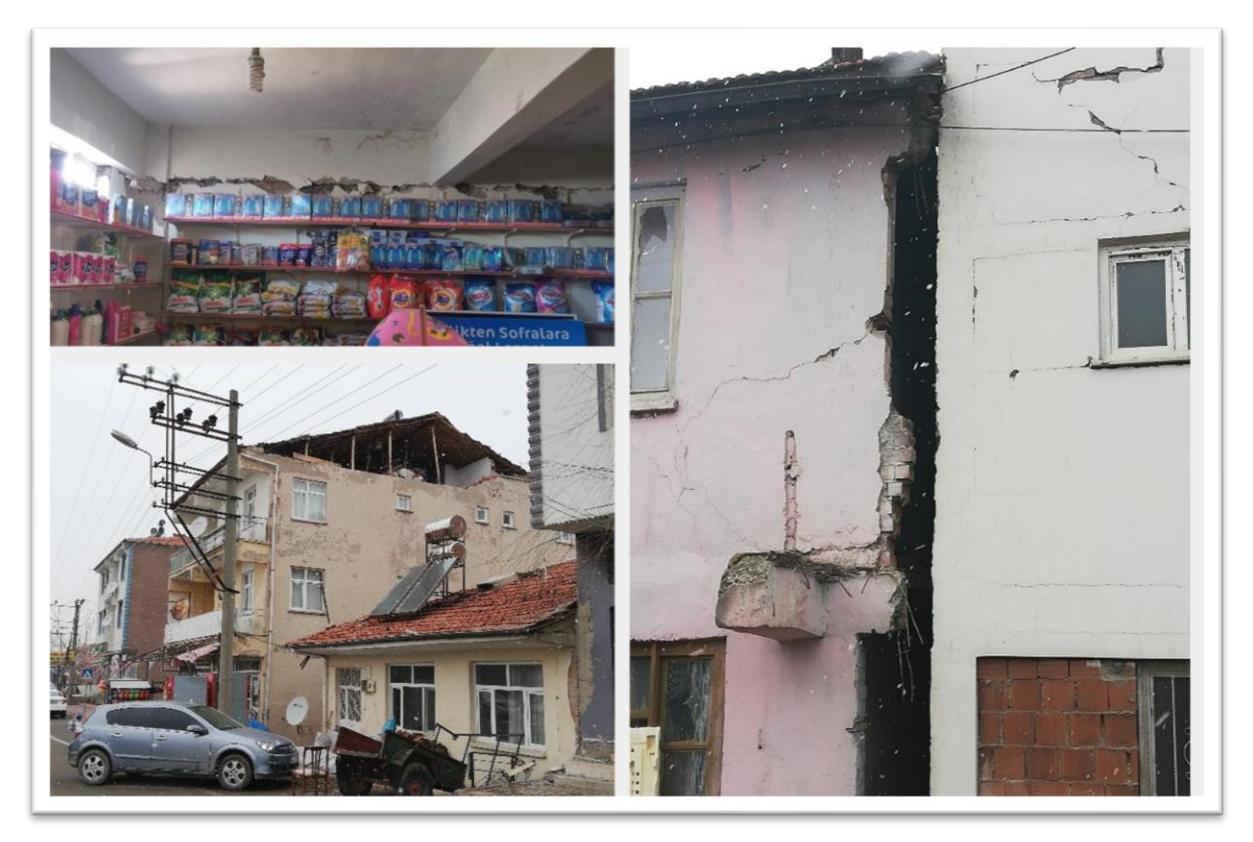
Figure 6.4 Photographs of damaged buildings in Sivrice

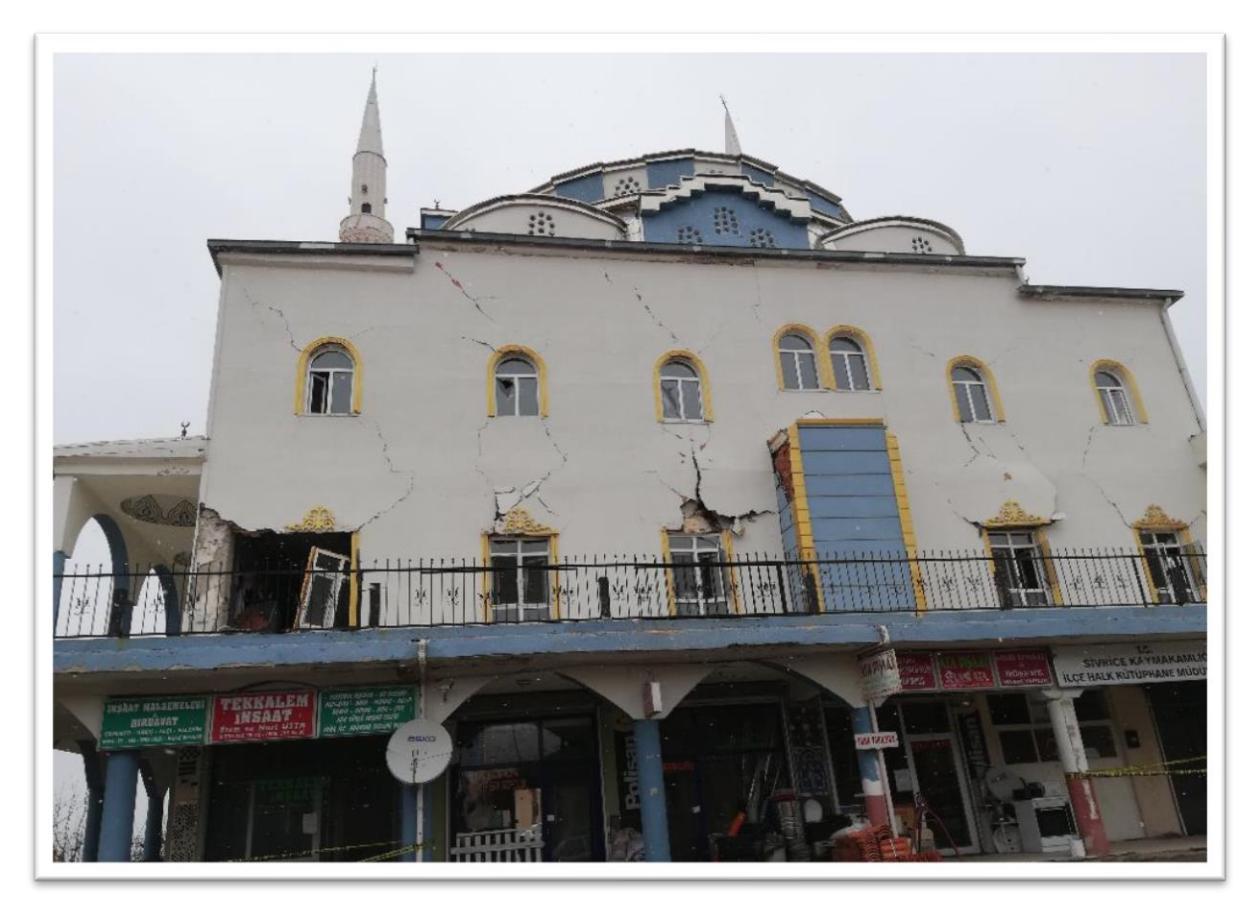
Figure 6.5 The Central Mosque of Sivrice, which was heavily damaged after the earthquake

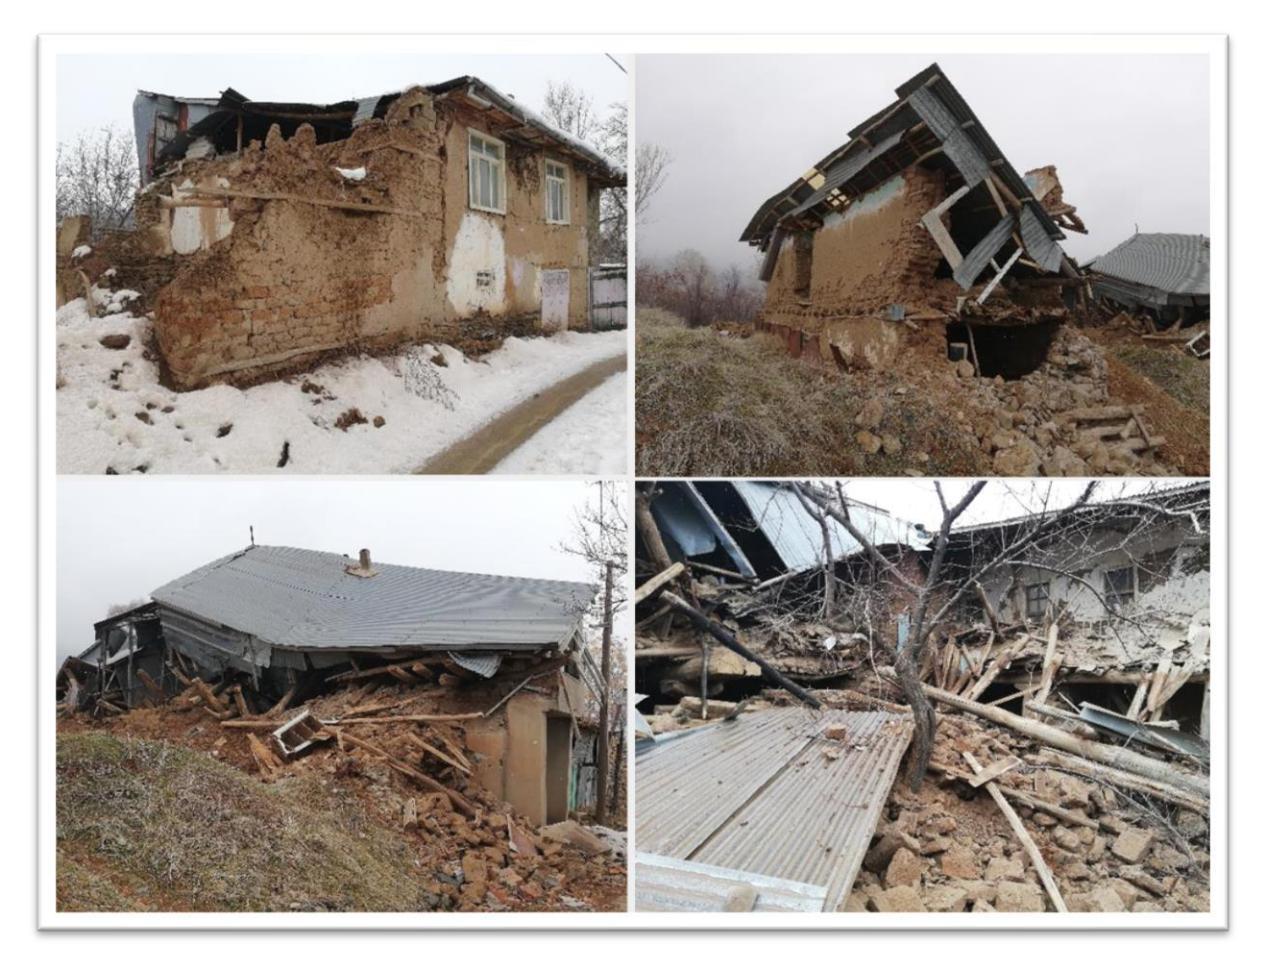
Figure 6.9 Heavily damaged or collapsed stone and adobe masonry buildings in Kürk village

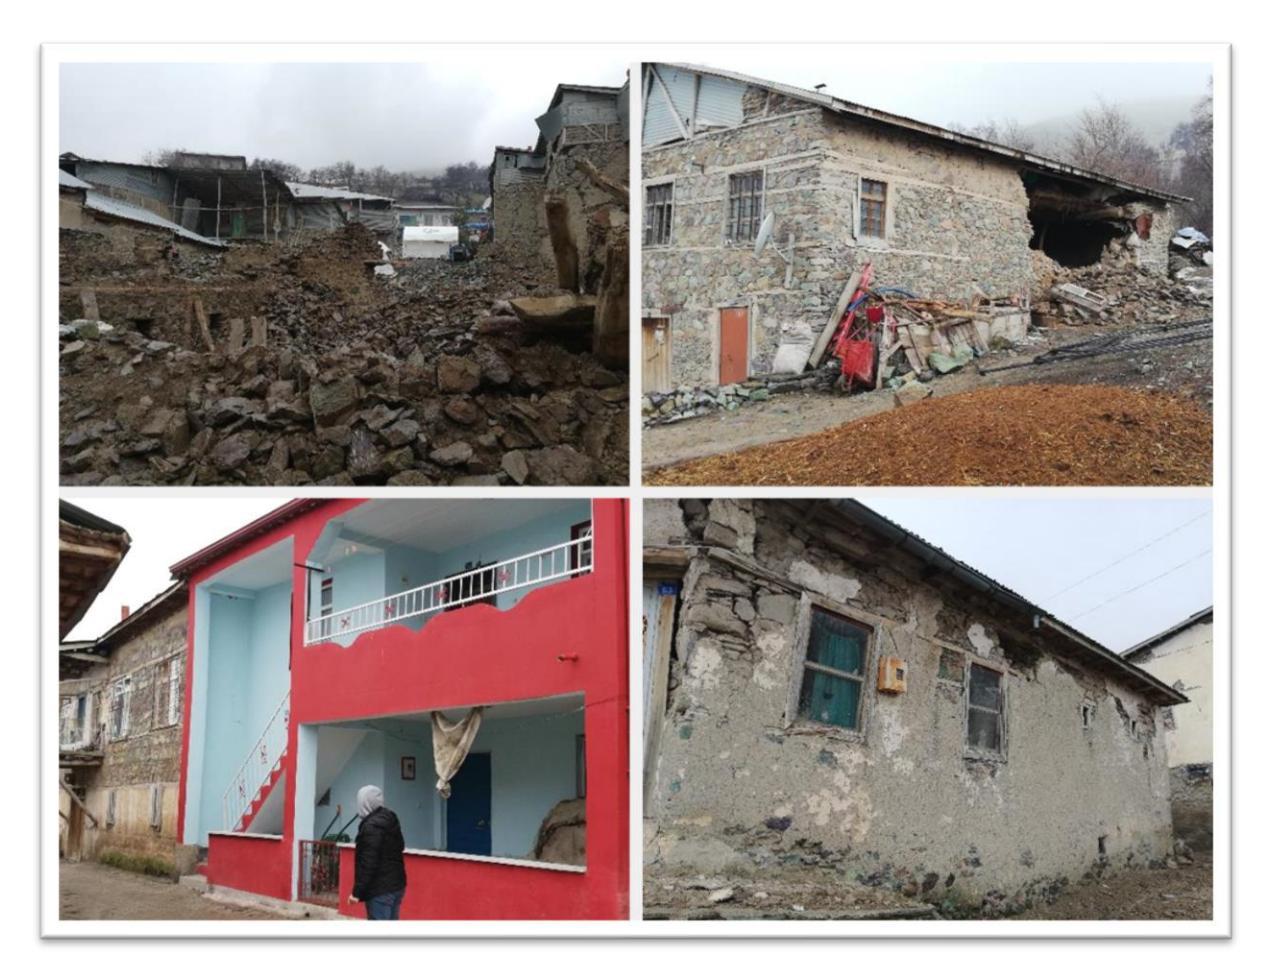
Figure 6.15 Rural structures in Duygulu village with different damage levels

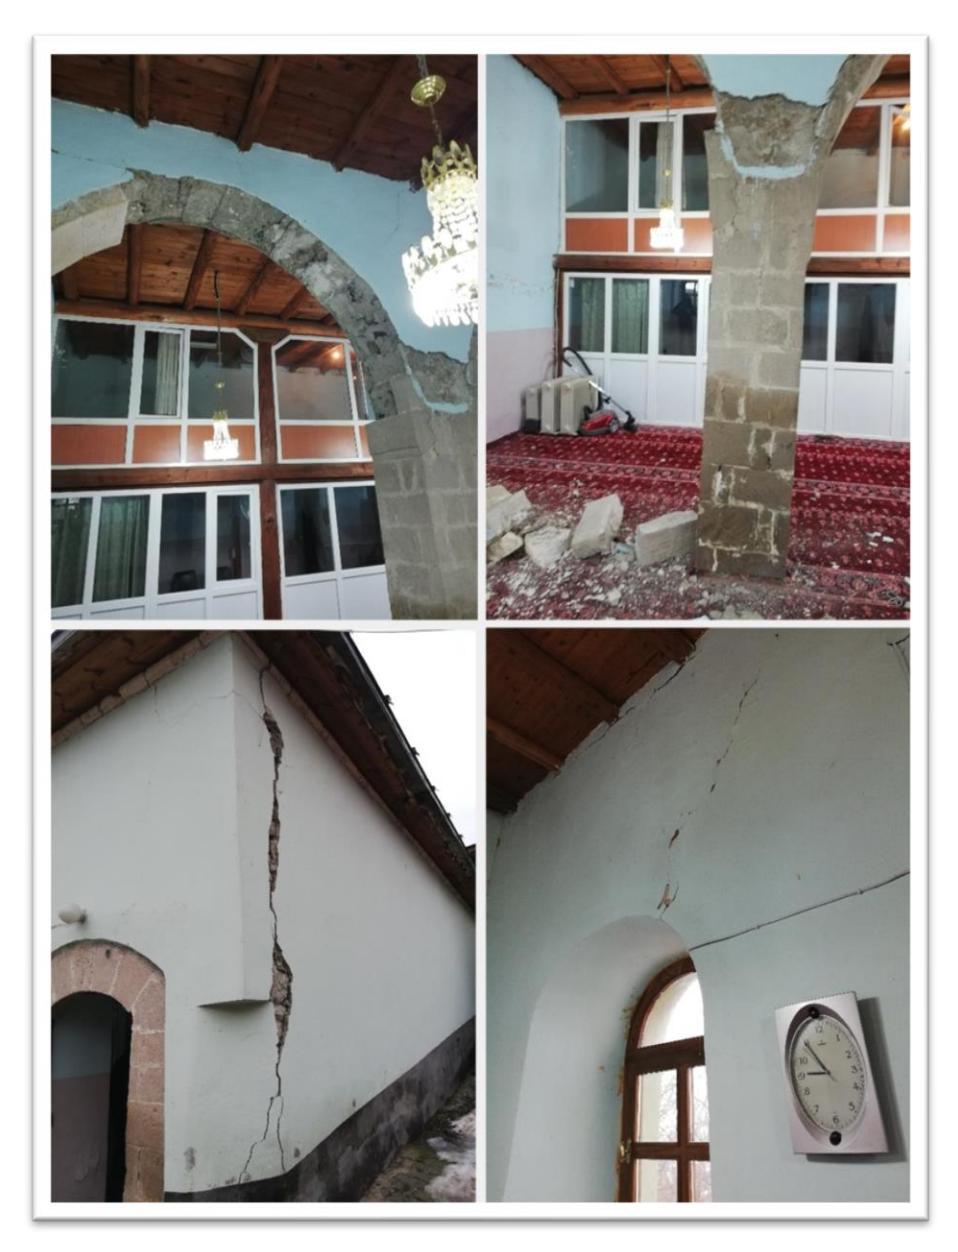
Figure 6.19 The observed damage in the mosque
