A REPORT ON THE 19 MAY 2011 KÜTAHYA-SİMAV EARTHQUAKE (PRELIMINARY REPORT)

REPORT NO: METU/EERC 2011-02

JUNE 2011 ANKARA

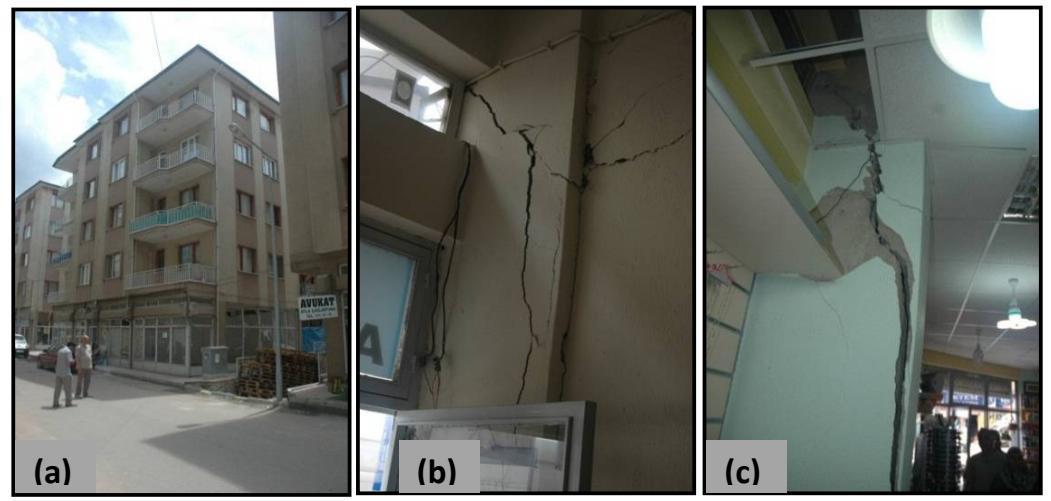
The site survey in Simav city center revealed that majority of the buildings had structural and/or non-structural damage. The main reasons of observed damage may be stated as structural system and member deficiencies, and fragility of the infill walls. Soft story formations and inadequate gap between buildings (i.e. to prevent pounding effect) are among the major structural deficiencies, as noticed by the first investigation of the damaged buildings from outside. The dense settlement in the city center and usage of the first stories as shops or stores (i.e. taller first stories and disuse of walls for exterior cladding) may be regarded as the reasons of these deficiencies. The soft stories caused by higher first floors and disuse of infill walls for exterior cladding may contribute to the extensive damage in the entrance level of these buildings. Such a building is presented in Figure 14. Although the building seemed to be undamaged from outside, wide shear cracks were observed on the first story columns, which had inadequate transverse reinforcement (Figure 14.b and 14.c).

Figure 14. Soft story and resulting damages

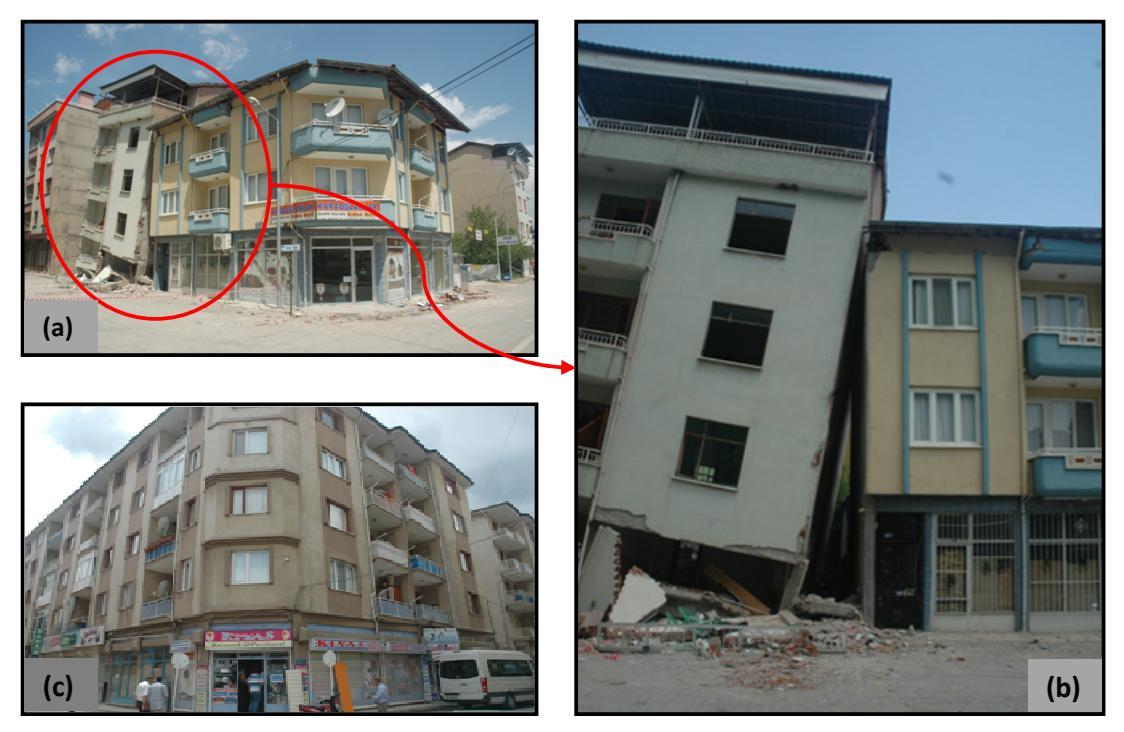
Figure 15. The outside view of the heavily damaged buildings in Simav county center: (a) - (b) Building 1; (c) Building 9

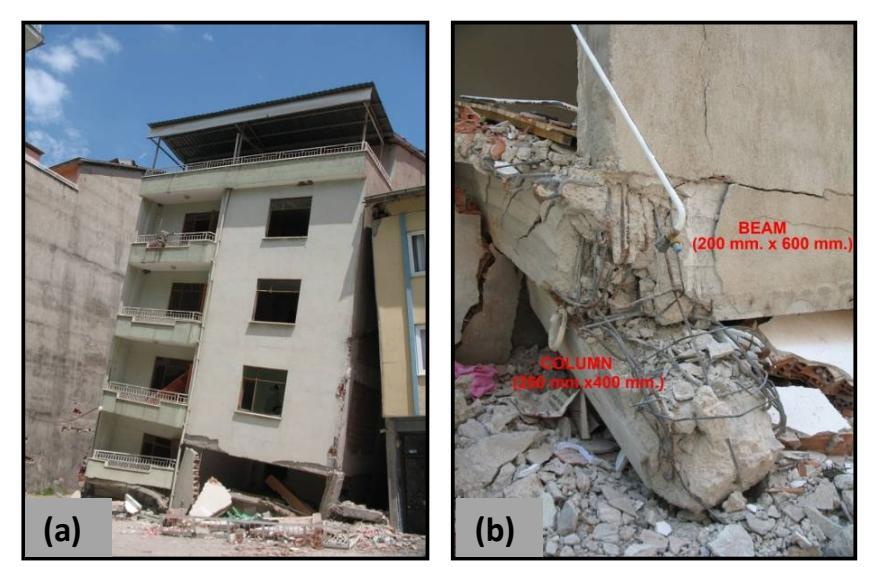
This building was the only reinforced concrete structure that collapsed due to earthquake. The building had six stories and a basement (Figure 15.a- 4.b and Figure 15). The entrance story was a handmade carpet workshop and the remaining five stories used as residence before the earthquake.

The basement and last four stories of the building remained almost undamaged. Whereas, the first two stories were totally damaged, which resulted in leaning on the adjacent building after the earthquake. The building constructed adjacent to the collapsed building remained stable as shown in Figure 16. A close investigation of the building indicated that the strong axes of all columns were located in the long direction of the building. The measurements yielded concrete compressive strength of 10.8 MPa and 20 MPa for the beams and columns, respectively, in the second story. The building was observed to have serious errors in reinforcement detailing. The main deficiencies of the building may be listed as follows:

- Soft story,
- Inadequate gap between the neighbouring buildings-pounding effect,
- Poor concrete quality,
- Inadequate transverse reinforcement at beam-column joints,
- Excessive spacing of beam and column transverse reinforcement,
- Poor detailing of transverse reinforcement (i.e. with 90 degree hooks),
- Use of plain rebars for reinforcement,
- Weak column-strong beam (cross-sectional dimensions and reinforcement details of both beams and columns are provided in Figure 17).

Figure 16. The collapsed building in Kütahya-Simav Earthquake (39.0920°N; 28.9793° E; 812 812 m)

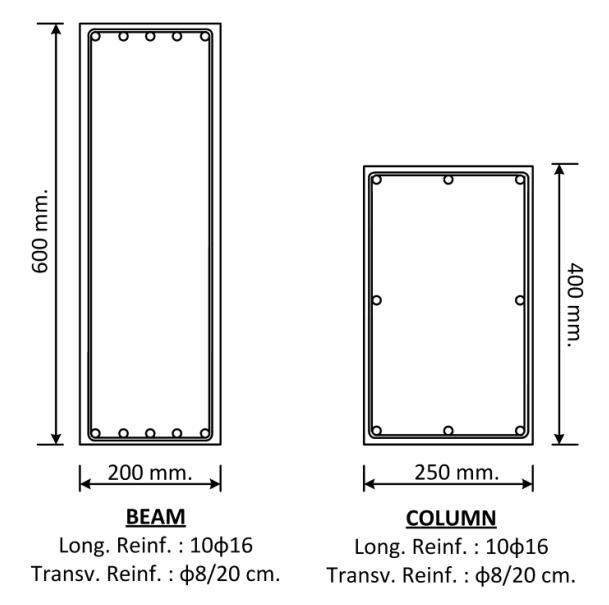
Figure 17. Cross-sectional dimensions and reinforcement details of beams and columns of the collapsed building

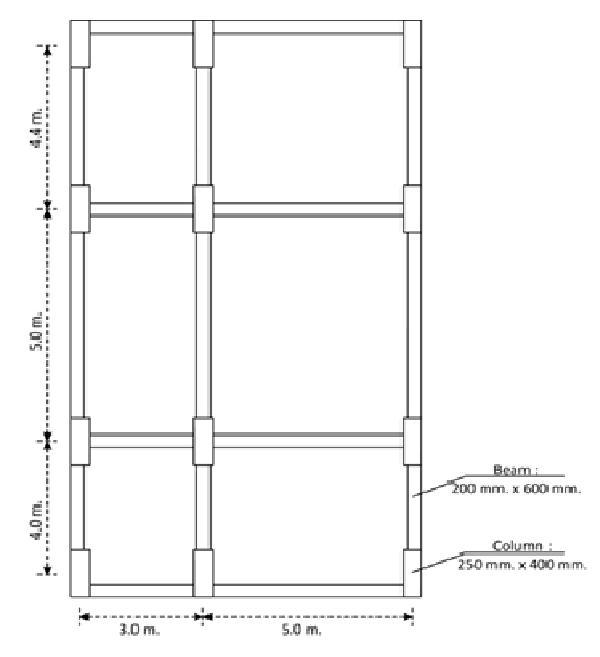
Figure 18. The Structural plan of "Building 1"

The most crucial structural system deficiency of "Building 1" was the arrangement of columns. As illustrated in Figure 18, the strong axes of all columns are in one direction only (i.e. parallel to each other). Therefore, the building did not have sufficient stiffness and strength to sustain the lateral earthquake demands in the short direction, resulting in total collapse. In order to mention the importance of this deficiency, the structural plan of another building (i.e. "Building 2"), which is located 10 m away from "Building 1" and had almost no structural damage due to earthquake, is presented in Figure 19. When structural plans of these two buildings are compared, it may be observed that "Building 2" has shear walls

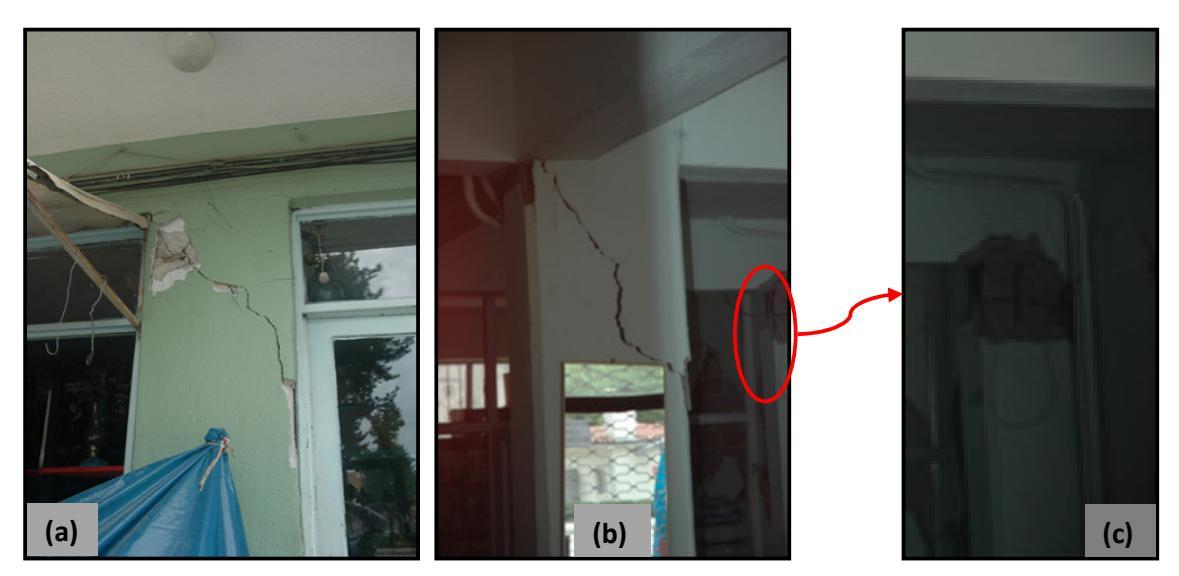
"Building 6" is a two story building which had serious shear damage in almost all first story columns due to the earthquake. The wide shear cracks demonstrate the poor detailing and insufficient number of column transverse reinforcement (Figure 20). The observed damage in

such a relatively low-rise building indicates how poor detailing may lead to catastrophic results.

Figure 20. Damage of "Building 6": (a) – (b) column shear cracks; (c) Plastic hinging at column ends

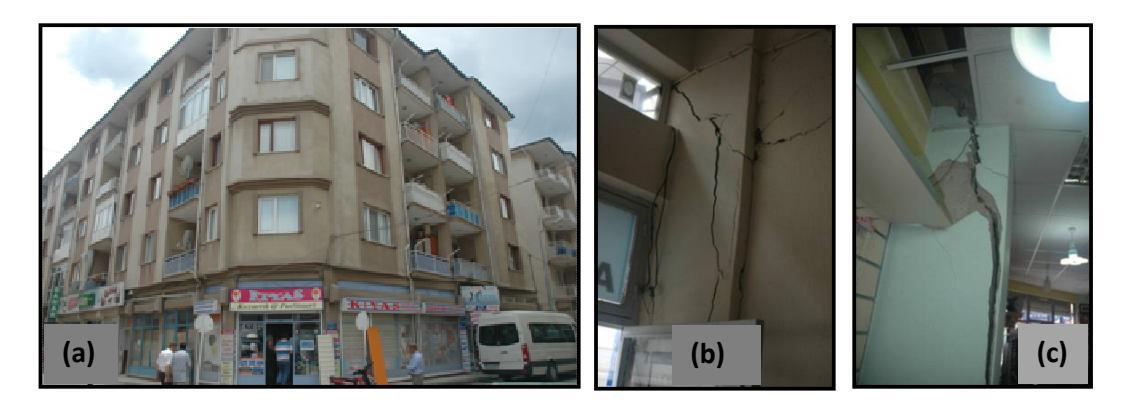
"Building 9" which was constructed in 1998 is a five story residential building with shopping stores at the entrance level. The building was reported to be repaired after experiencing light damage in an earthquake occurred on 17th of February, 2009 (i.e. overcoating in one column and grouting for cracks). During the survey, the concrete compressive strength was measured as 15 MPa. Significant damage was observed on the first story columns due to recent Kütahya-Simav Earthquake (Figure 21). The major reason of shear damage on columns may be attributed to the poor detailing of transverse reinforcements.

Figure 21. Building 9 and the observed damage: (a) Outside view; (b) Column shear cracks; (c) Wide cracking at the upper ends of the columns

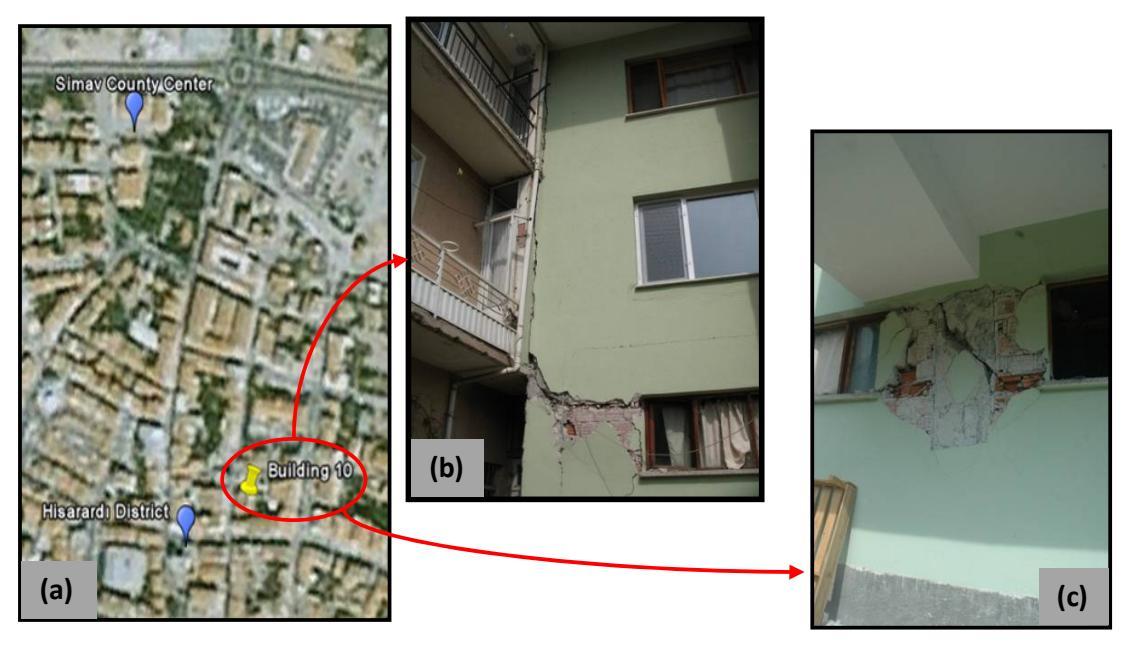
Hisarardı district is located in Simav and is also approximately 10 km away from the epicenter of the earthquake. During the survey in Hisarardı, it was observed that majority of the investigated buildings experienced moderate damage. The types of observed damages were similar to those explained for Simav city center. On the other hand, heavy damage was observed in one of the buildings in the district. The map location and damage state of the building are given in Figure 22. The concrete compressive strength was measured as 20 MPa.

Figure 22. Building 10 and the observed damage: (a) Map view; (b) - (c) Insufficient gap between the buildings and wide shear cracks formed due to short column effect (39.0896°N; 28.9794°E; 818 m)

The adjacent construction of these buildings, where the required gap was not provided, prevented free movement of these structures and lead to pounding effect which further increased the damage. The adjacent buildings are shown in Figure 22.b. The higher building on the left caused significant damage on "Building 10" (i.e. having three stories on the right) due to pounding during the earthquake. The separation between two buildings and pounding damage on the shorter building may also be observed in Figure 22.b. Additionally, the windows at the top of first story infills resulted in a short column formation and corresponding wide shear cracks on the column (Figure 22.c). Besides, no other structural or member deficiency was observed in the building.

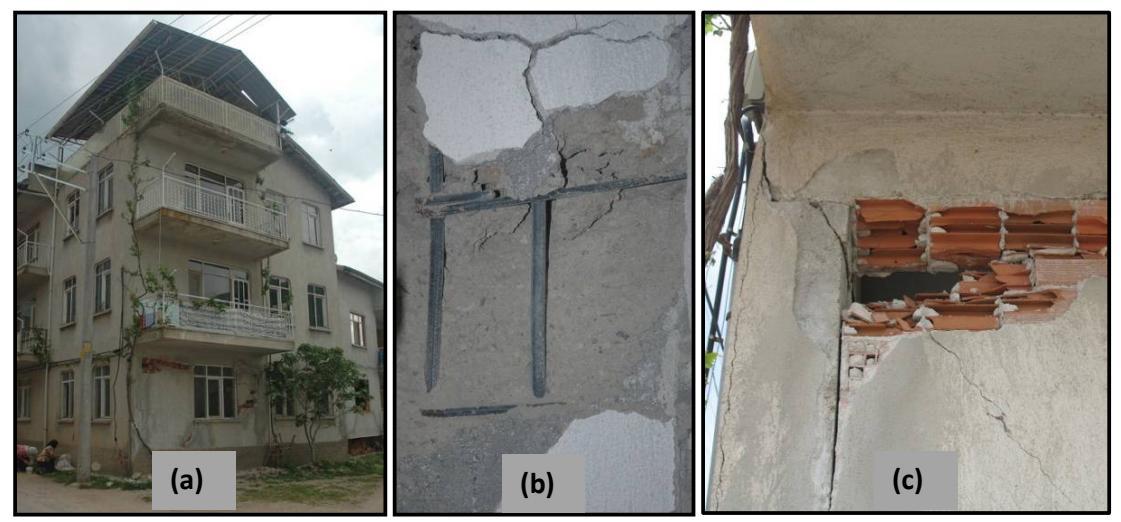
The damage on the reinforced concrete building, Building 11, which has three stories are shown in Figure 24. It was observed that the lateral reinforcement spacing at the column ends were insufficient and the free ends of ties were bent 90[°] instead of 135[°] (Figure 24.b). Besides, after crushing of the infill walls at the corners, the columns were subjected to high shear demands at these regions due to formation of a short column (Figure 24.c). When it was considered that the building was constructed in a village with limited engineering design and control service, it should be considered as a lucky survivor since such deficiencies did not result in the collapse of the building.

Figure 24. Three-story building in Gökçeler village and observed damage (Building 11)

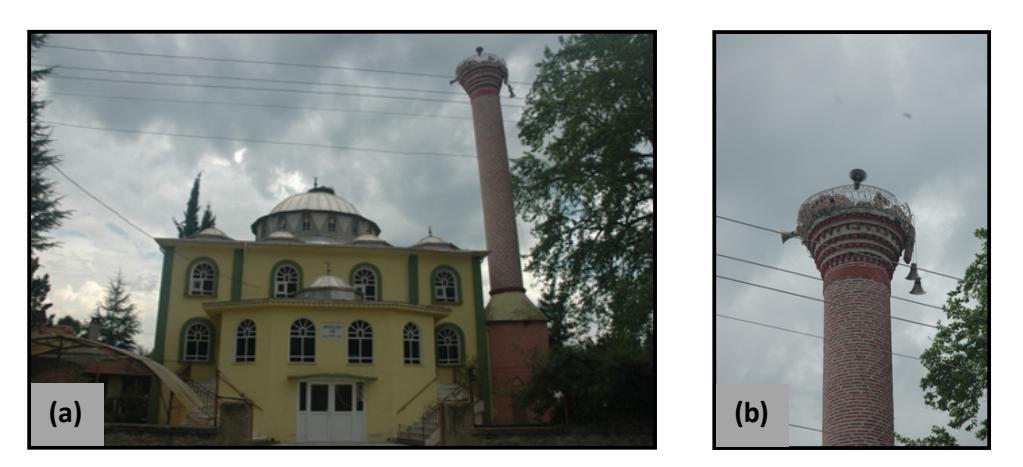
The mosque of Gökçeler village was constructed in 1998 (Figure 25). The earthquake performance of the main structure may be regarded as successful since the structure did not experience significant damage. However, earthquake damage to mosques generally indicate that minarets may sustain much severe damage then the main structure as was the case in Gökçeler, Figure 25. The performance and earthquake stability of the masonry type minaret should be investigated more thoroughly considering the actual material strength and imposed demand on this distributed mass structure.

Figure 25. Damage of the mosque in Gökçeler village

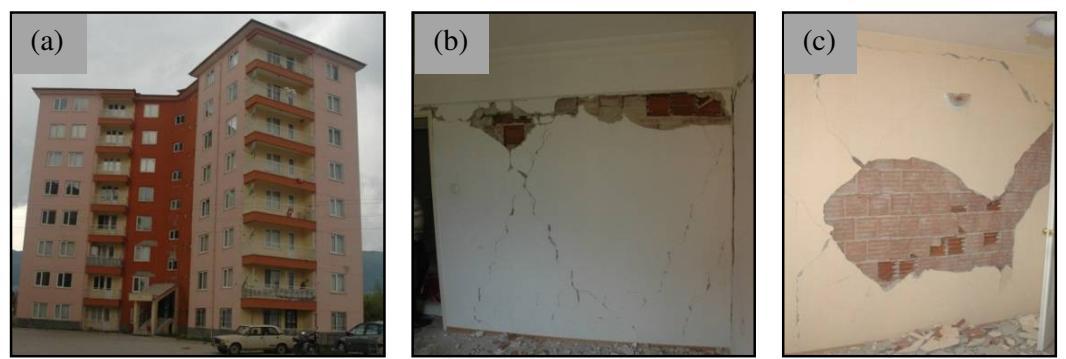
The concrete compressive strength was determined as approximately 20 MPa. In the building, infill wall damage and hairline flexural cracks were observed on some beams in the first four stories (Figures 27.b and c). The width of these cracks support the fact that the damage can be classified as light to moderate.

Figure 27. (a) C-Block of Esenevler building complex and (b) - (c) Damage state

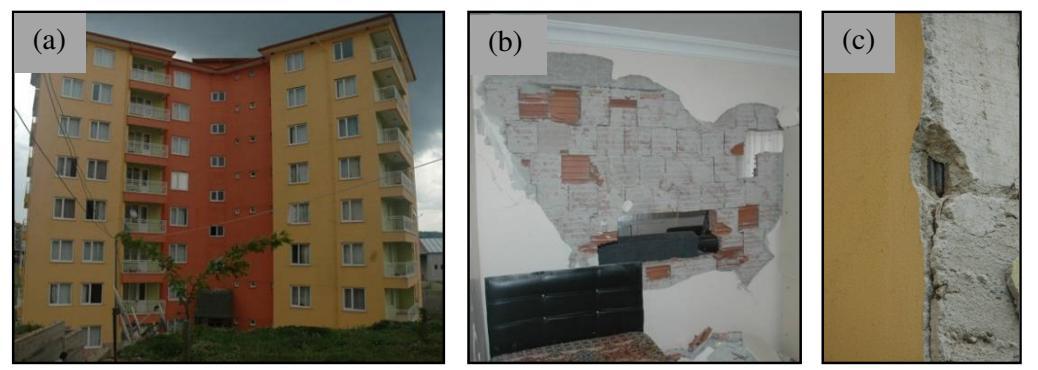
Among all the other investigated buildings in Esenevler, Sayar and Peker Apartment (Figure 28.a) had the highest damage. The building was constructed after 1999 Izmit Earthquake. The diagonal cracks, local crushing and spillage of the plaster was observed on the infill walls, as in other buildings in Esenevler (Figure 28.b). Besides, the beam and column cover concrete crushed in some certain locations on the building facade (Figure 28.c).

Figure 28. (a) Esenevler building complex, Sayar and Peker apartment, (b) Infill wall damage and (c) Crushing of cover concrete

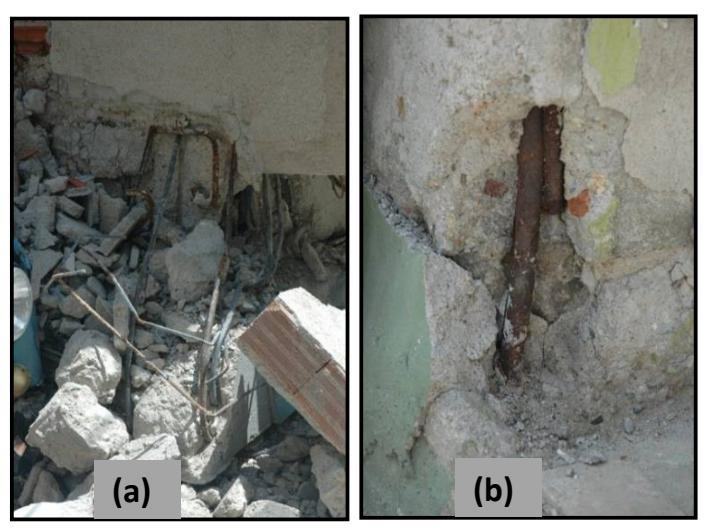
Additionally, the use of plain bars and low quality concrete were the most noticeable deficiency observed in damaged structures. This is similar to previous observations in other regions of Turkey. Use of low strength concrete causes adherence problems in reinforced concrete members, which in turn results in significant plastic hinge damage (See Figure 29). Another significant detailing problem is the use of insufficient lap splice length for the longitudinal reinforcement. Nearly, all of the investigated buildings reveal that the longitudinal reinforcements are lapped at the base of columns (Figure 29.b) over an insufficient length.

Figure 29. Adherence problems due to plain bars

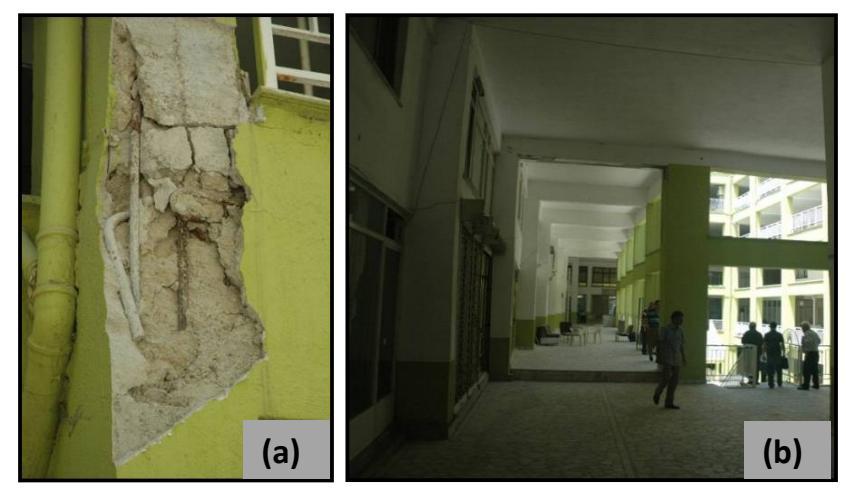
Figure 30. (a) Lack of stirrups at the joints and (b) Redundancy of columns (Building 5)

Another problem observed in Simav is the lack of stirrups at the joints. This detailing mistake makes the column-beam joints vulnerable to earthquake induced effects and heavy damage is inevitable at those regions. This situation is illustrated in Figure 30. The three adjacent frame buildings (Building 5) are well – separated from each other (no pounding effect) in this case. In addition to improper detailing of the reinforcement, these buildings have weak and soft storey irregularities. However, the redundancy of columns provided the safety of these buildings (See Figure 30.b).
