March 08, 2010 Başyurt-Karakoçan (Elazığ) Earthquake

Supplementary Report

March 25, 2010

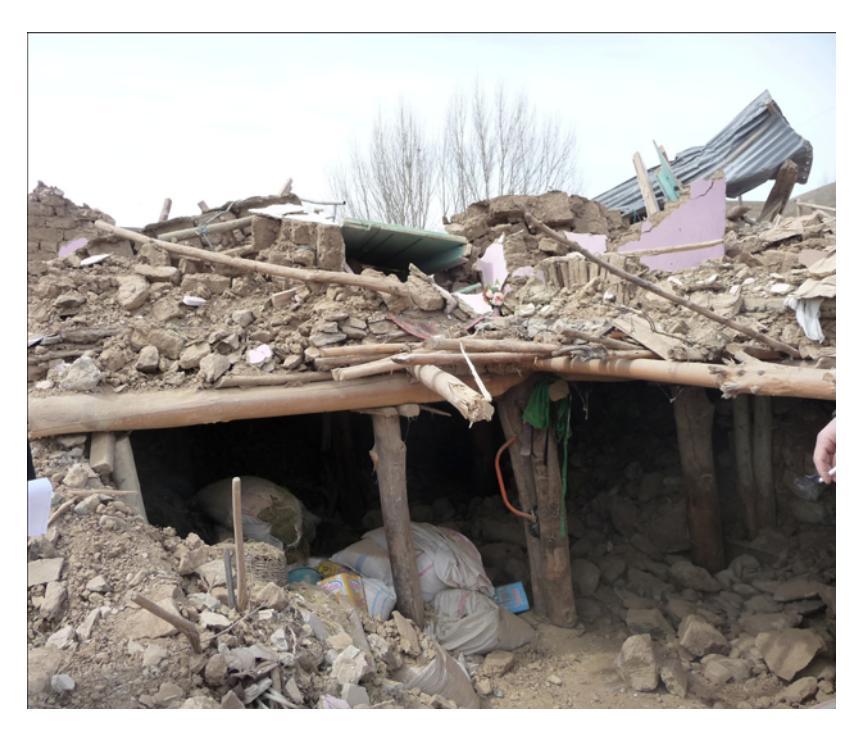
Most of the structures have wooden logs in the place of columns and beams as shown in Figure 4. Mostly due to weak connection of these primitive elements, these could not function well during the shaking. The major cause of deaths and injuries was falling of the buildings' components on the people living there and / or getting trapped under the debris due to failures of the wall as well as the roof.

Figure 4. Wooden logs being used as columns and beams (Okçular village)

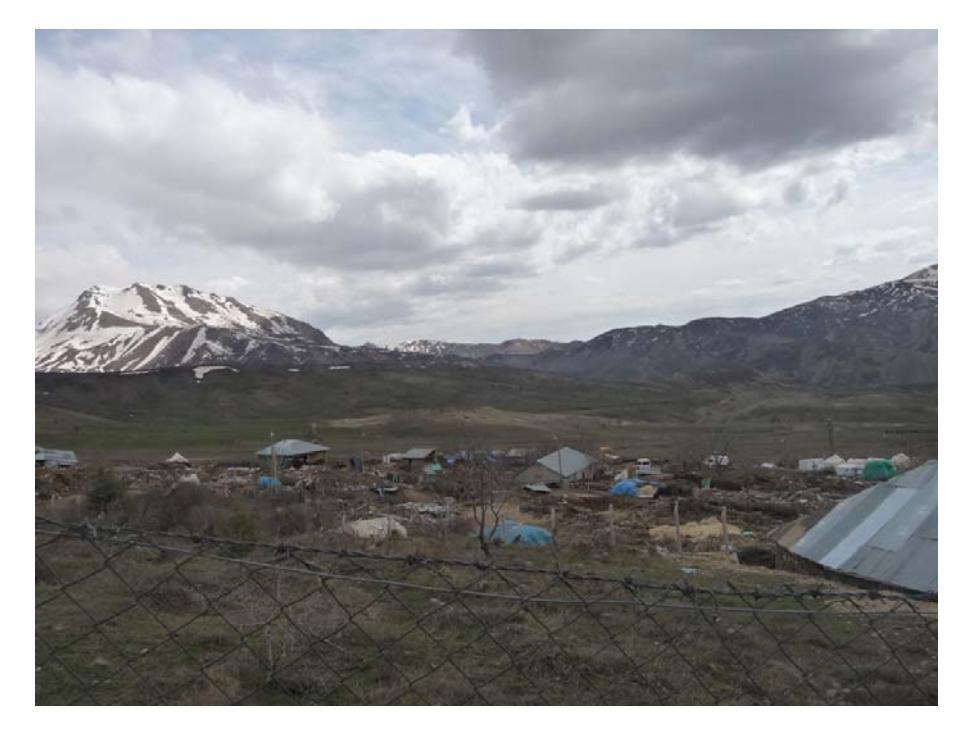
Yukarı Demirci village is located at 38° 52'N and 40°10'E with an altitude of 1735m. According to local residents, out of a population of 320, 14 of them have lost lives and 23 are injured. Almost 100% of the residential buildings in Yukarı Demirci are either collapsed or severely damaged. Major mode of failure in these buildings is the total collapse of the structure (Figures 5 & 6).

Figure 5. Yukarı Demirci Village (An overview)

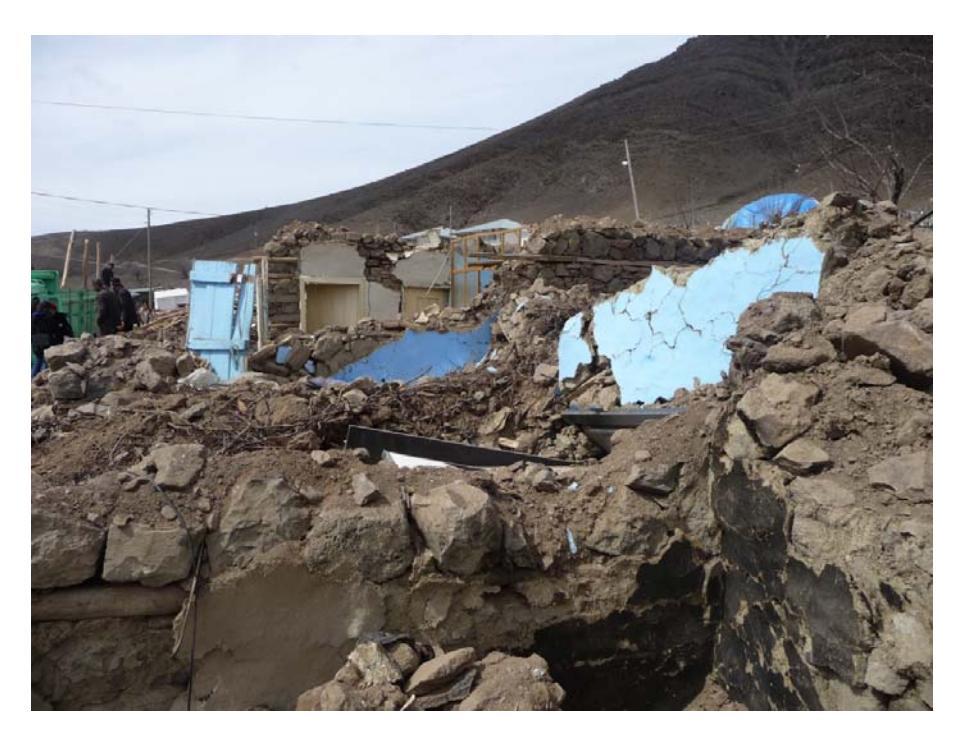
Figure 6. Yukarı Demirci village: several collapsed buildings next to each other

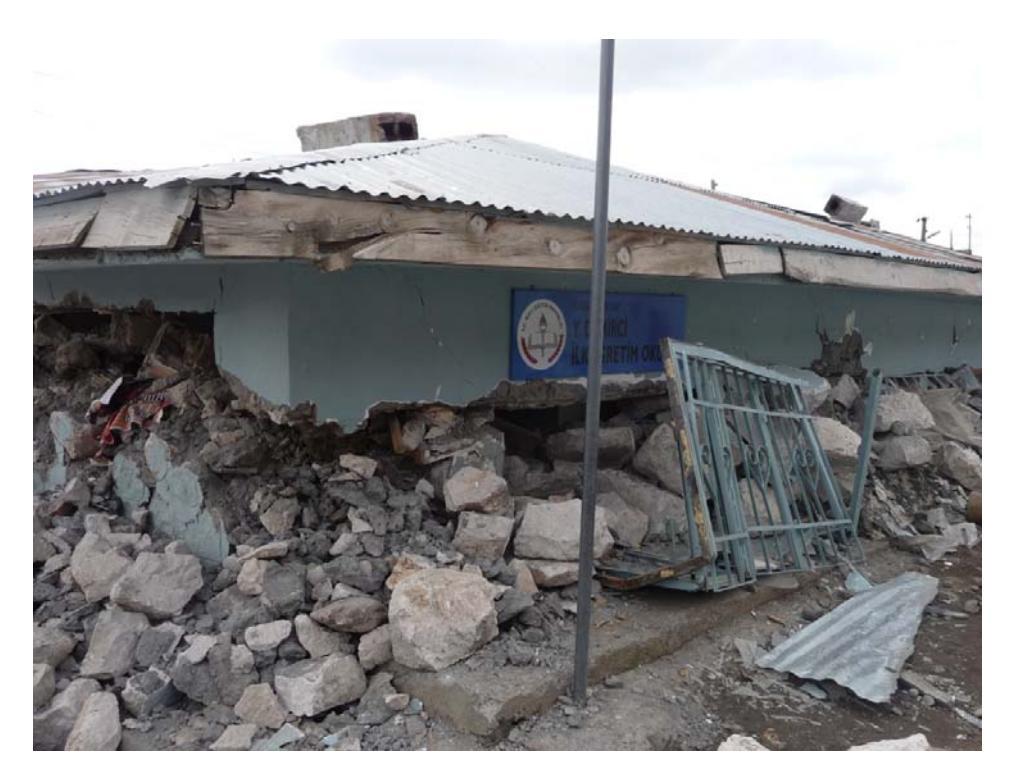
The team has inspected the collapsed Yukarı Demirci Primary School which has a R/C main beam on stone masonry walls that have failed completely (Figures 7 and 8). It was fortunate that the earthquake did not happen during the school hours; otherwise it would have been difficult for the students and teachers to escape from such collapsed buildings.

Figure 7. Yukarı Demirci Primary School (An exterior view)

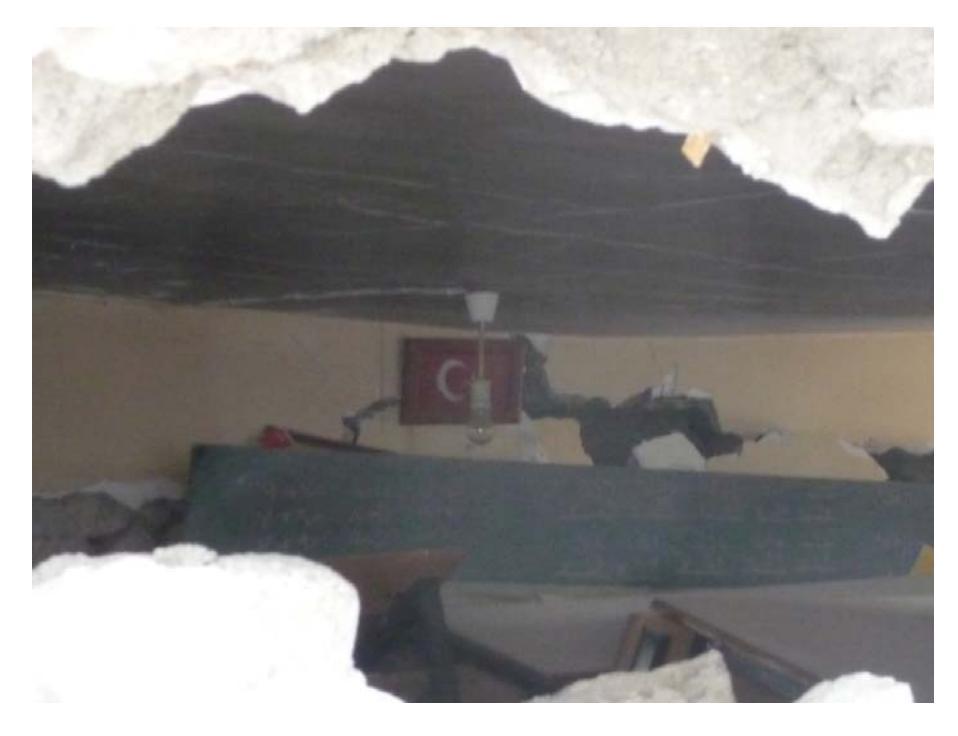
Figure 8. Yukarı Demirci Primary School (An interior view)

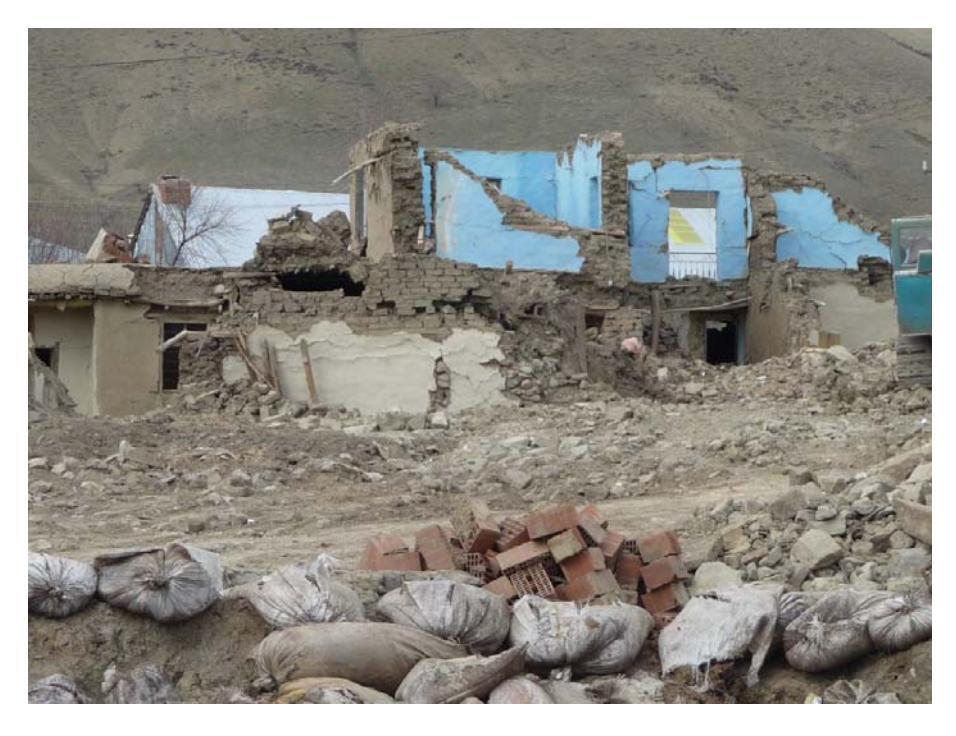
This village is located at 38° 50'N and 40°04'E with an altitude of 1303m. There are approximately 50 severely damaged buildings in Tabanözü but no deaths or injuries are reported. The type of failure of the adobe buildings is similar to the ones observed in Yukarı Demirci. One of the severely-damaged adobe buildings is shown in Figure 9. There are several R/C residential buildings in this village, of which a few has light damage. Figure 10 shows the exterior view of a 2 storey R/C building with diagonal shear cracks on the brick walls. Figure 11 displays transverse (out of plane shear) displacement of the parapet of a 3 storey R/C building.

Figure 9. A severely damaged three-bay, two-storey adobe building in Tabanözü

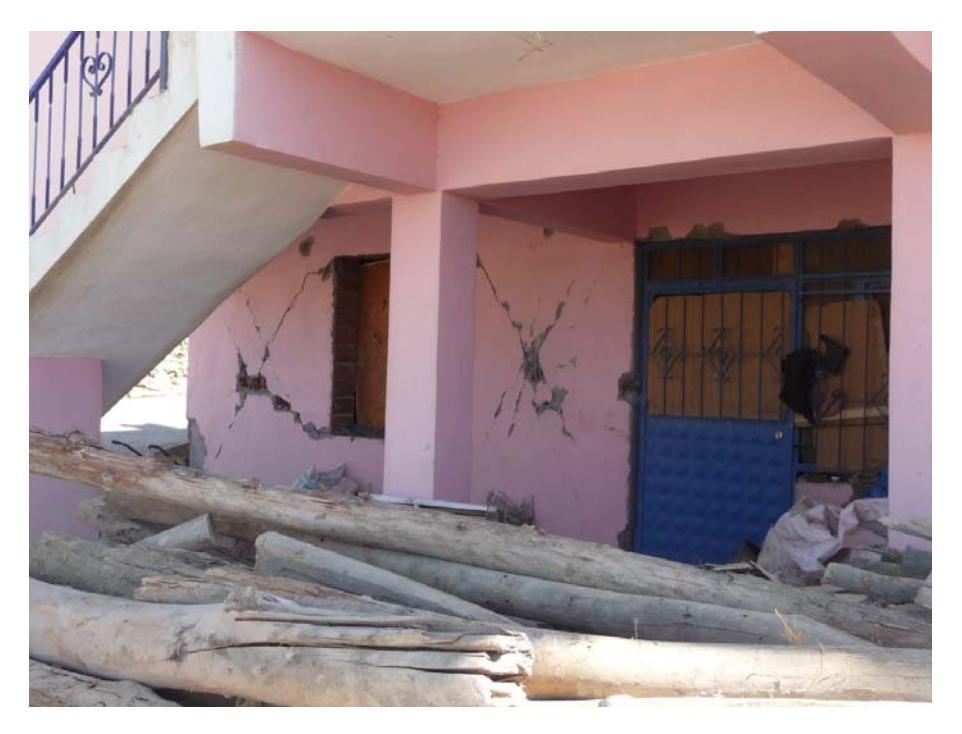
Figure 10. Shear cracks in a R/C building in Tabanözü

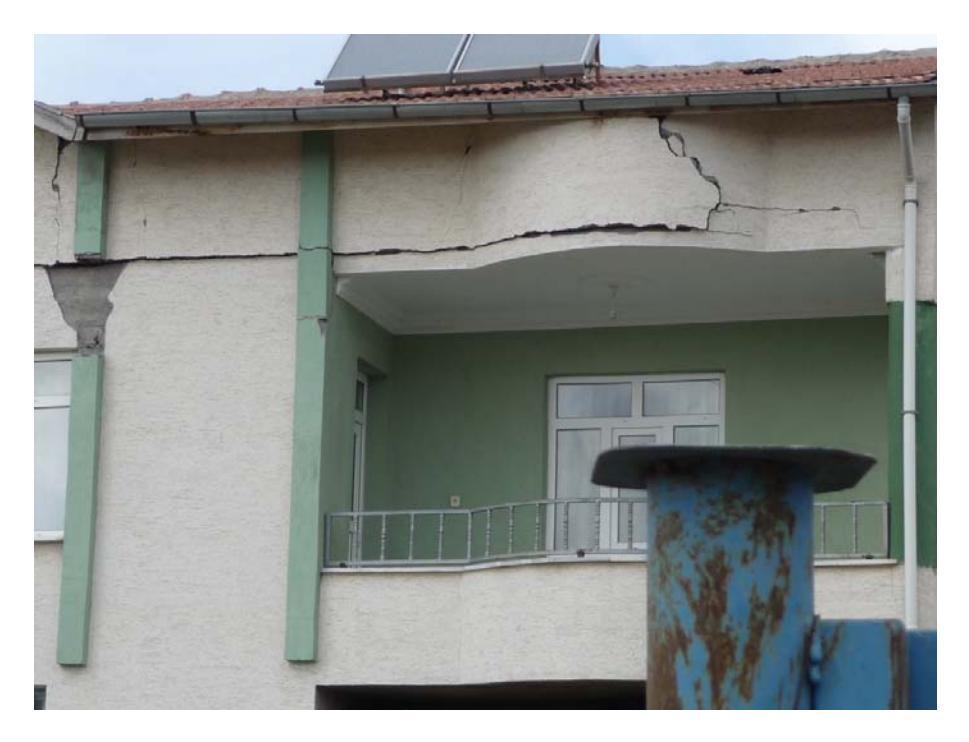
Figure 11. Transverse displacement of the parapet of a R/C building in Tabanözü

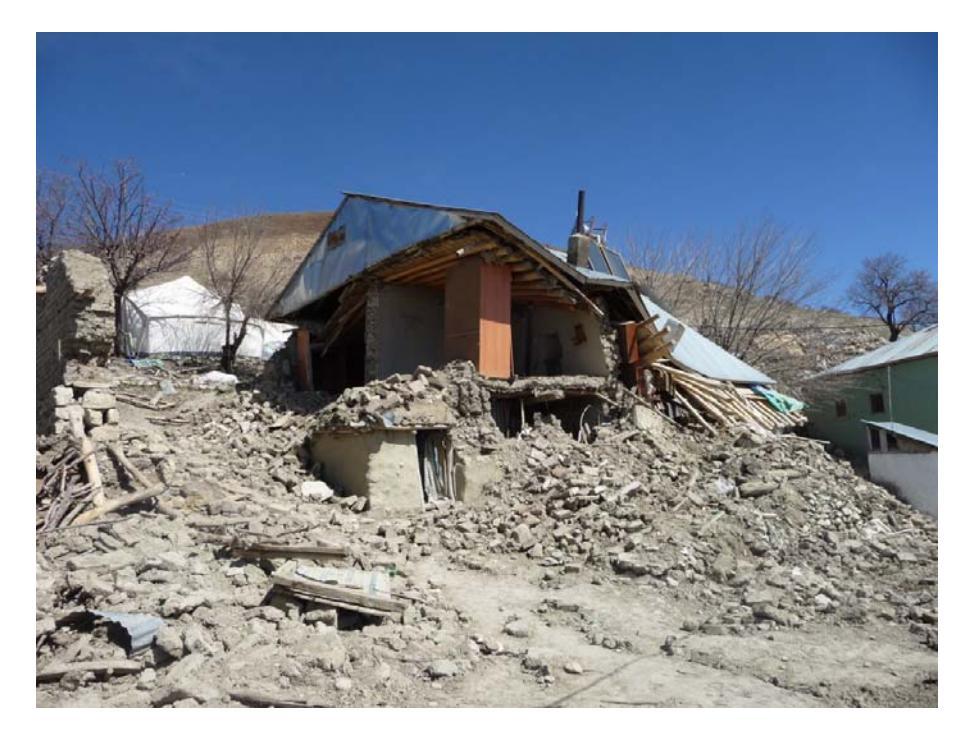
Located at 38° 51'N and 40°05'E, this village has more than 50 severely-damaged and collapsed buildings with 3 fatalities and few injuries. Type of construction and typical modes of failure are very similar to those observed in the other villages. In Figure 12, a severely damaged stone masonry building is shown where a cupboard worked like a column and saved lives of the household.

Figure 12. A stone masonry house

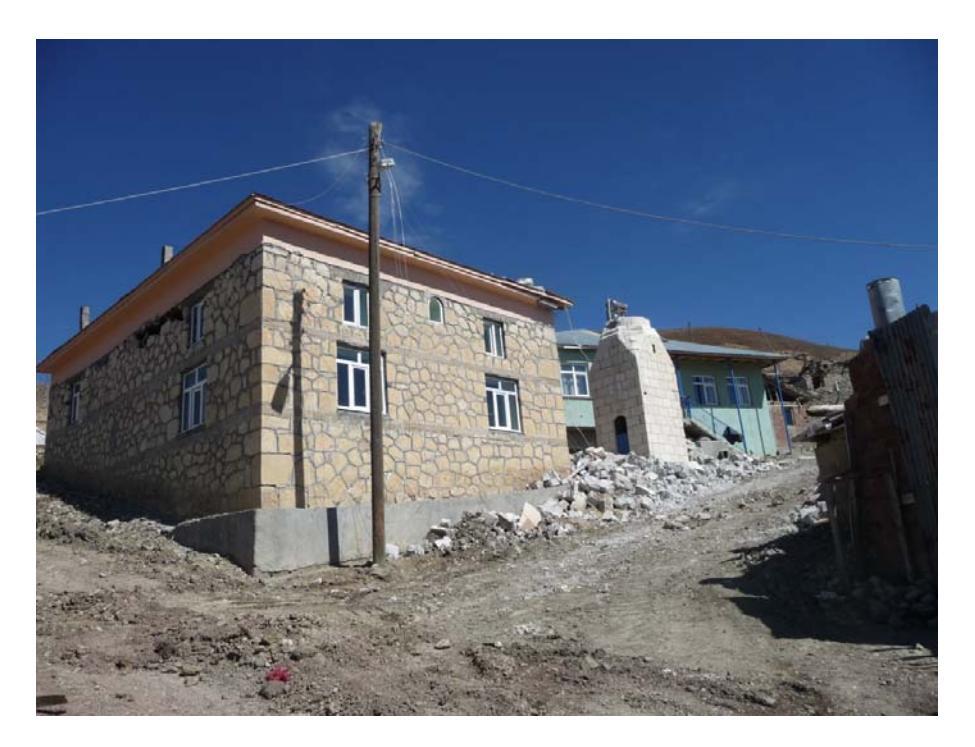
The mosque in the village has a R/C frame with stone masonry infill and exterior walls. The stone minaret collapsed during the earthquake as shown in Figure 13. The exterior view of the mosque does not display the damage entirely but as observed in Figure 14, the stone walls have partially collapsed inside.

Figure 13. Mosque and collapsed minaret in Yukarı Kanatlı village (An exterior view)

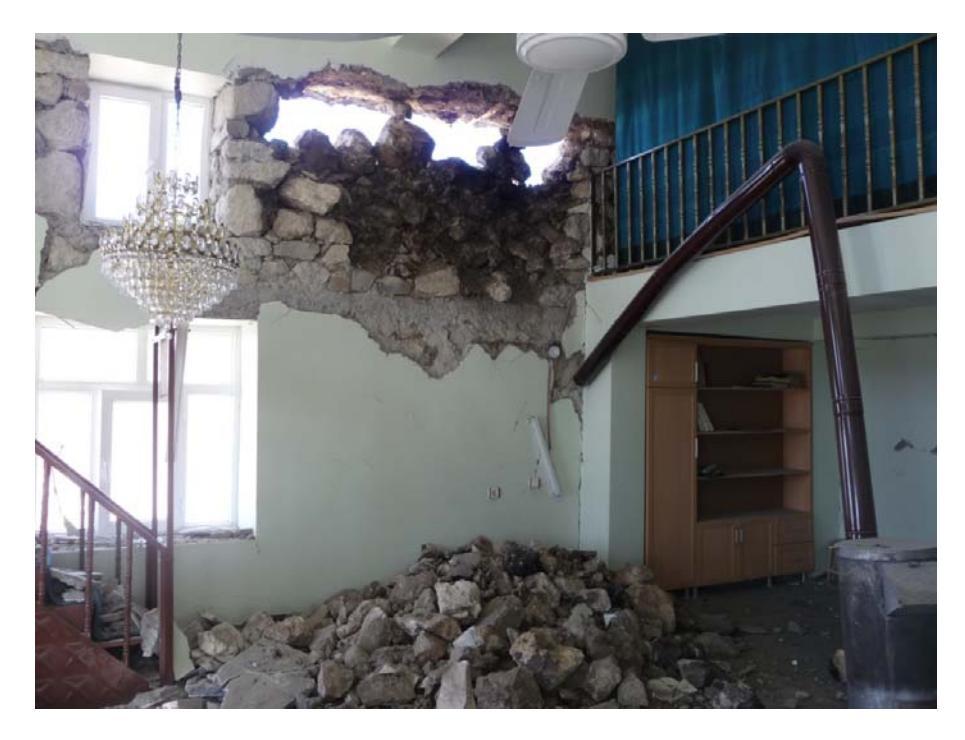
Figure 14. Mosque in Yukarı Kanatlı village (An interior view)

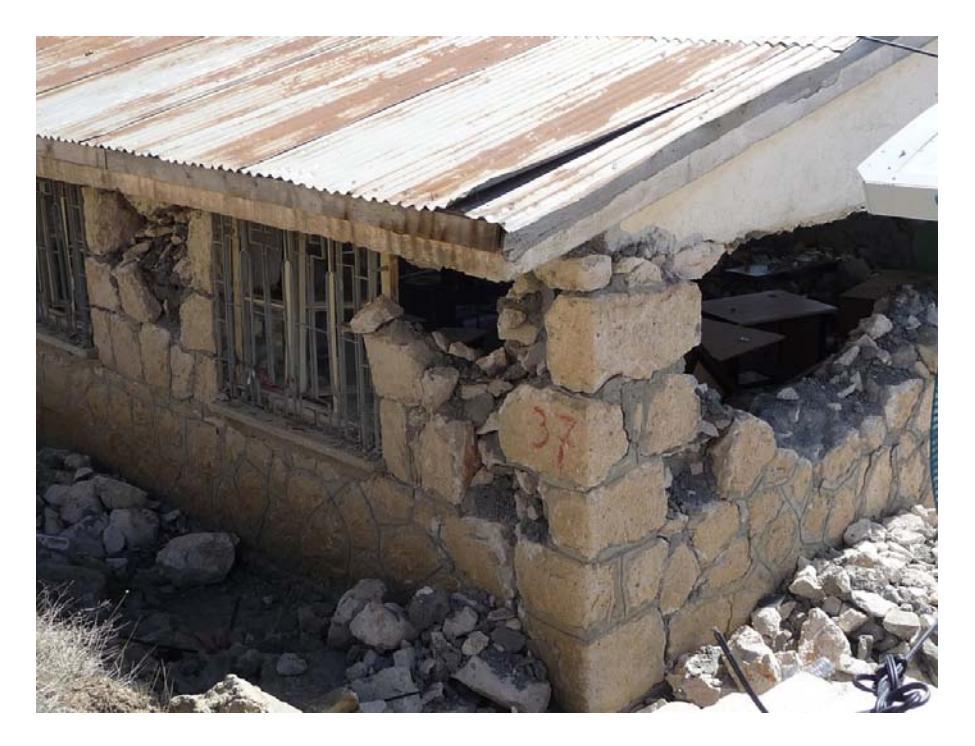
The primary school building in Yukarı Kanatlı village is a stone masonry building and it has severe damage with partially failed stone walls as shown in Figure 15 & 16.

Figure 15. Yukarı Kanatlı Primary School (An exterior view)

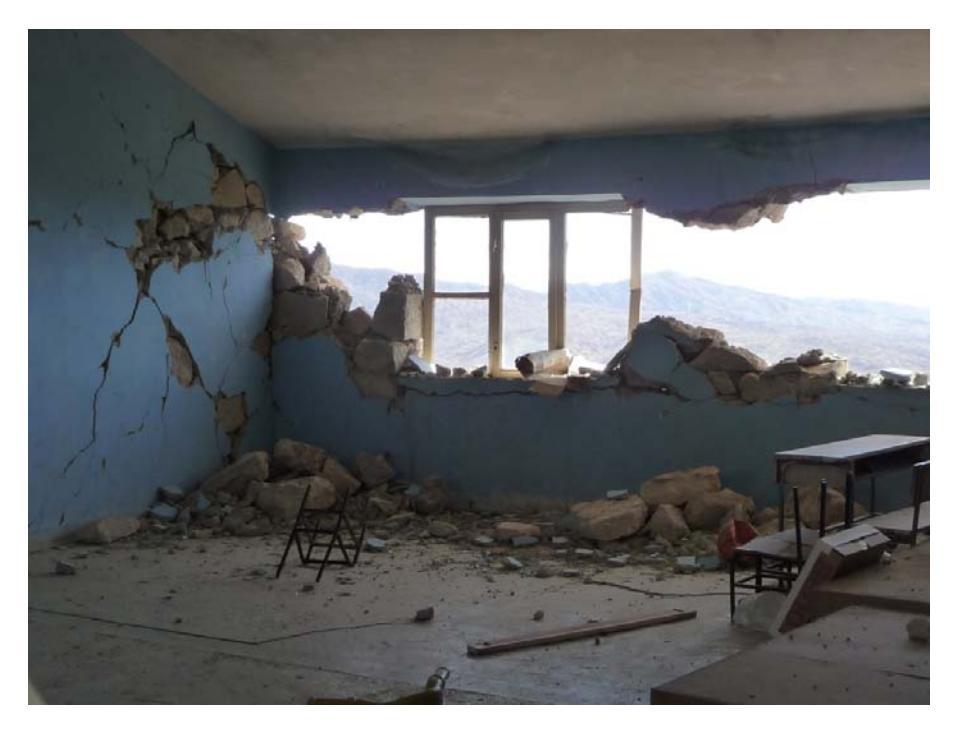
Figure 16. Yukarı Kanatlı Primary School (An interior view)

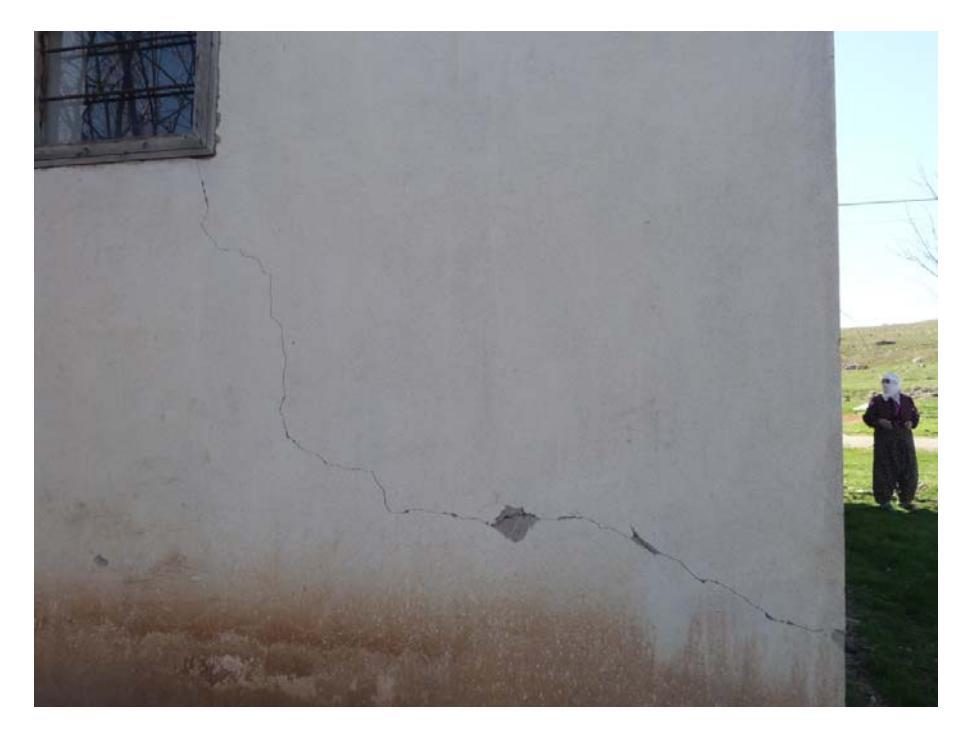
Başyurt village is located at 38° 50'N and 39°58'E with an altitude of 947m. Located relatively distant from the epicenter, only light damage in a few buildings with no deaths or injuries are reported in this village. Most of the buildings are either adobe or stone masonry buildings with very few R/C frame structures. Figure 17 shows one of the lightly-damaged R/C frame buildings and Figure 18 shows a stone building with moderate damage.

Figure 17. Fine shear cracks in a R/C frame building in Başyurt

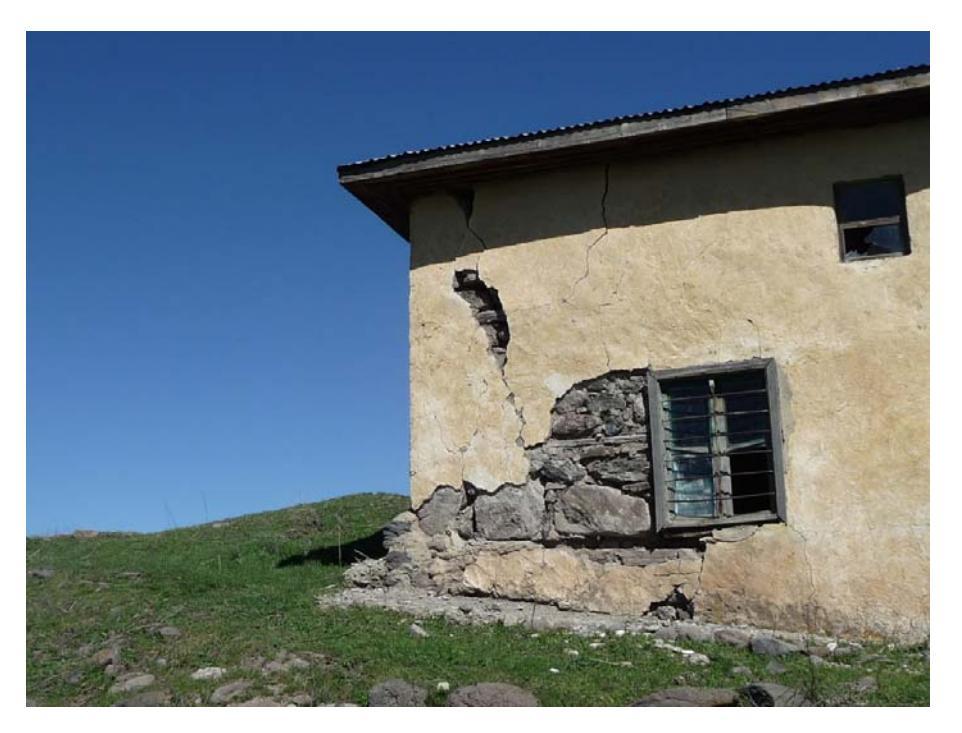
Figure 18. A moderately damaged stone masonry building in Başyurt

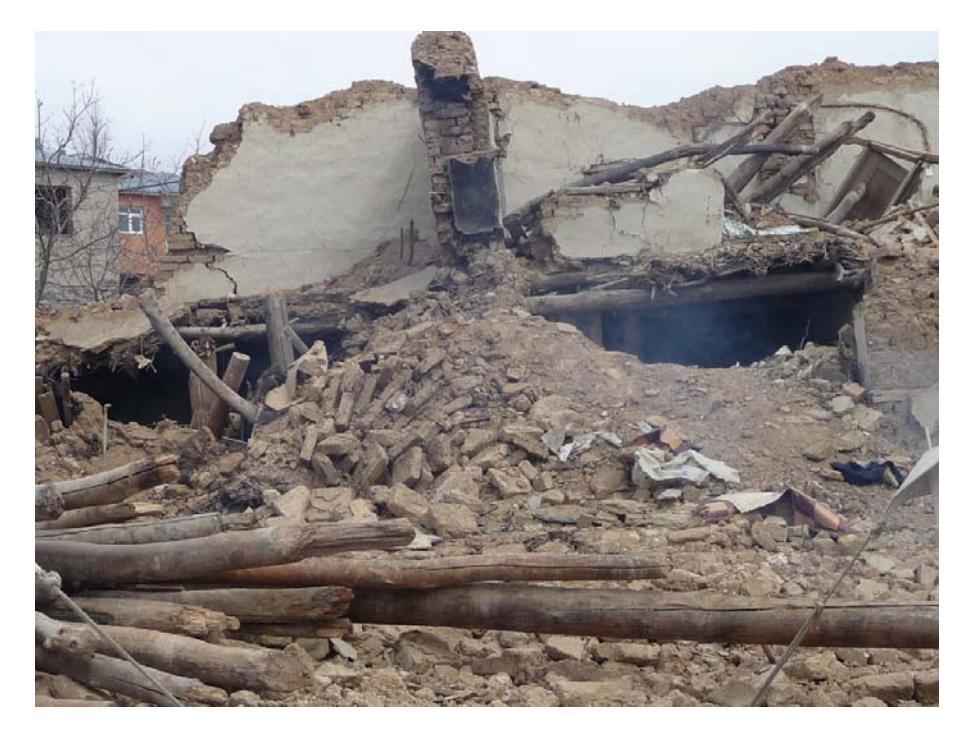
Most of the collapsed houses are either adobe or stone masonry with out of plane failures of the walls and total collapse of heavy roofs (Figures 20, 21 and 22).

Figure 20. A collapsed adobe house in Okçular

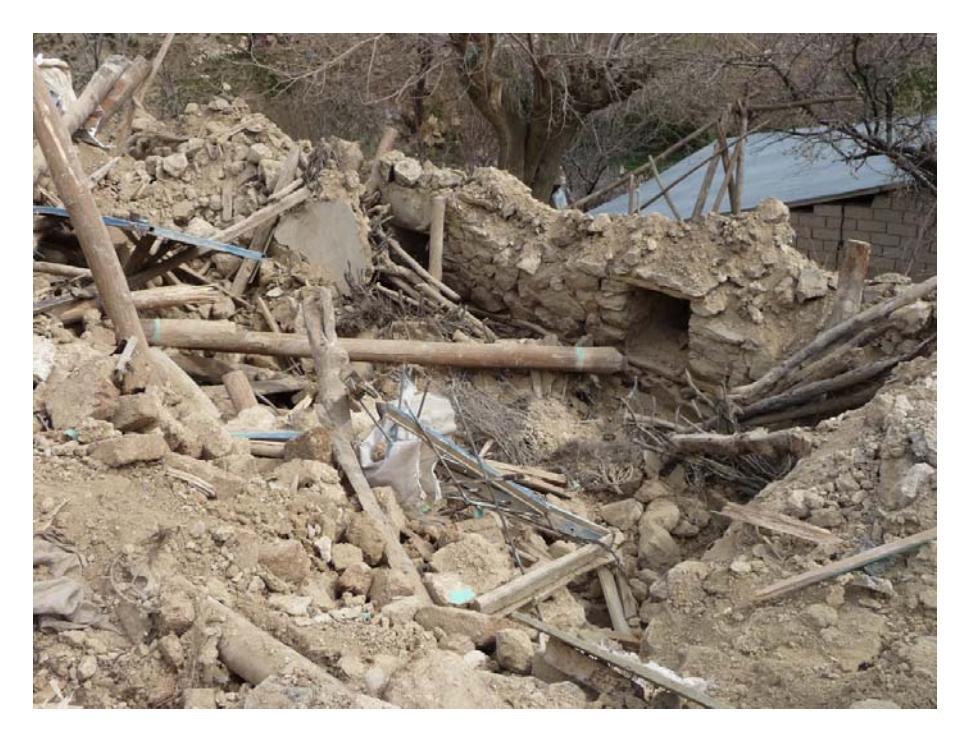
Figure 21. A collapsed stone masonry-adobe house in Okçular

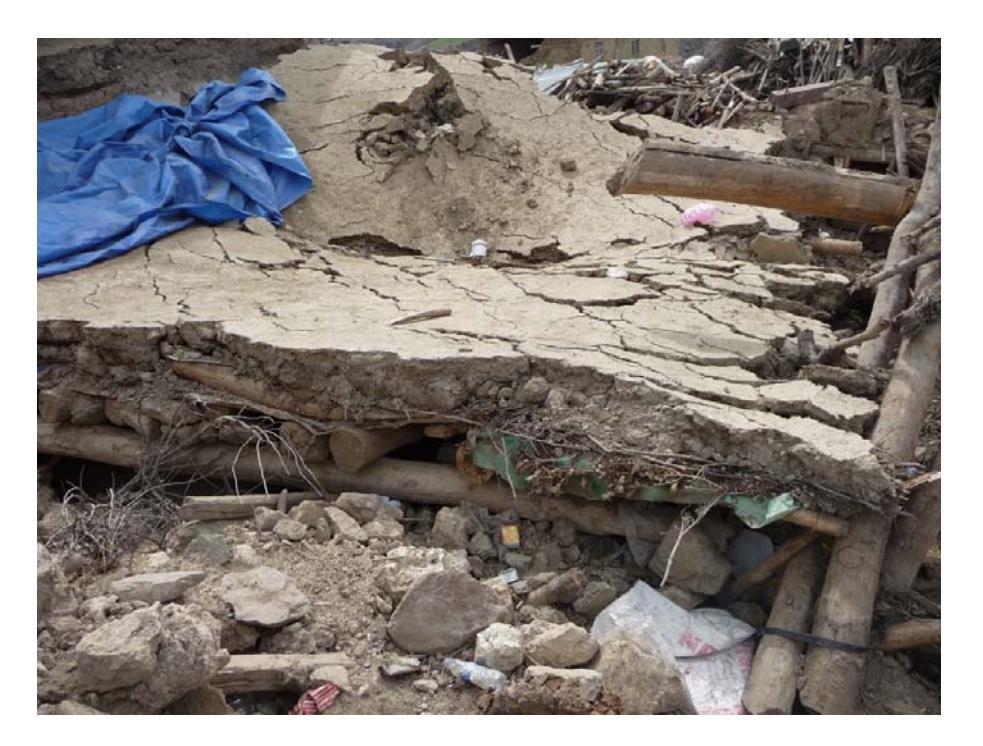
Figure 22. A collapsed house in Okçular with a roof failure

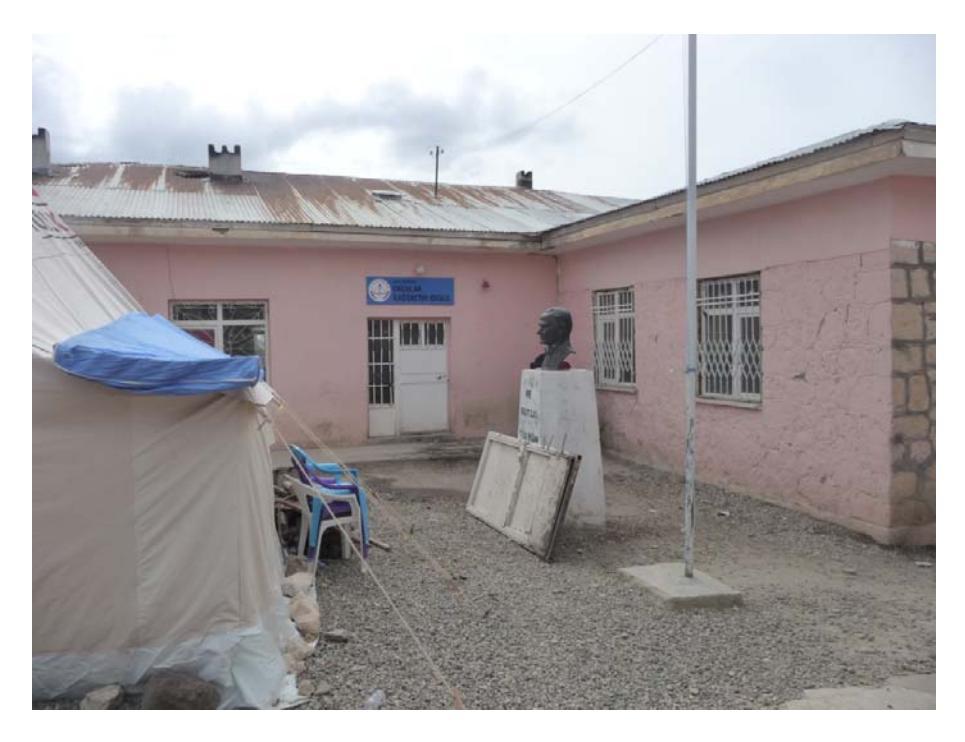
The stone masonry primary school building in Okçular village (Figure 23) is classified as moderatelydamaged by the team because of the severe cracks in the exterior wall connections (Figure 24).

Figure 23. Okçular Primary School (An exterior view)

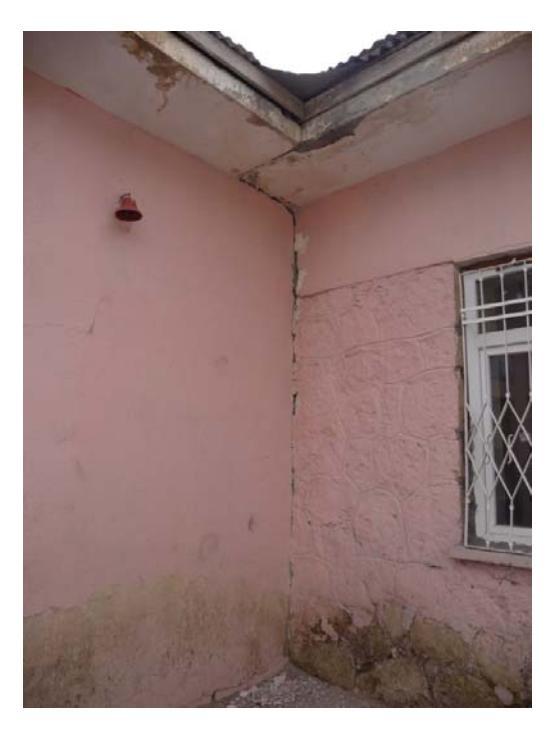
Figure 24. Okçular Primary School (Exterior wall connections)

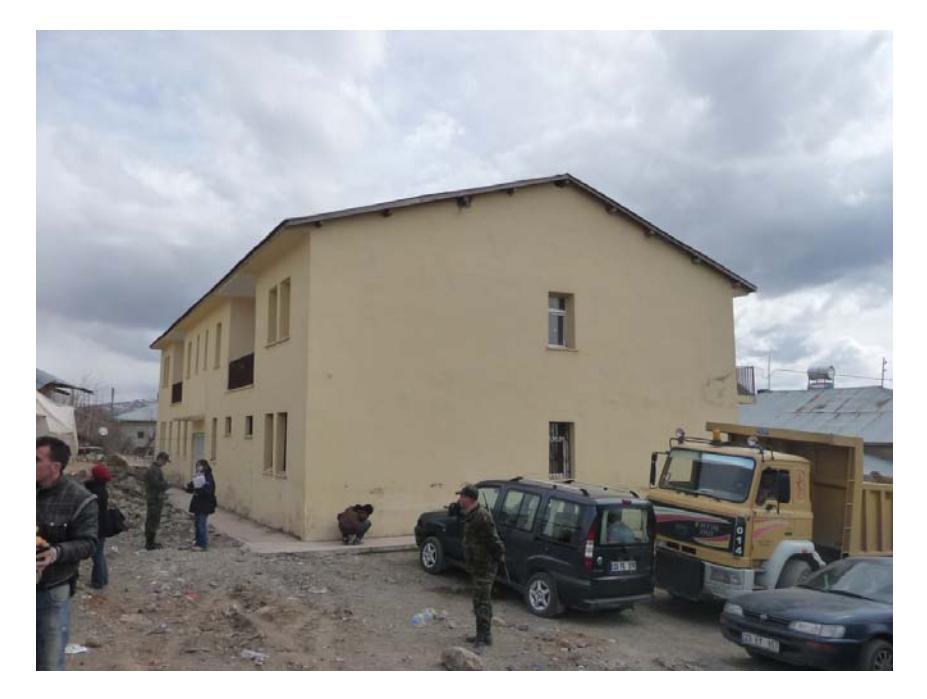
The R/C frame medical-care building in Okçular does not have any damage as observed in Figure 25, except a fine crack in one of the walls.

Figure 25. Okçular Village Medical-care building

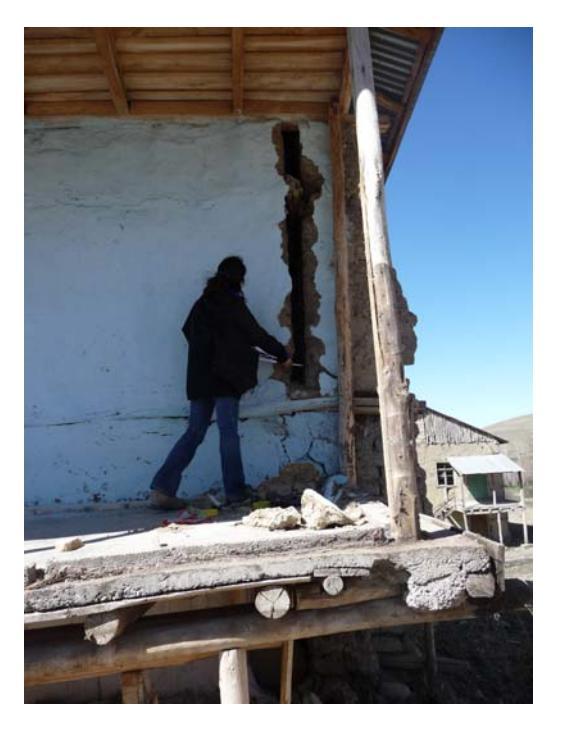
Bayramyazı village is located at 38° 48'N and 39° 59'E. Although it is located fairly close to the epicenter, the team did not observe any collapsed buildings. Severe damage is observed especially in adobe masonry houses (Figure 26 and 27). The team did not observe any damage in the R/C mosque and minaret shown in Figure 28 whereas the adobe masonry house next to it, is moderately damaged.

Figure 26. An adobe house in Bayramyazı which has a wide opening in its exterior wall

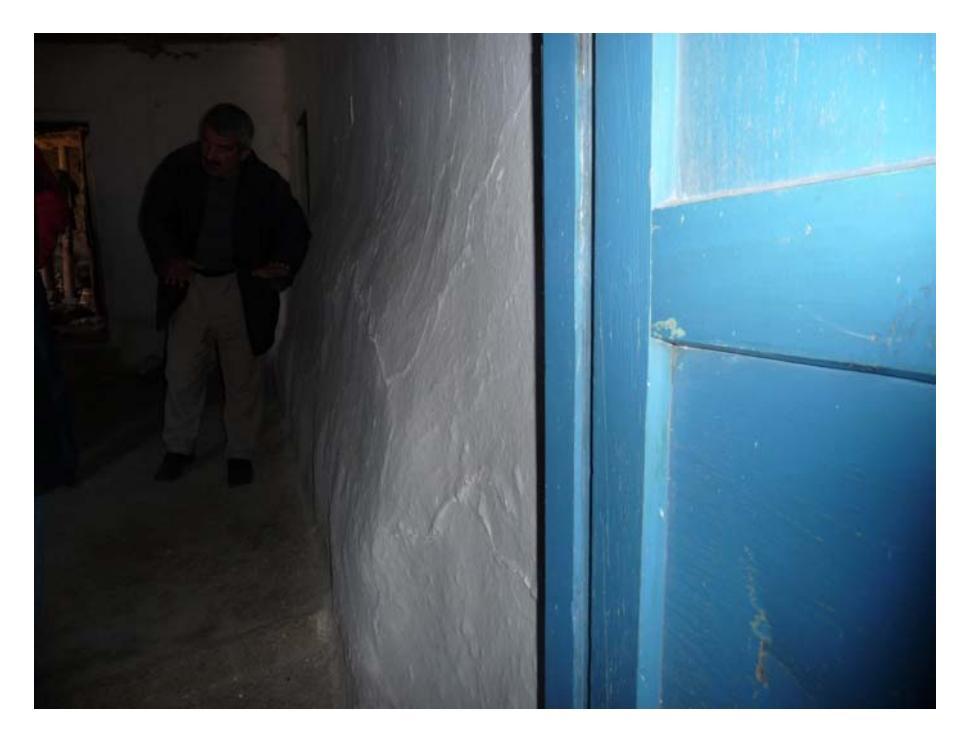
Figure 27. An adobe house in Bayramyazı where an interior wall has experienced major out-of plane displacement

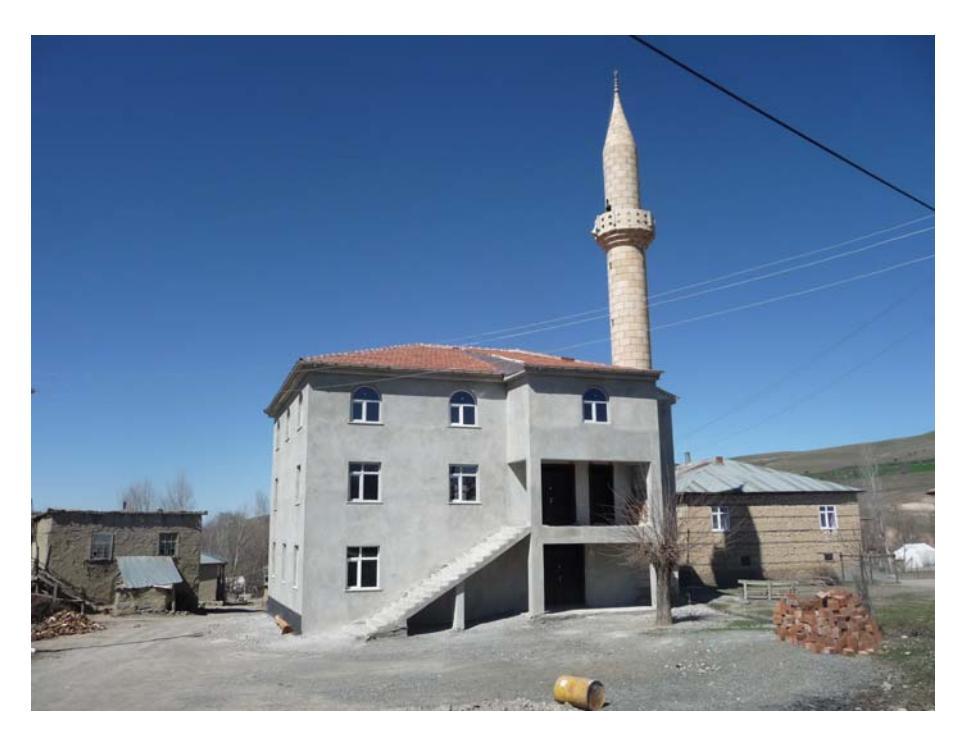
Figure 28. A moderately- damaged adobe house (Left) and R/C mosque and minaret (Right) with no damage in Bayramyazı

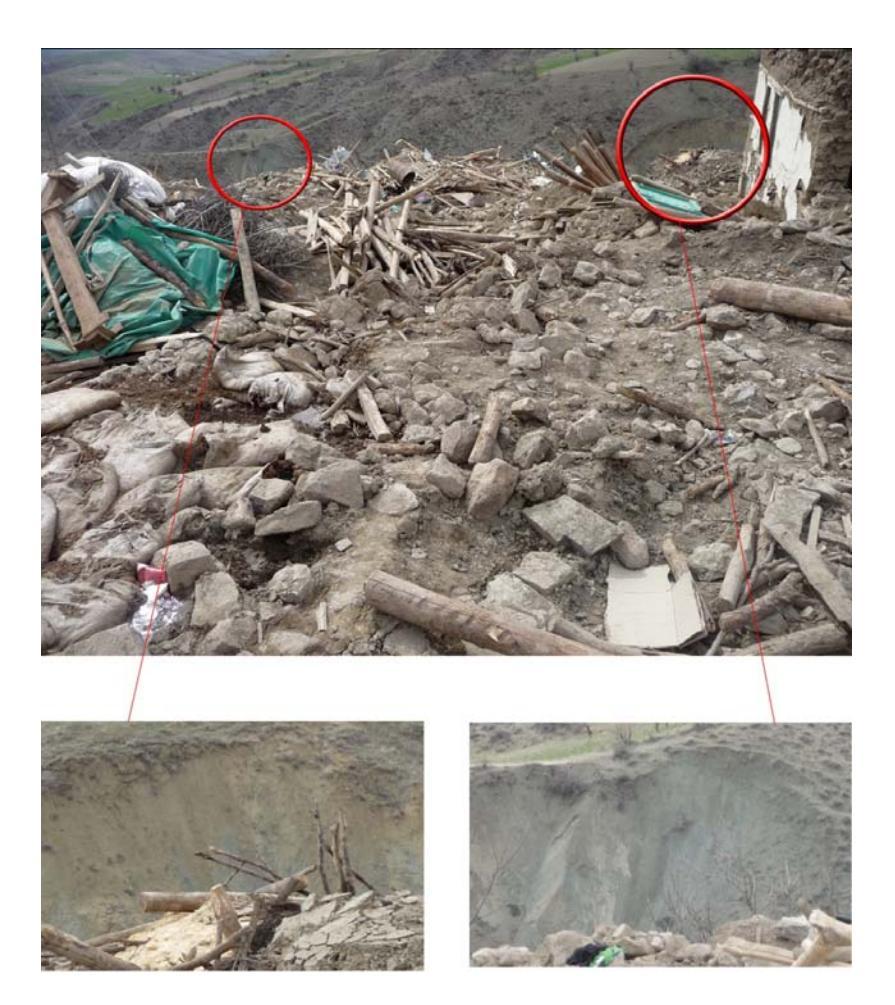
In the field, the team could not find any good evidences of ground failures in the form of major ground cracks, differential settlement / displacements, bulging or landslides due to the shaking. However, in Okçular, residents reported that the some of the buildings displaced as a rigid body and the gaps between the buildings changed. As per their statement, this may have happened due to land sliding on the slopes where these buildings were located. The team did not find any clear evidence for slope movements on the surface (may be due to slopes being covered with building debris at the time of observation, landslide features were not clearly evident); however, two big landslides were found on the opposite slopes of the hill (Figure 29). But, no clear escarpment of the landslides on the damage side could be seen.

Figure 29. Landslides in the background

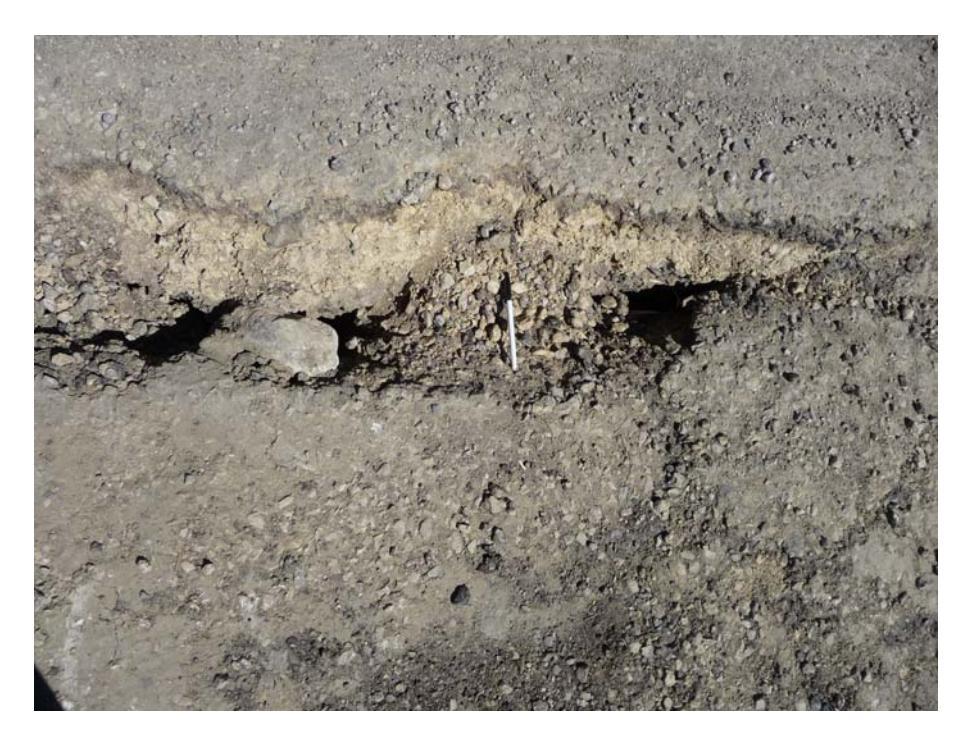
Among the impacts of earthquake on the ground, the team did observe a 30m long running crack with 25-35 cm wide opening along the road edge as indicated in Figure 30. The crack was aligned along N140-N320. Even though the villagers stated that the crack formed at the time of earthquake, it was not fully apparent whether the crack has appeared due to ground shaking or not.

Figure 30. Cracks observed along the road edge
