## THE ELÂZIĞ-SİVRİCE EARTHQUAKE [24 JANUARY 2020 M<sub>w</sub>=6.8] FIELD OBSERVATIONS ON SEISMIC AND STRUCTURAL DAMAGE

REPORT NO: METU/EERC 2020-01

MARCH 2020 ANKARA

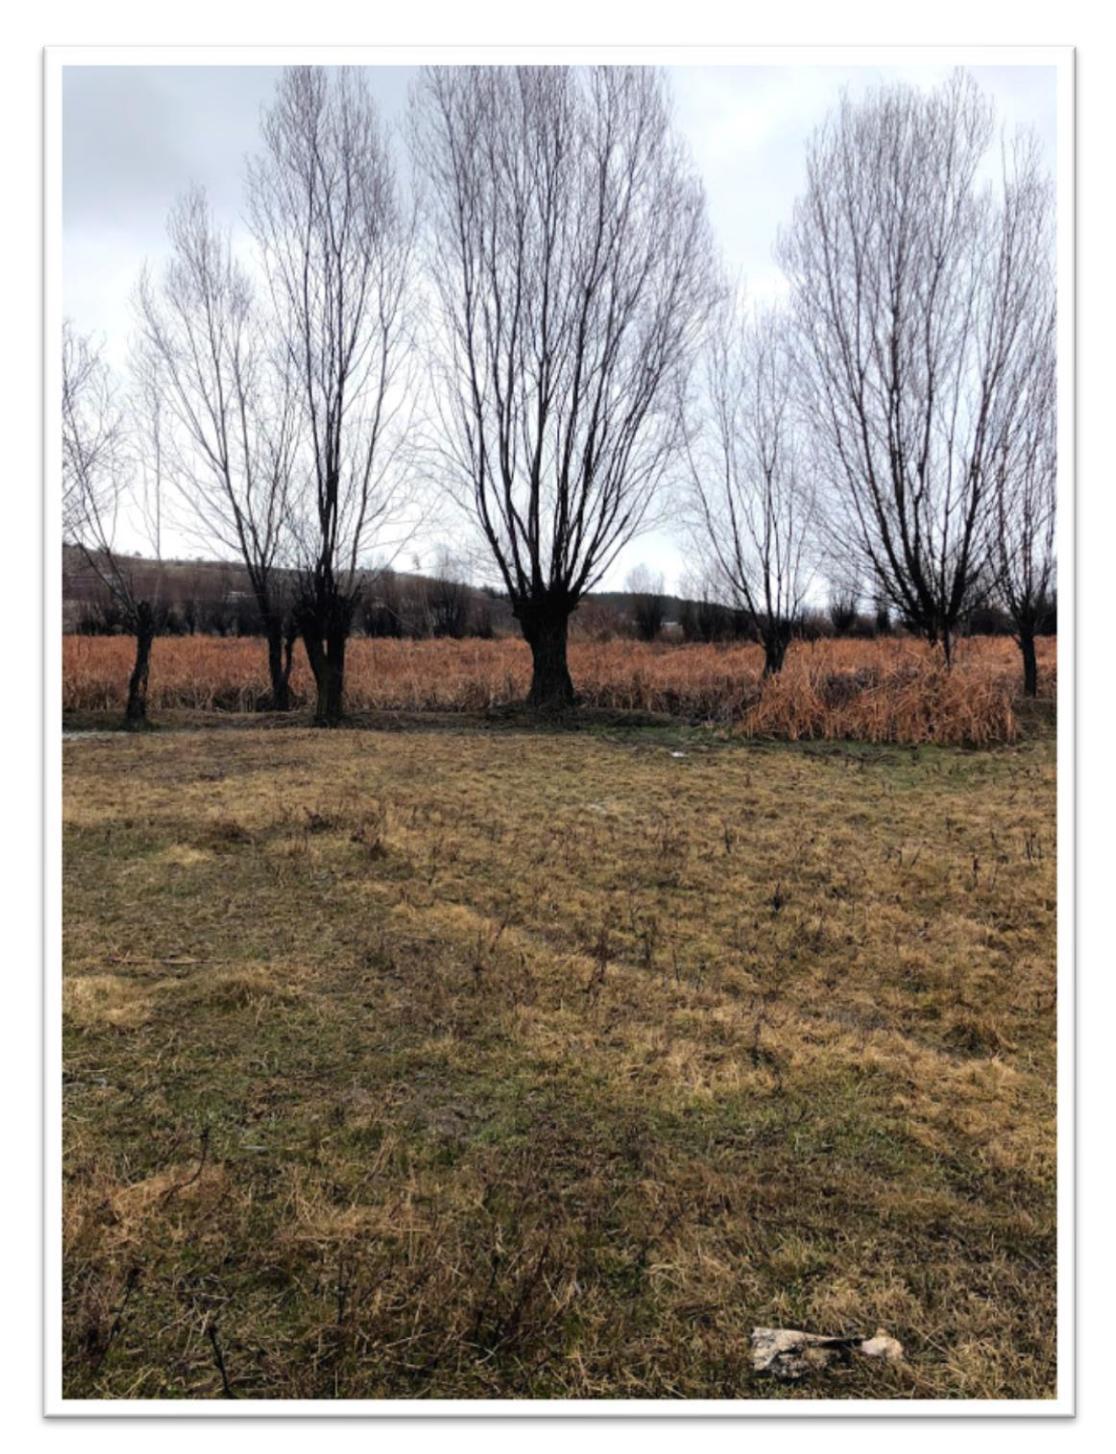
The surficial soils and the alluvial geological setting are concluded to be suitable for liquefaction triggering. However, no signs of liquefaction in the form of sand boils, lateral spread, excessive settlements, etc. were observed at the first stop, as shown in Figure 4.8.

Figure 4.8 A view of the site taken by Sivrice road (38°28'08.6"N 39°16'40.2"E / 31.01.2020 / 11:47)

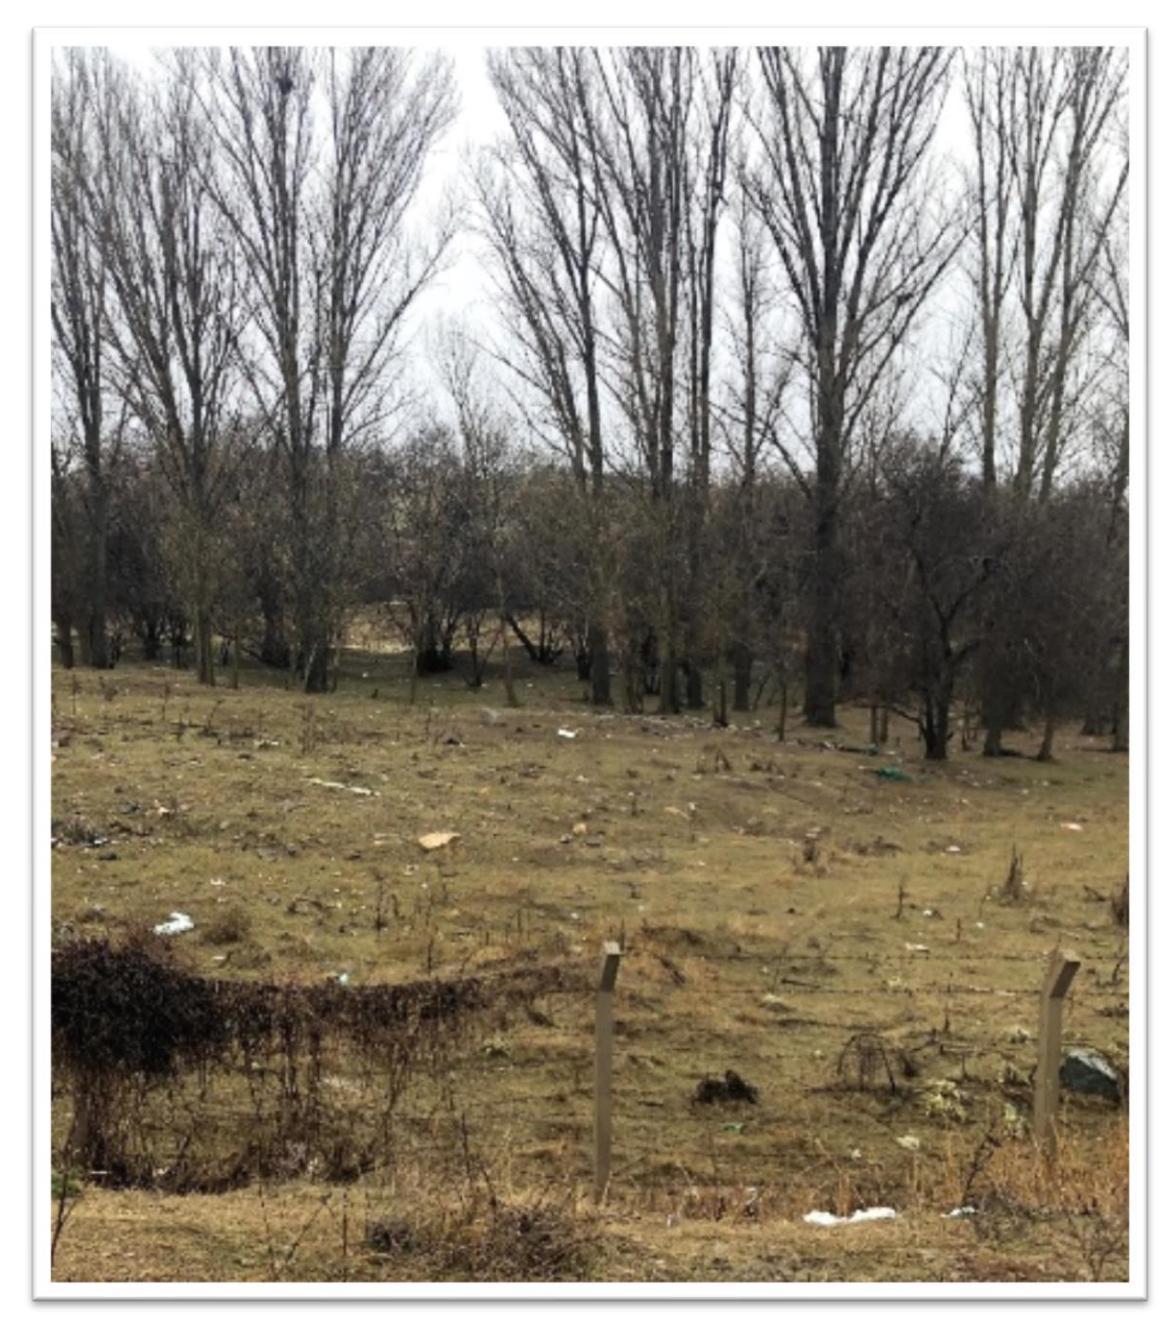
On the first stop just down the road embankment, a neighboring site was also visited, as shown in Figure 4.10. The site is composed of surficial clayey soils based on field observations. No damage and surface manifestation of ground deformations were observed.

Figure 4.10 Clayey site and no signs of ground failure (38°28'09.0"N 39°16'46.8"E / 31.01.2020 / 11:51)

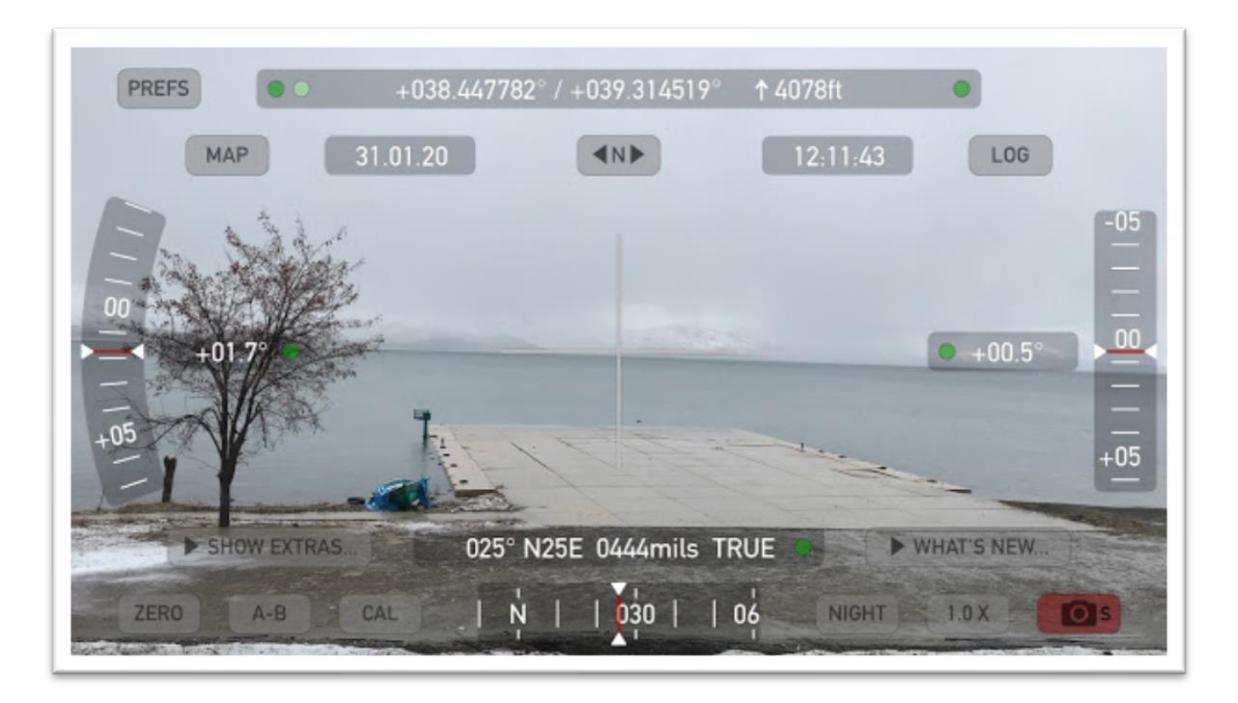
Seismically-induced lateral spreading and volumetric settlements were observed on the natural beach of Hazar Lake shoreline and Sivrice dock. Observed ground failure was mapped and discussed in a detailed manner in Section 4.7. Distribution of volumetric settlement and lateral displacements are mapped as shown in Figures 4.12 to 4.19, respectively. Next to the lake beach, where liquefaction manifestation is observed, a neighboring beach has exhibited no signs of ground failure, as given in Figure 4.20 and 4.21.

Figure 4.12 Seismically-induced volumetric settlement in the dock of Hazar Lake (38°28'10.0"N 39°17'03.6"E / 31.01.2020 / 12:11 & 38°26'53.2"N 39°18'53.4"E / 31.01.2020 / 12:14)

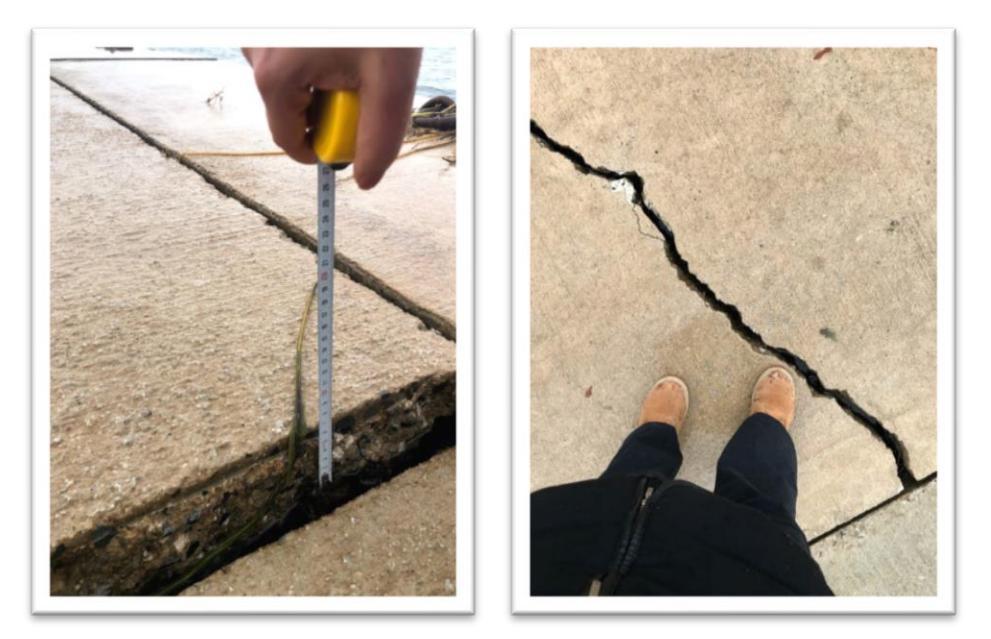
Figure 4.13 Measurements of seismically-induced volumetric settlement in the dock of Hazar Lake

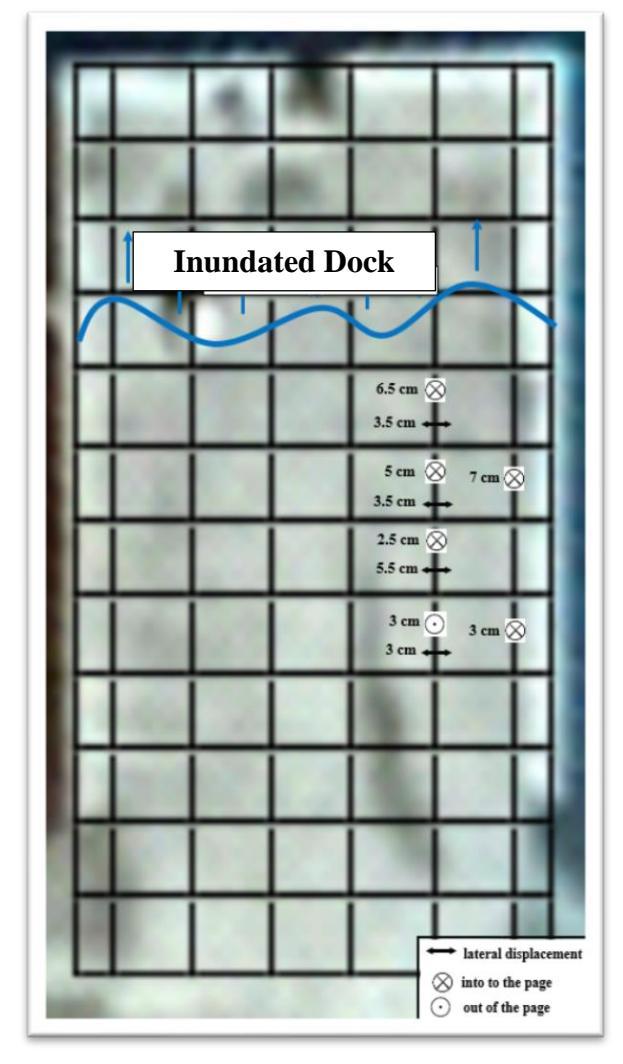
Figure 4.14 Displacements observed on reinforced concrete dock blocks

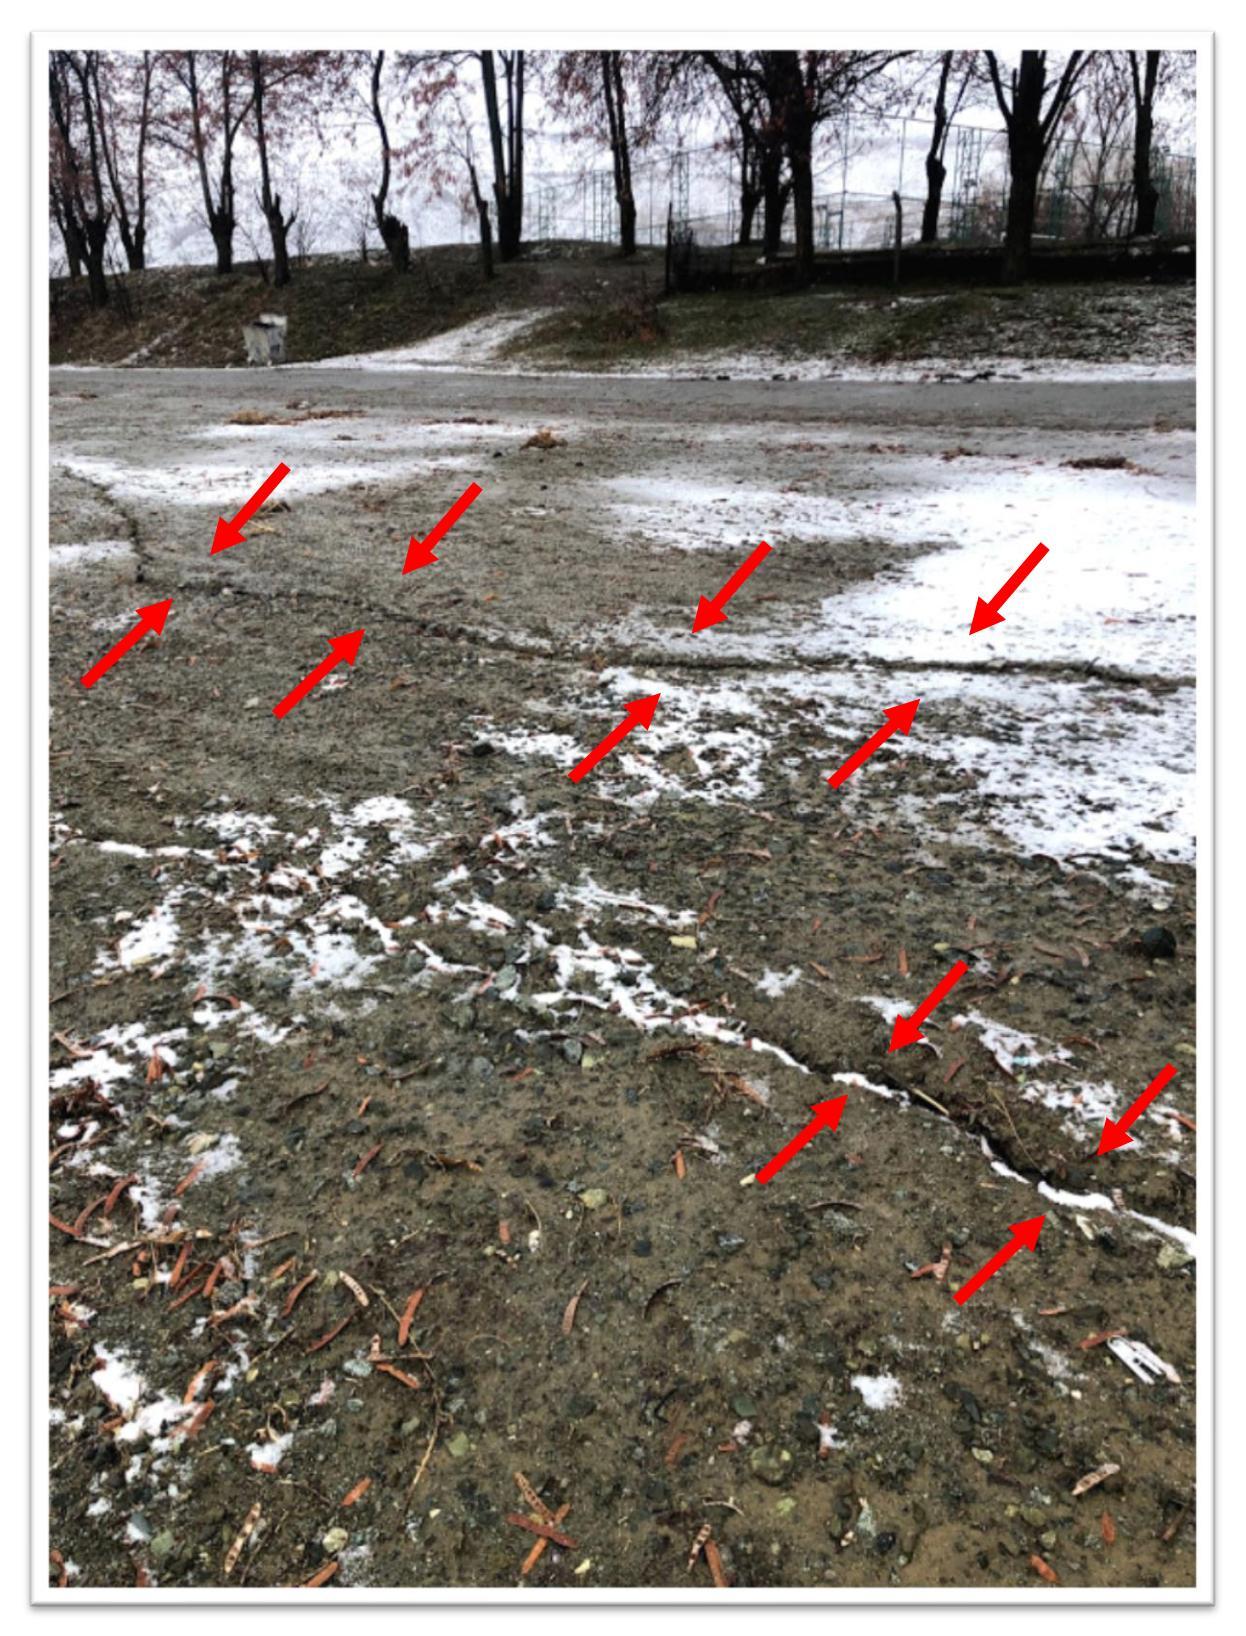
Figure 4.16 Seismically-induced lateral spreading ground deformations mapped on the beach of Hazar Lake (38°26'50.7"N 39°18'56.7"E / 31.01.2020 / 12:28)

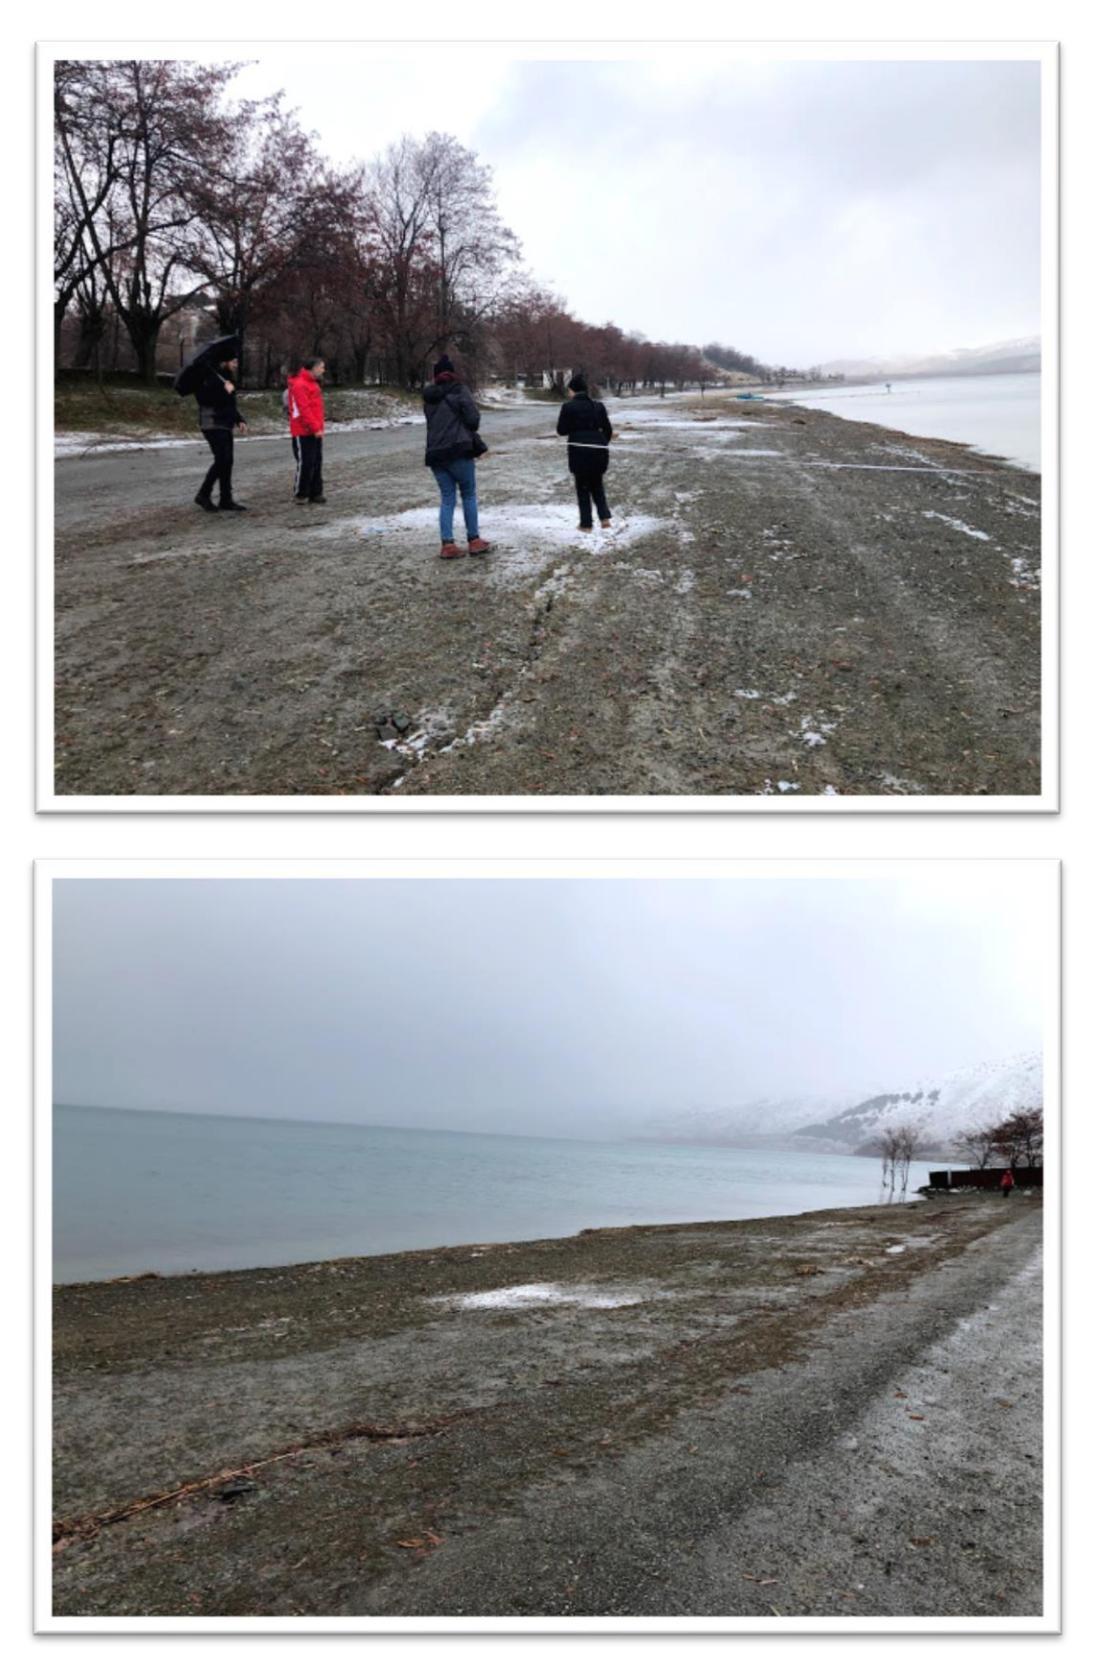
Figure 4.17 Seismically-induced lateral spreading on the beach of Hazar Lake (38°26'48.4"N 39°18'57.4"E / 31.01.2020 / 12:31 & 38°26'50.1"N 39°18'57.2"E / 31.01.2020 / 12:54)

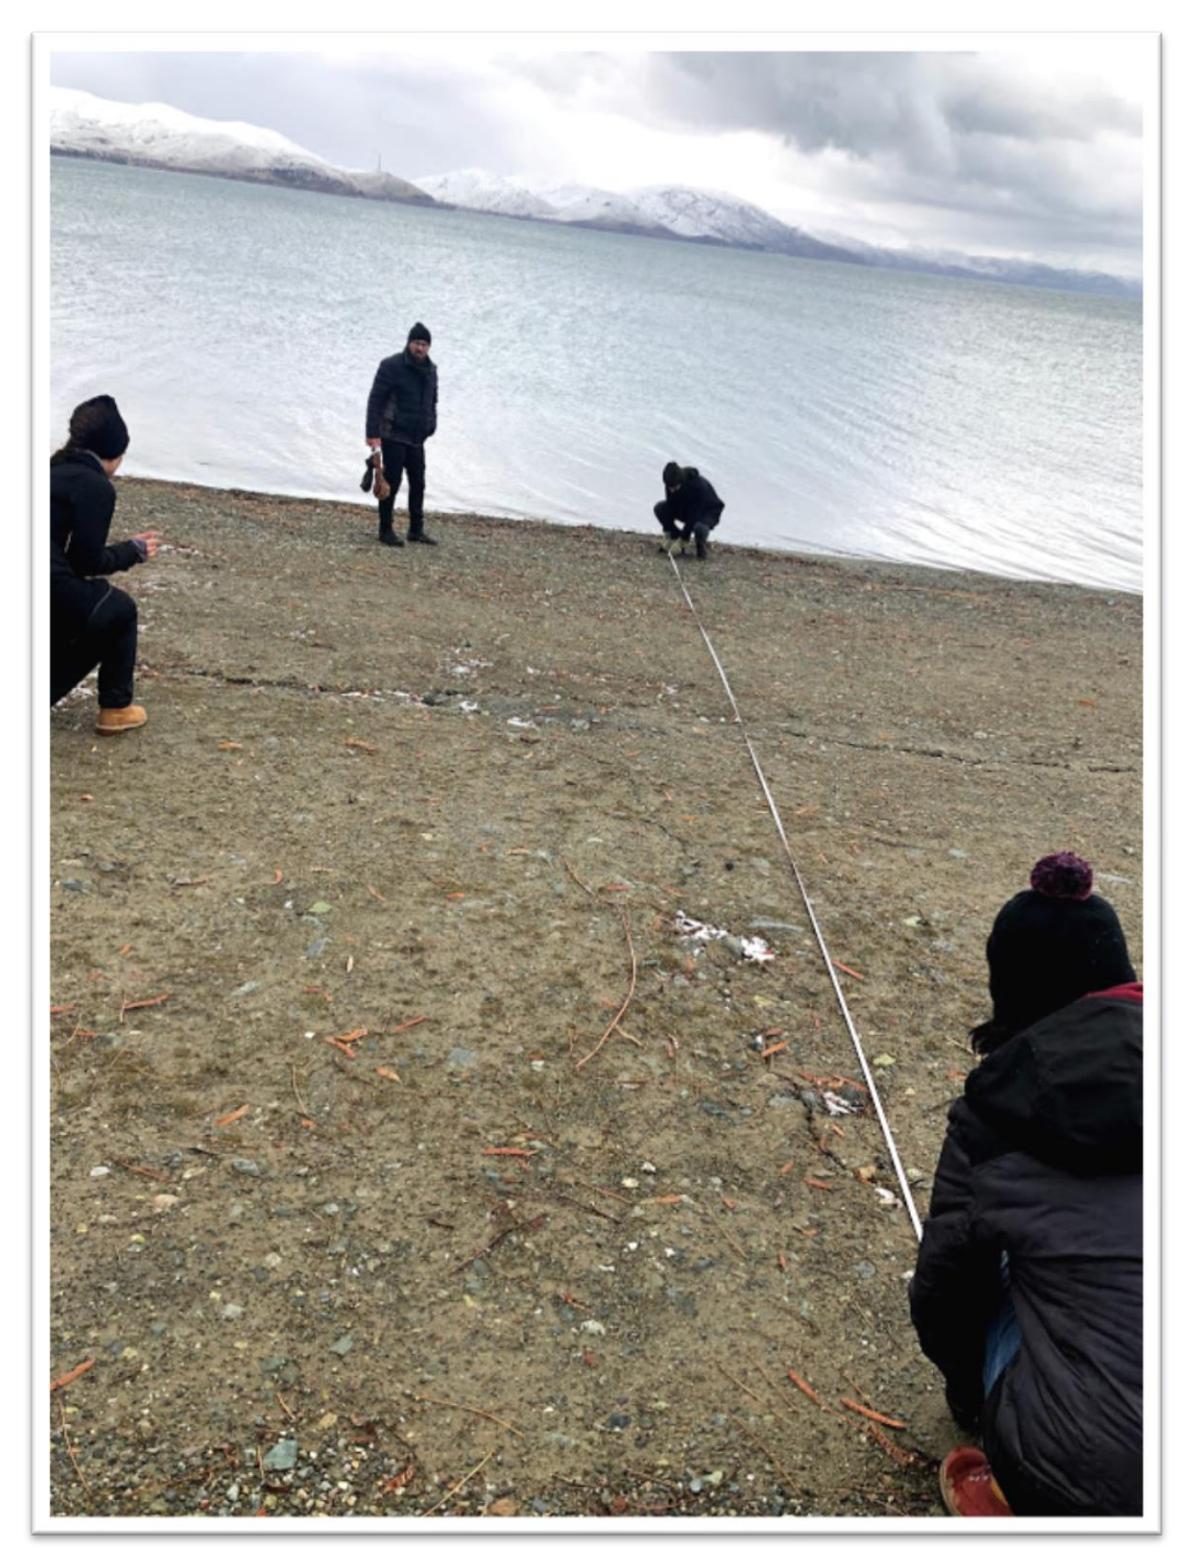
Figure 4.19 Mapping efforts of seismically-induced lateral spreading on the beach of Hazar Lake (38°26'50.0"N 39°18'57.2"E / 31.01.2020 / 13:14)

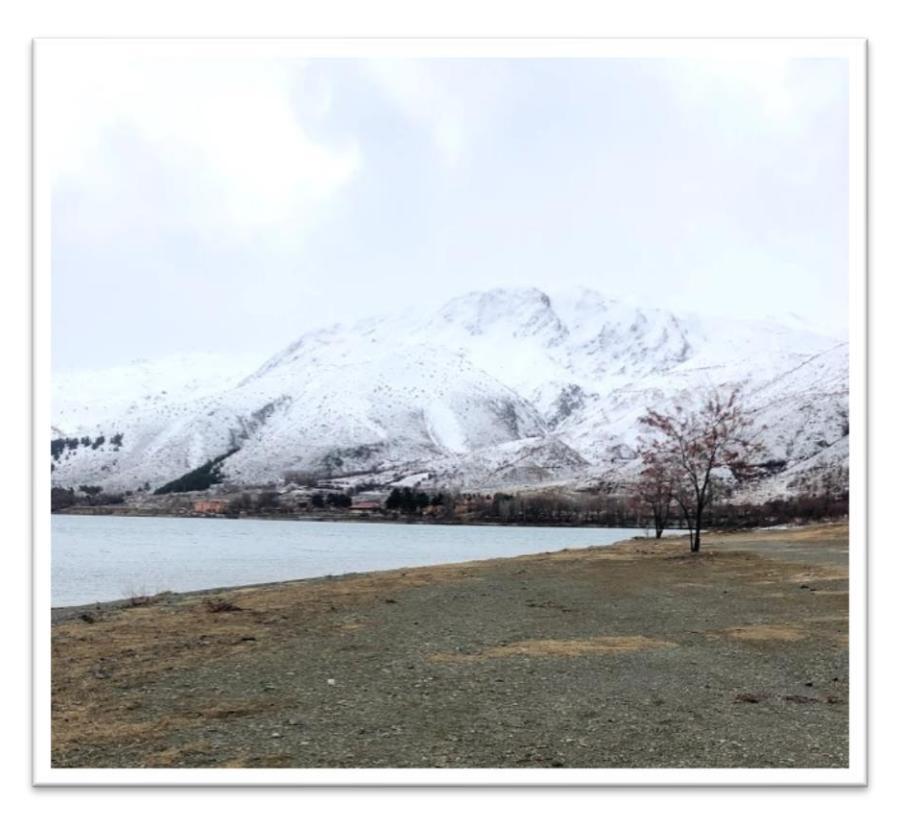
Figure 4.20 No ground failure on a neighboring beach of Hazar Lake (38°26'48.9"N 39°18'59.4"E / 31.01.2020 / 13:08)

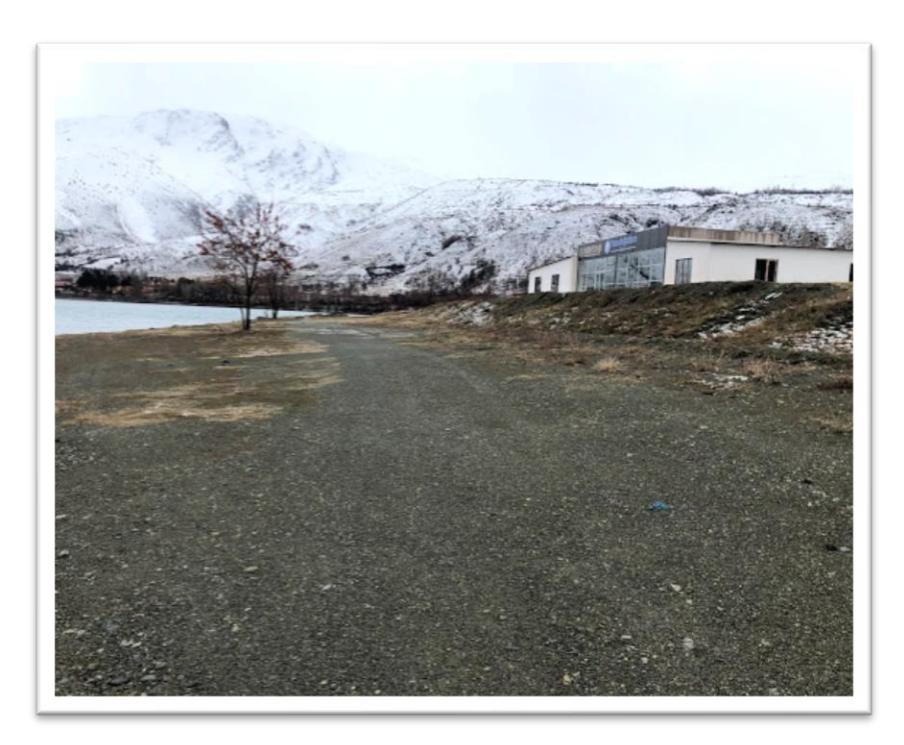
Figure 4.21 No ground failure on a neighboring beach of Hazar Lake (38°26'48.9"N 39°18'59.4"E / 31.01.2020 / 13:08)

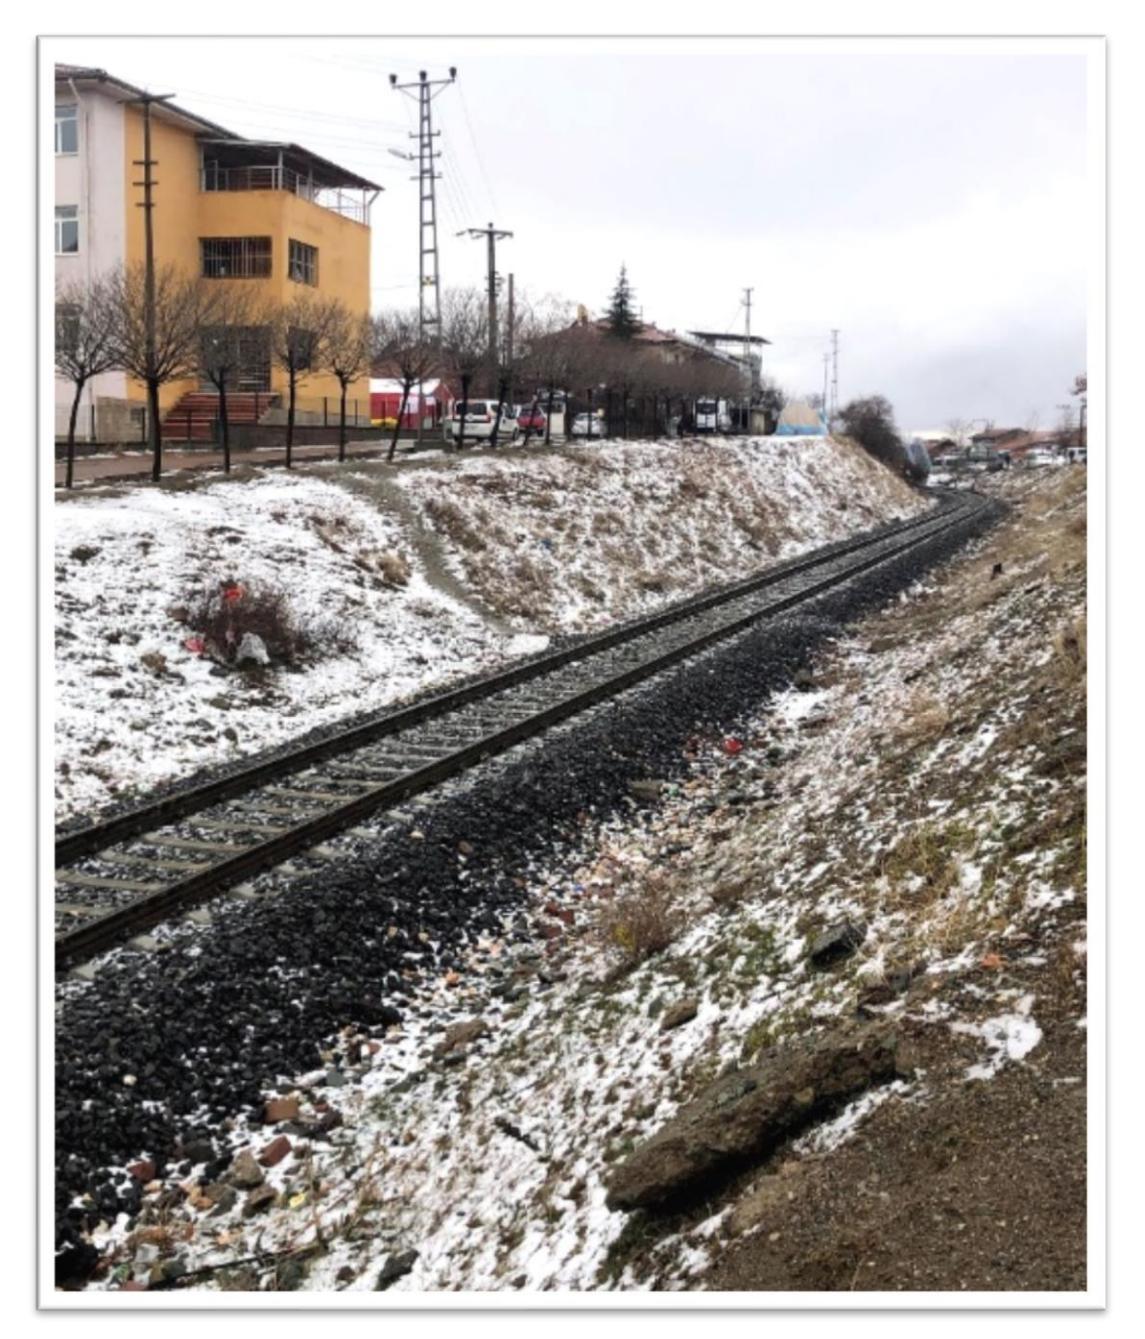
In the third stop, the railway tracks were observed to experience no damage, as shown in Figure 4.22.

Figure 4.22 A view of railway tracks without any damage at Sivrice (38°26'49.5"N 39°18'33.4"E / 31.01.2020 / 13:29)

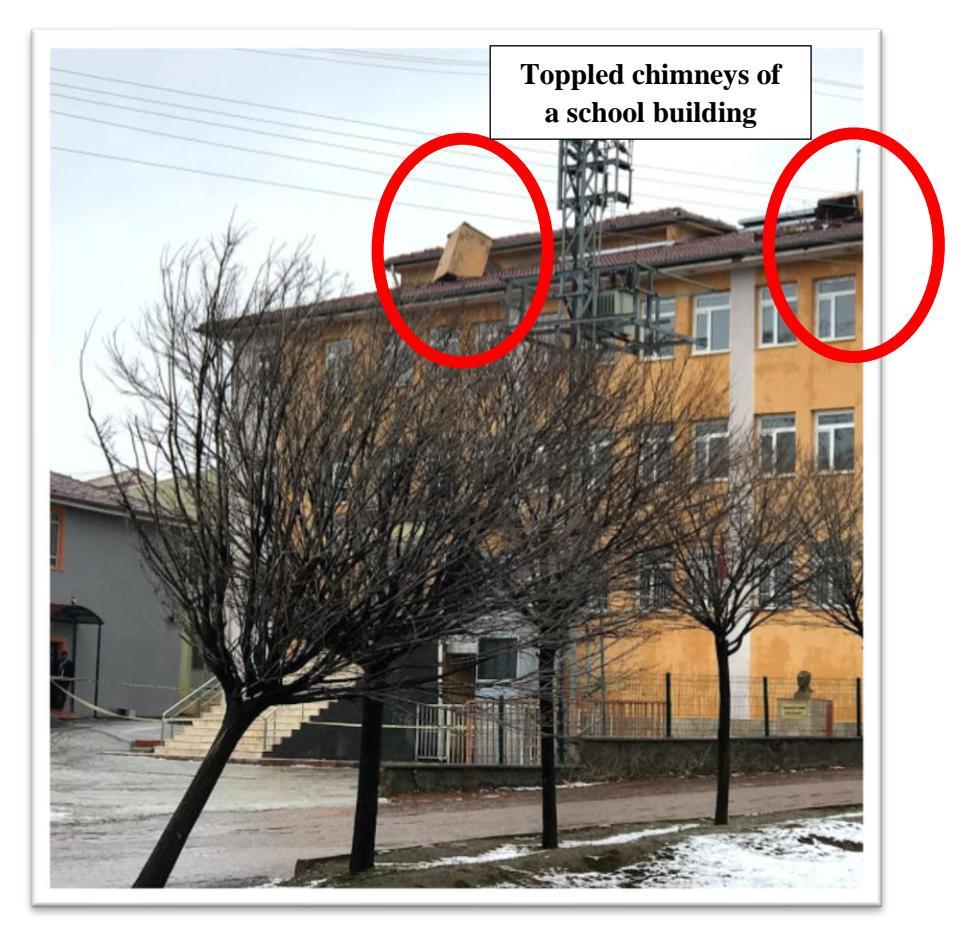
Toppled chimneys were observed as presented in Figure 4.23 and Figure 4.24. These failures show the intensity of shaking observed at the site, indicating a Mercalli intensity scale of VIII.

Figure 4.23 Toppled chimneys in Sivrice (38°26'49.6"N 39°18'32.9"E / 31.01.2020 / 13:29)

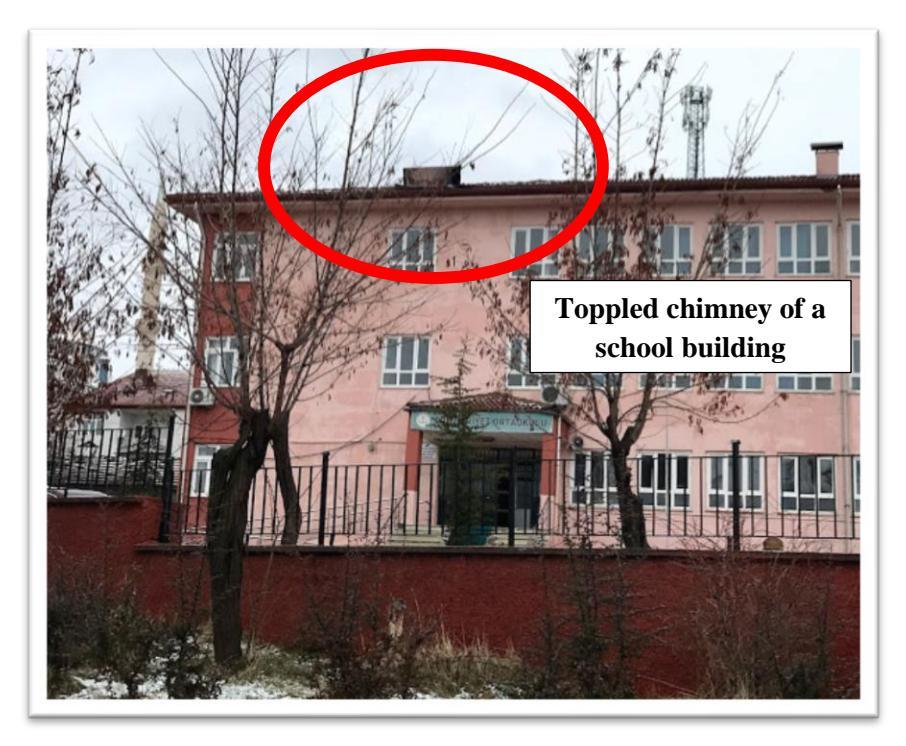
Figure 4.24 Toppled chimney in Sivrice (38°26'49.7"N 39°18'33.0"E / 31.01.2020 / 13:30)

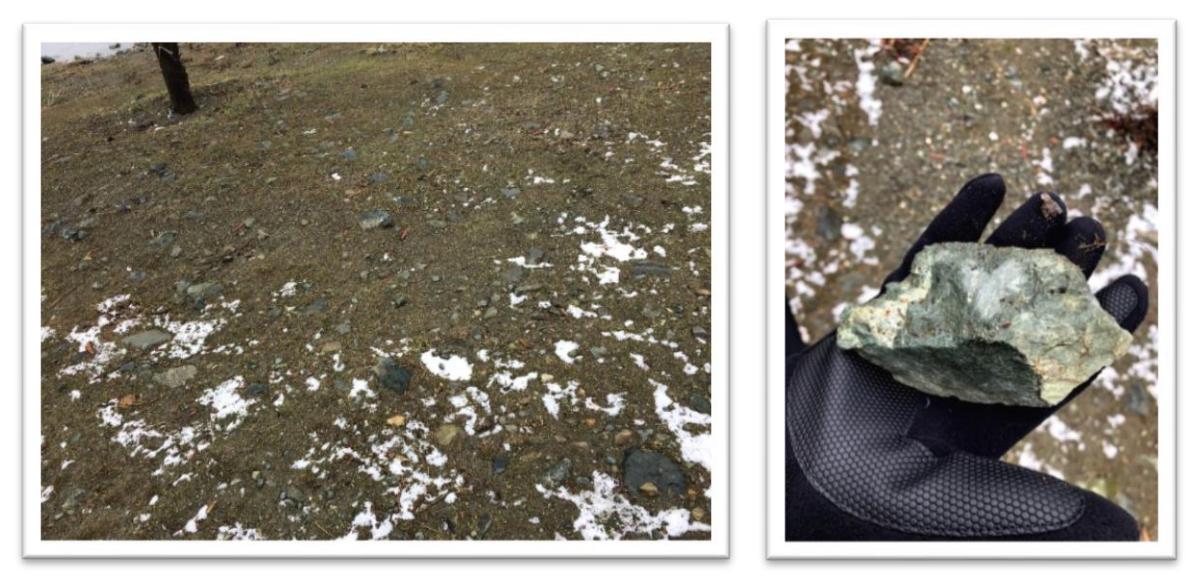
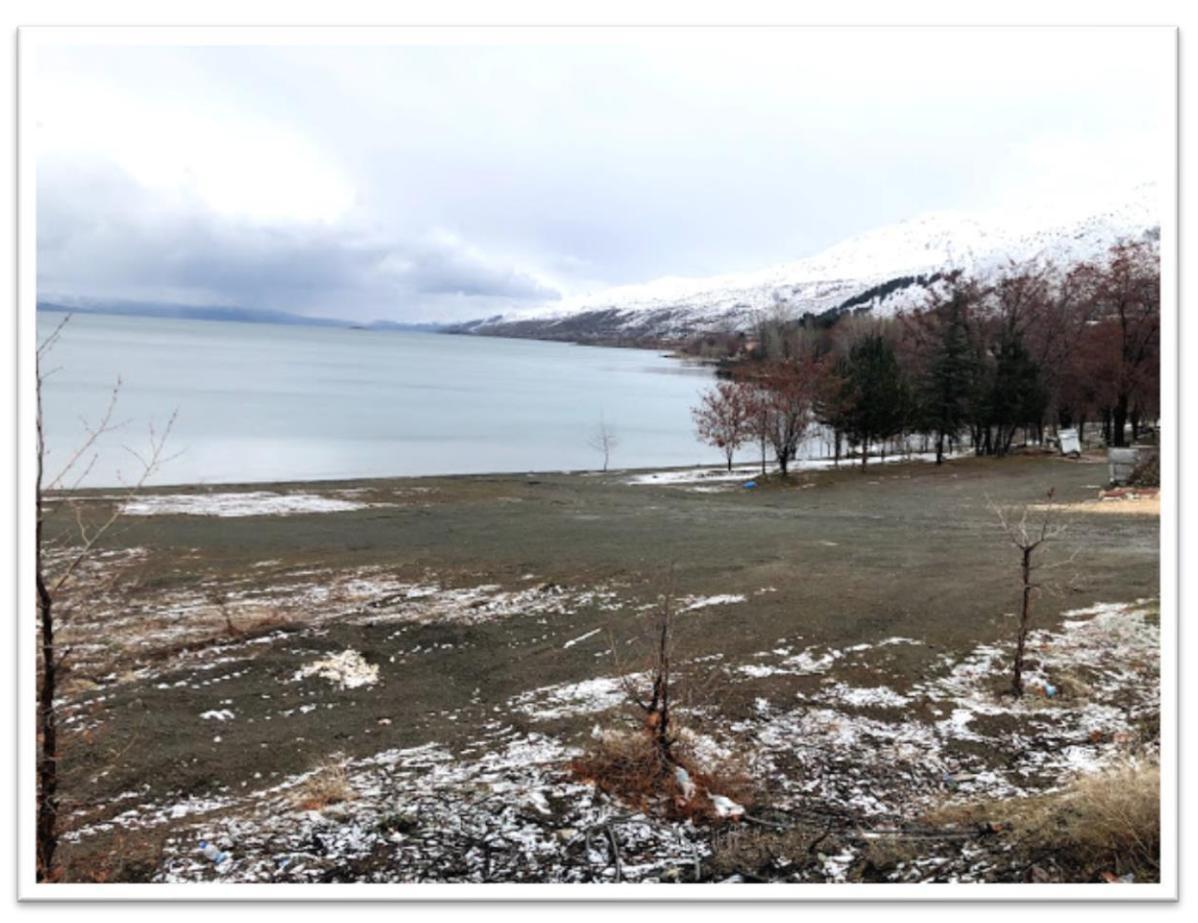
In the fourth stop, surface geology has changed to volcanic rocks, as shown in Figure 4.25. No ground failure was observed due to earthquake.

Figure 4.25 No signs of ground failure (38°26'32.0"N 39°19'11.4"E / 31.01.2020 / 13:42 & 38°26'33.2"N 39°19'10.0"E / 31.01.2020 / 13:42 & 38°26'31.9"N 39°19'04.4"E / 31.01.2020 / 13:3)

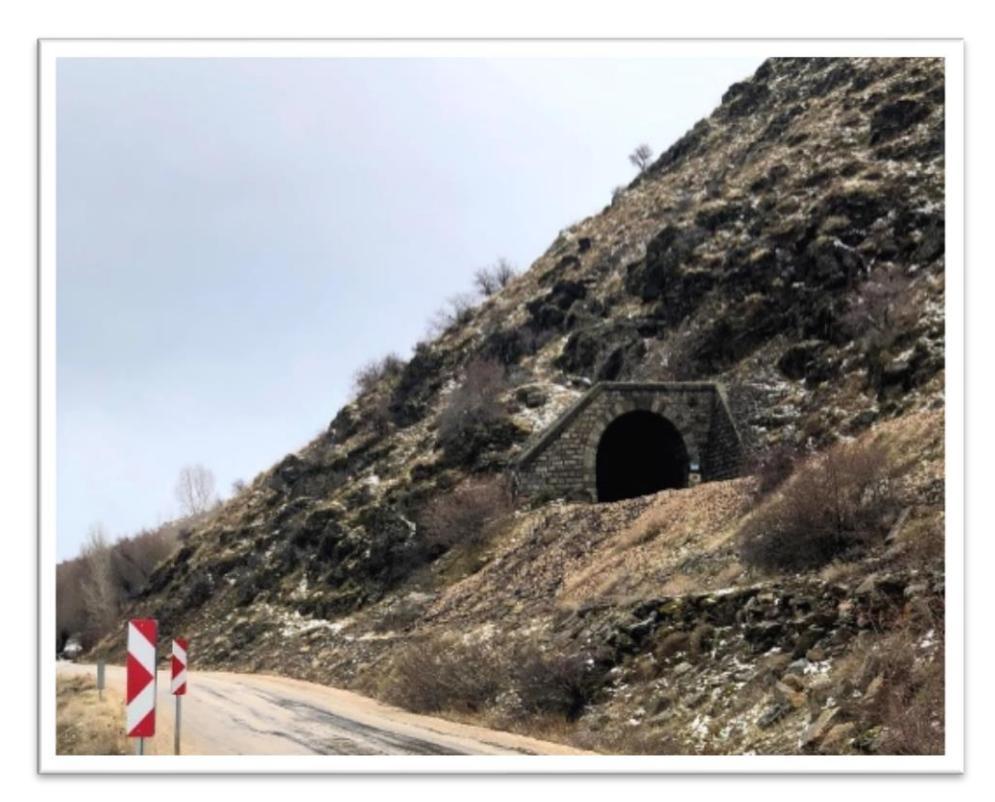
No damage was observed on the railway tunnel. Railway tunnel is open to service and Güney Kurtalan Express Train was serving, as documented in Figures 4.26 and 4.27 along with the coordinates of the pictures taken.

Figure 4.26 A view of the tunnel in Stop 5 (38°26'43.7"N 39°20'40.8"E / 31.01.2020 / 13:54)

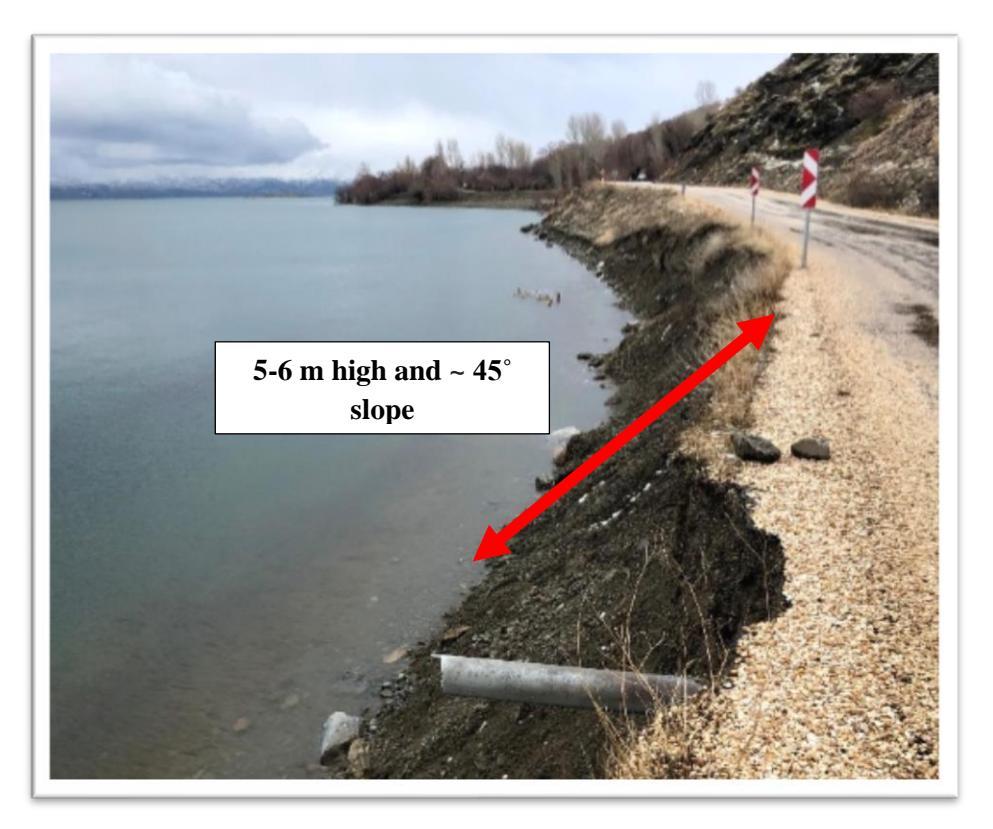
The shoreline by the railway tunnel was also visited. The road embankment has relatively steep slopes (nearly 45°); however, no ground failure was observed along this shoreline (Figure 4.28).

Figure 4.28 No failure on the road embankment (38°26'43.7"N 39°20'40.7"E / 31.01.2020 / 13:54)

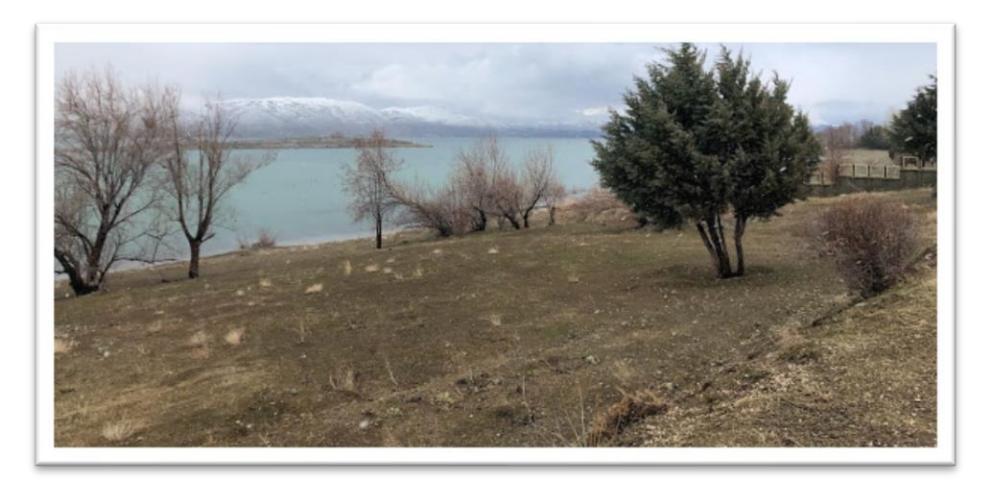
The surficial soil layers are composed of low plasticity clays as shown in Figure 4.29. No signs of ground failure were observed.

Figure 4.29 No ground failure at the 6<sup>th</sup> stop (38°27'17.1"N 39°21'49.3"E / 31.01.2020 / 14:03

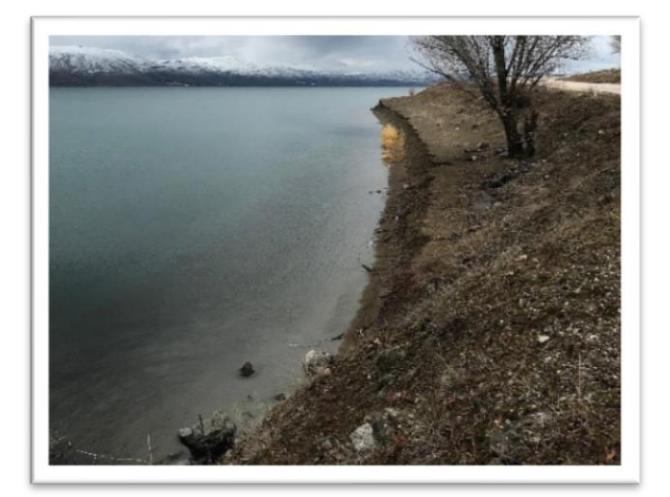
No ground failure was observed at steep slopes of the 7<sup>th</sup> stop, as shown in Figure 4.30.

Figure 4.30 No ground failure was observed at the shores of 7<sup>th</sup> stop (38°27'31.0"N 39°22'55.9"E / 31.01.2020 / 14:08)

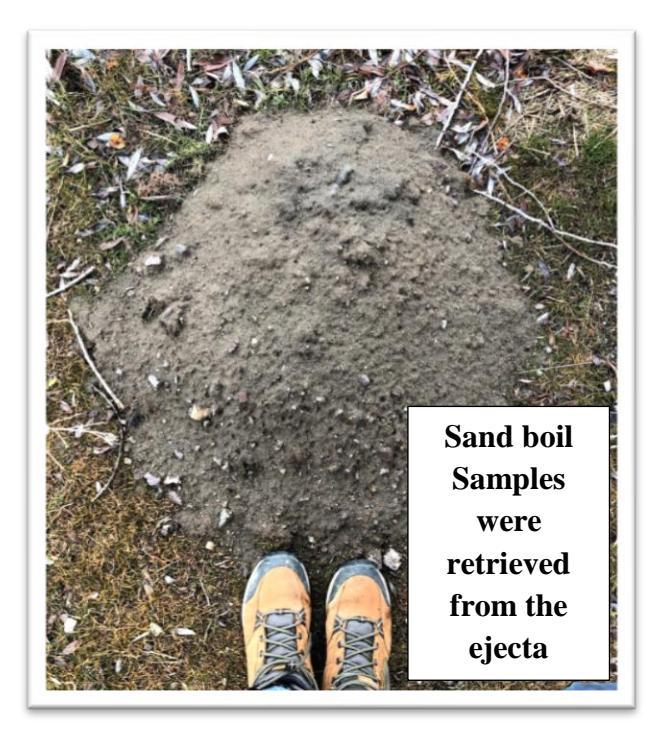
Seismically-induced liquefaction failure was observed in the form of sand boils as shown in Figures from 4.31 to 4.37.

Figure 4.31 Sand boil observed in Stop 8 (38°27'49.7"N 39°24'01.1"E / 31.01.2020 / 14:38)

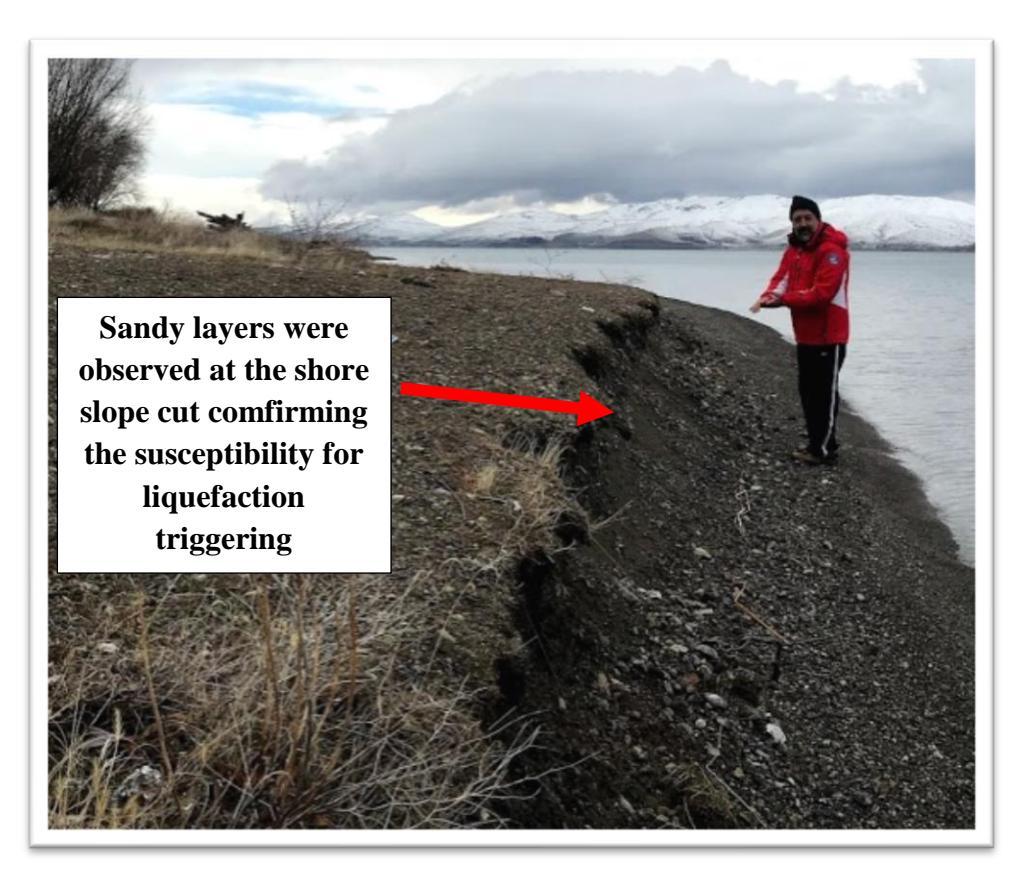
Figure 4.34 Sandy soil layers observed in Stop 8 (38°27'50.3"N 39°24'02.1"E / 31.01.2020 / 14:21)
