## THE ELÂZIĞ-SİVRİCE EARTHQUAKE [24 JANUARY 2020 M<sub>w</sub>=6.8] FIELD OBSERVATIONS ON SEISMIC AND STRUCTURAL DAMAGE

REPORT NO: METU/EERC 2020-01

MARCH 2020 ANKARA

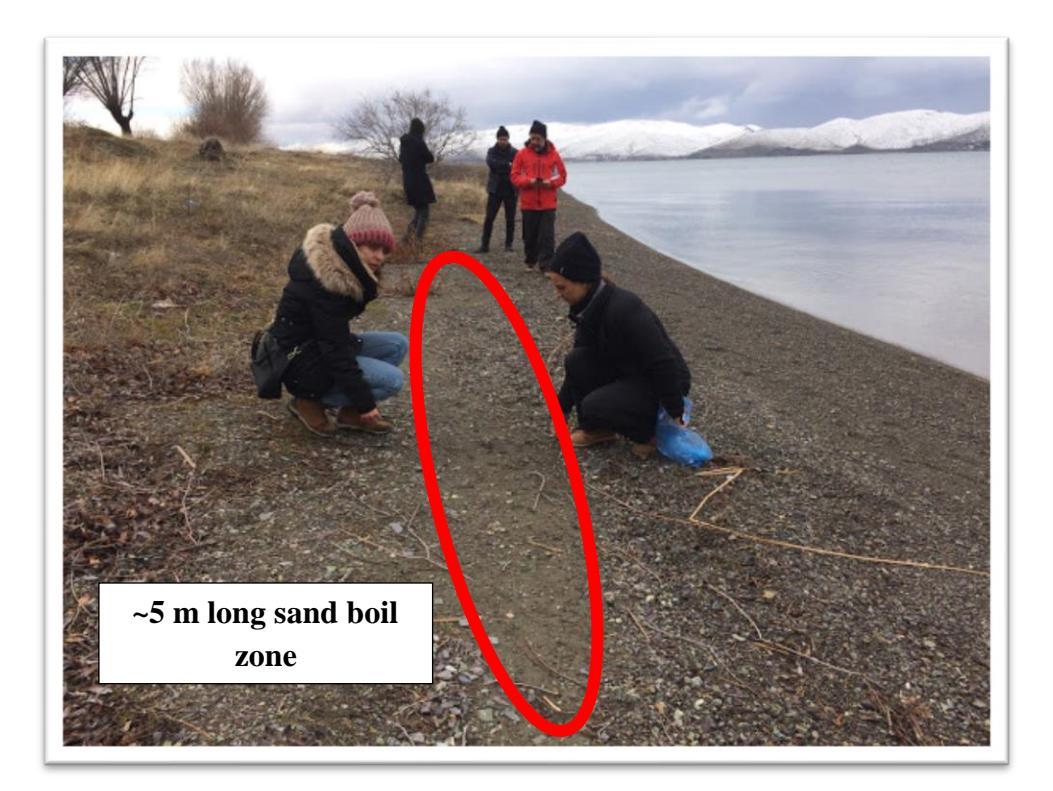
Seismically-induced liquefaction failure was observed in the form of sand boils as shown in Figures from 4.31 to 4.37.

Figure 4.35 A line of sand boils observed in Stop 8 (38°27'49.7"N 39°24'03.3"E / 31.01.2020 / 14:16)

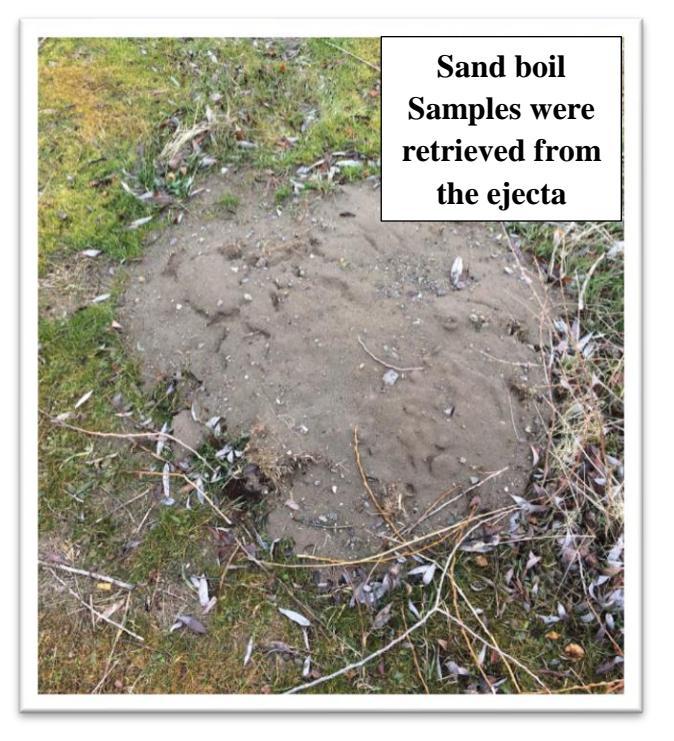
Figure 4.36 Sand boil observed in Stop 8 (38°27'49.6"N 39°24'01.7"E / 31.01.2020 / 14:38)

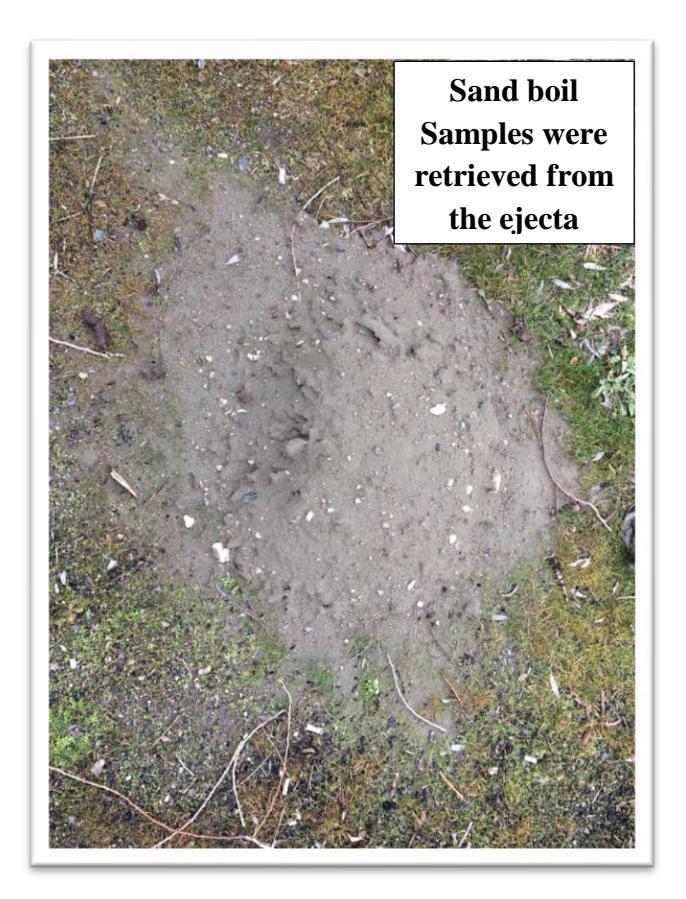
Figure 4.37 Sand boil observed in Stop 8 (38°27'50.1"N 39°24'01.3"E / 31.01.2020 / 14:43)

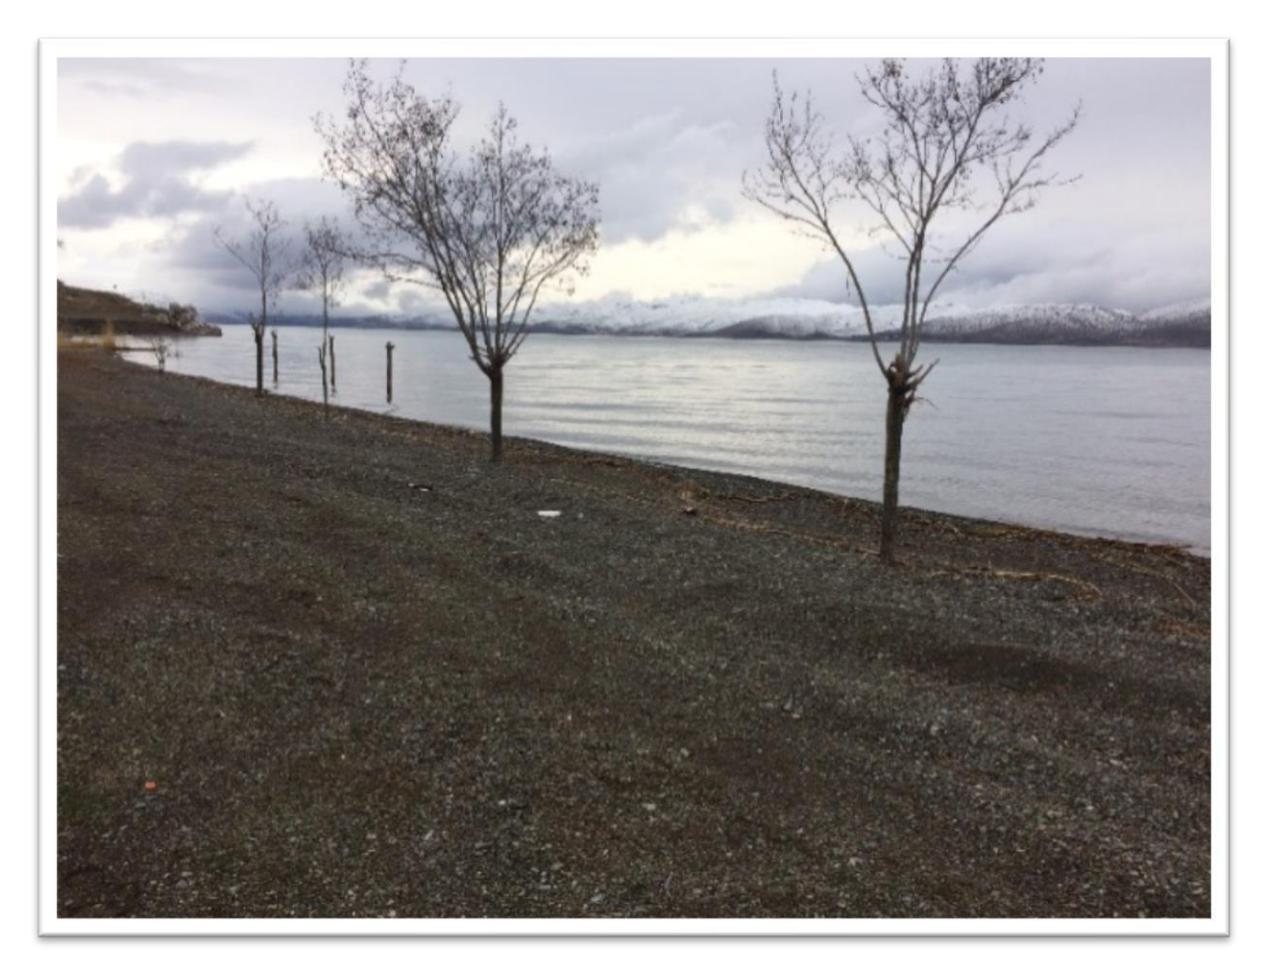
No ground failure was observed at this site, as presented in Figure 4.38.

Figure 4.38 No ground failure was observed at shore of 9<sup>th</sup> stop (38°28'22.2"N 39°25'24.9"E / 31.01.2020 / 14:53)

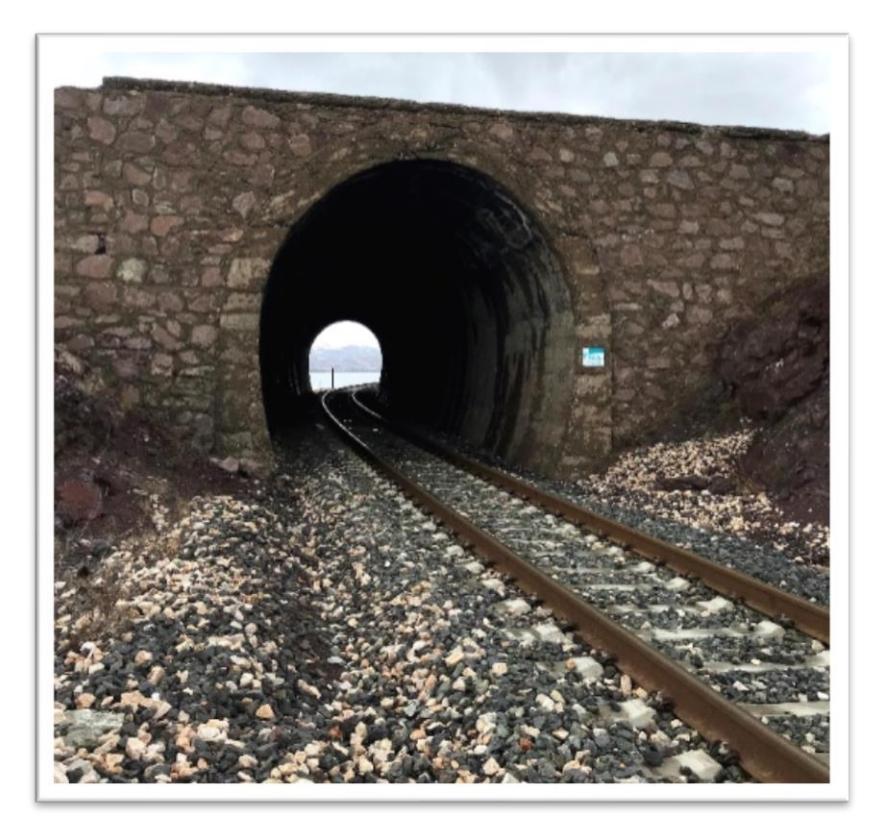
A relatively very short (~15 m long) railway tunnel was constructed at the toe of a highly weathered rock steep slope. Tunnel has been possibly designed to eliminate toe excavations, which may trigger slope instability problems. No damage was observed, as also presented in Figures 4.39 to 4.41. Additionally, no slope failure was observed near Hazar Lake, as presented in Figure 4.42.

Figure 4.39 A railway tunnel and rails exhibiting no damage (38°28'52.8"N 39°27'18.2"E / 31.01.2020 / 15:08)

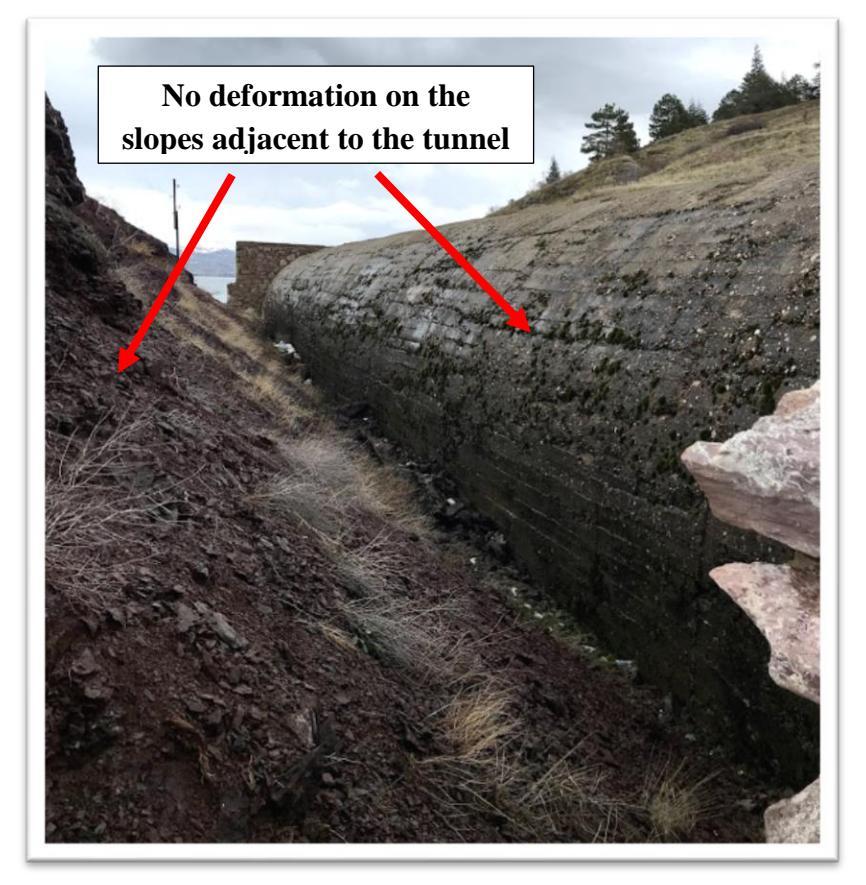
Figure 4.40 A view of tunnel body at Stop 10 (38°28'53.2"N 39°27'18.4"E / 31.01.2020 / 15:09)

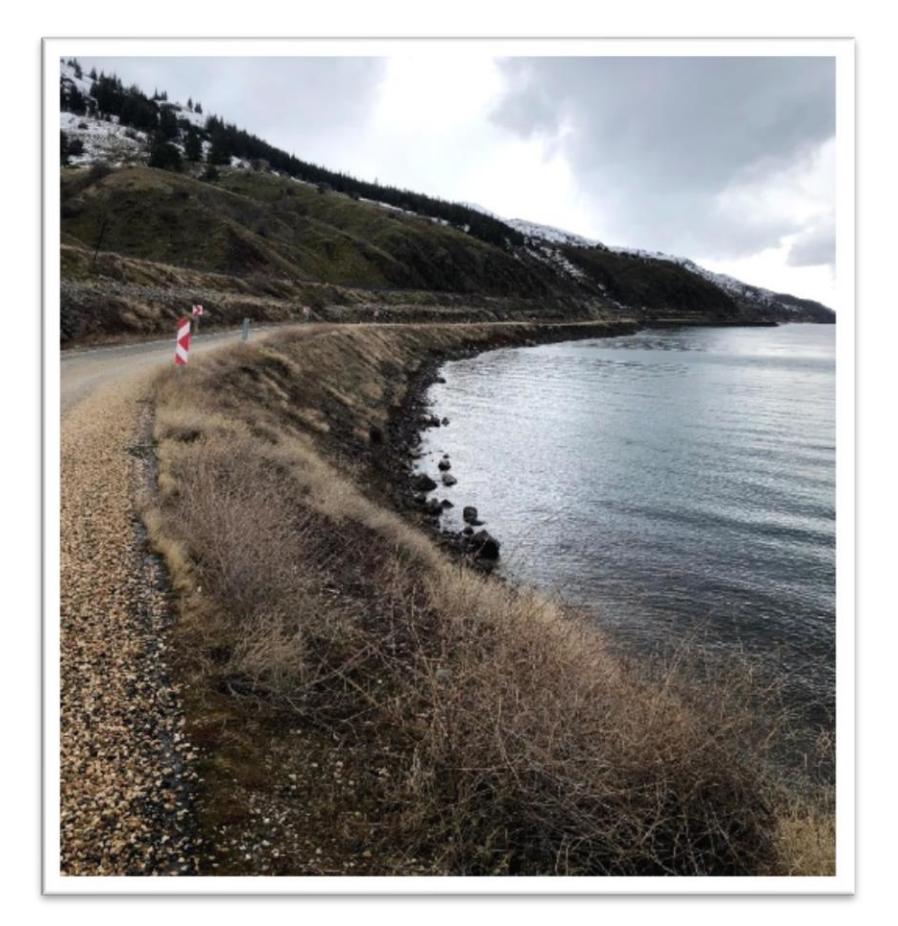
Figure 4.42 No ground failure was observed at shore of 10<sup>th</sup> stop (38°28'52.6"N 39°27'16.9"E / 31.01.2020 / 15:04)

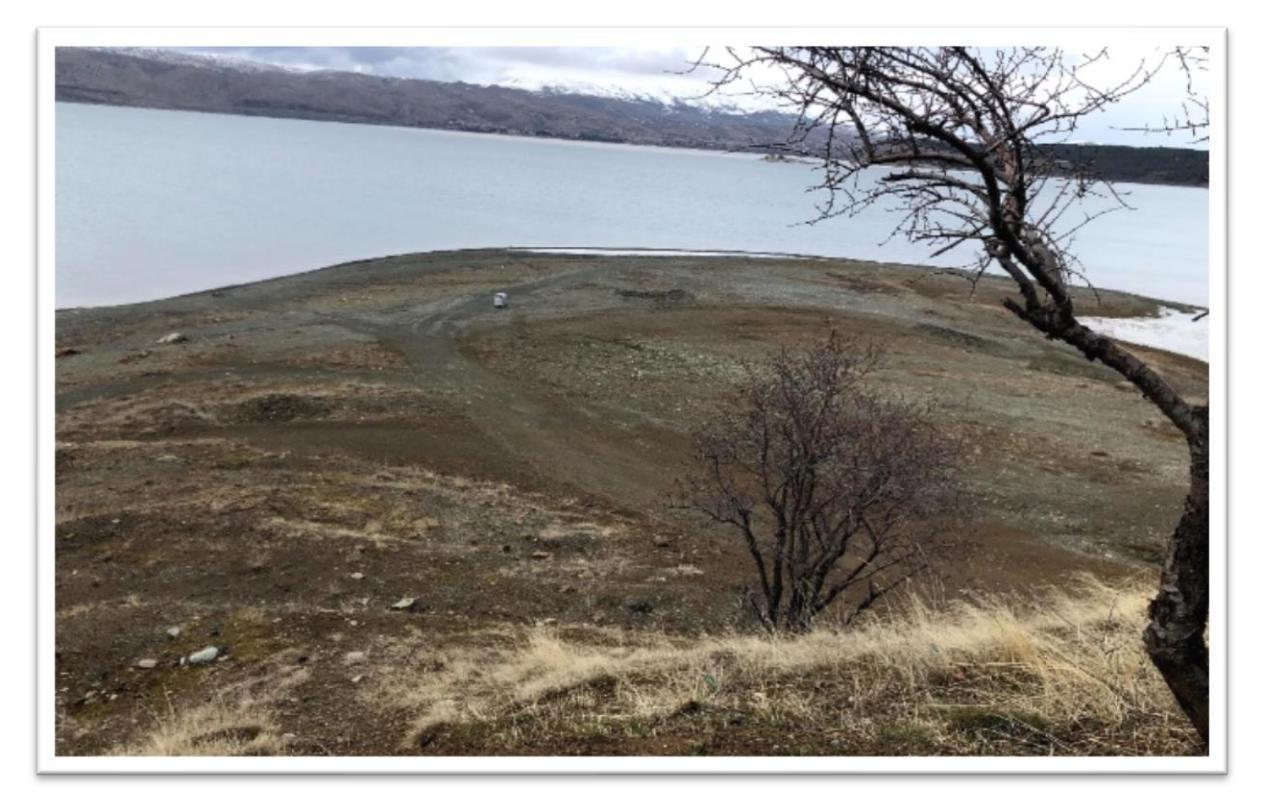
At 11<sup>th</sup> stop, no ground failure was observed as shown in Figure 4.43.

Figure 4.43 No ground failure was observed at shore of 11<sup>th</sup> stop (38°29'37.1"N 39°29'02.3"E / 31.01.2020 / 15:18)

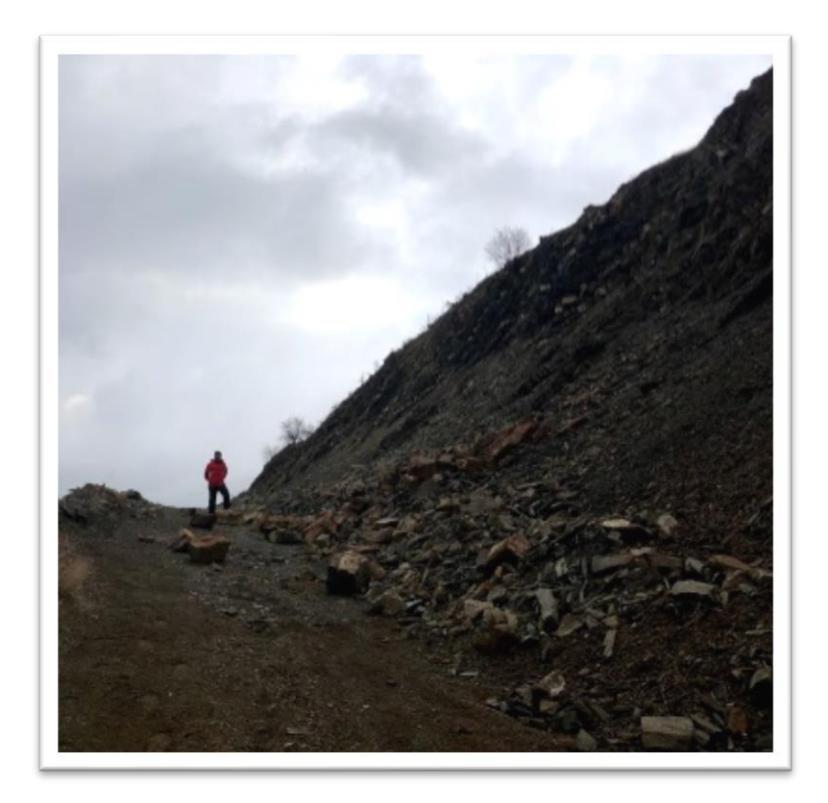
Rock falls were mapped at 13<sup>th</sup> stop as shown in Figures 4.45 to 4.49. Approximate dimensions (length, width, height) of the rocks are measured in the field. A simulation of the rock fall mechanism suggested a peak ground velocity of 4-6 m/s at the region as will be discussed later in the report. Fallen rock blocks horizontal distances from the toe of the first bench were measured as 3-5 m. The details of rockfall assessments will be presented later in the report.

Figure 4.46 Rockfall at 13<sup>th</sup> stop (upper bench) (38°31'41.5"N 39°27'60.0"E / 31.01.2020 / 16:10)

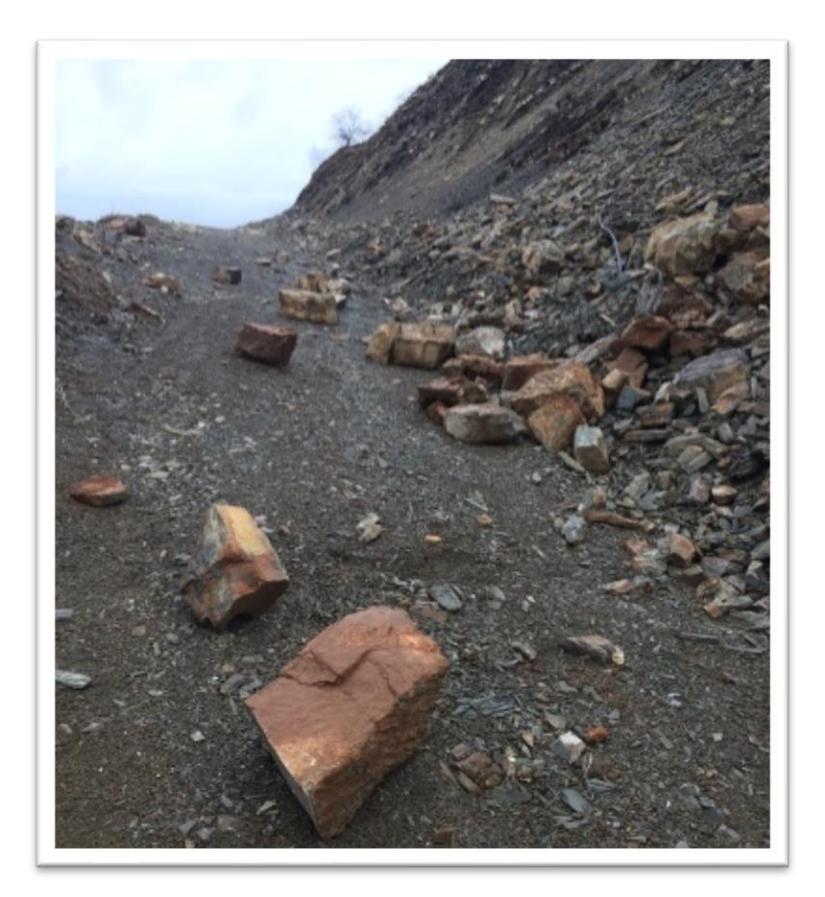
Figure 4.47 Rockfalls at 13<sup>th</sup> stop (38°31'41.0"N 39°27'59.6"E / 31.01.2020 / 16:13)

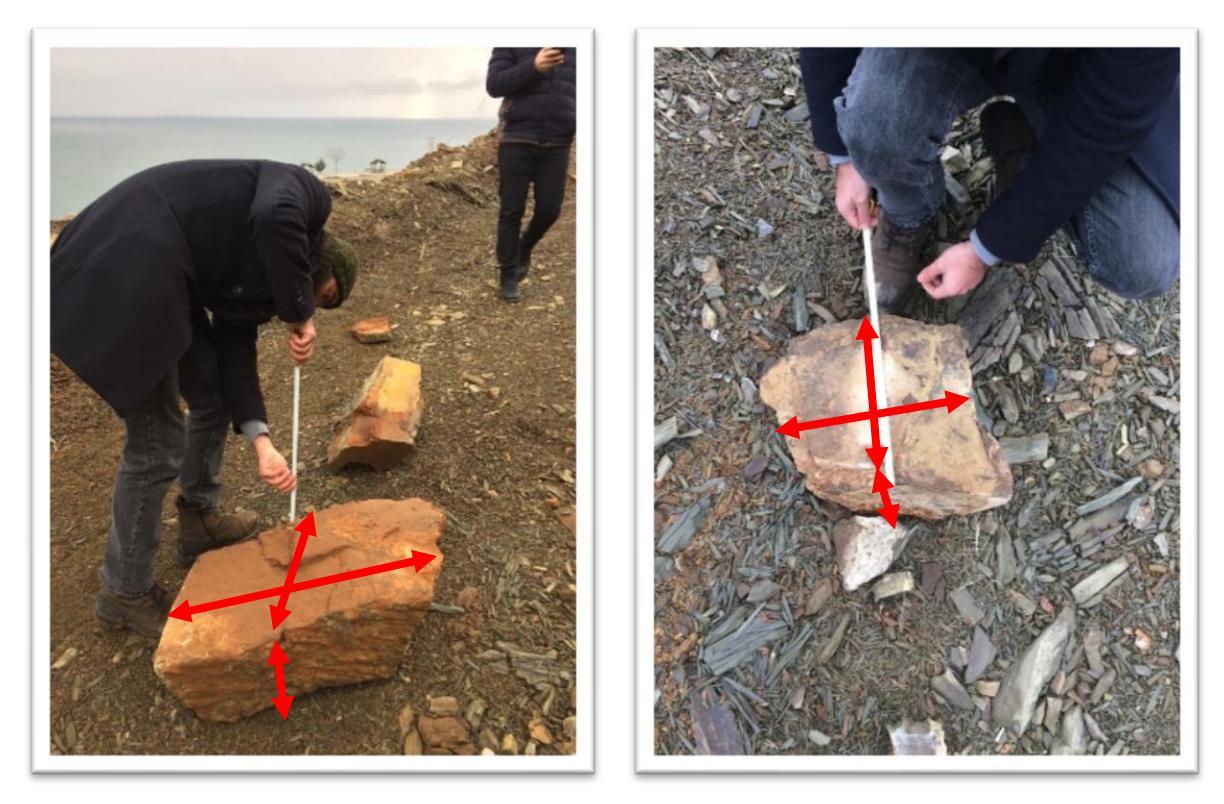
Figure 4.48 Measurement of rockfalls' dimensions at 13<sup>th</sup> stop (38°31'41.3"N 39°27'59.5"E / 31.01.2020 / 16:15 & 38°31'41.5"N 39°27'59.0"E / 31.01.2020 / 16:16)

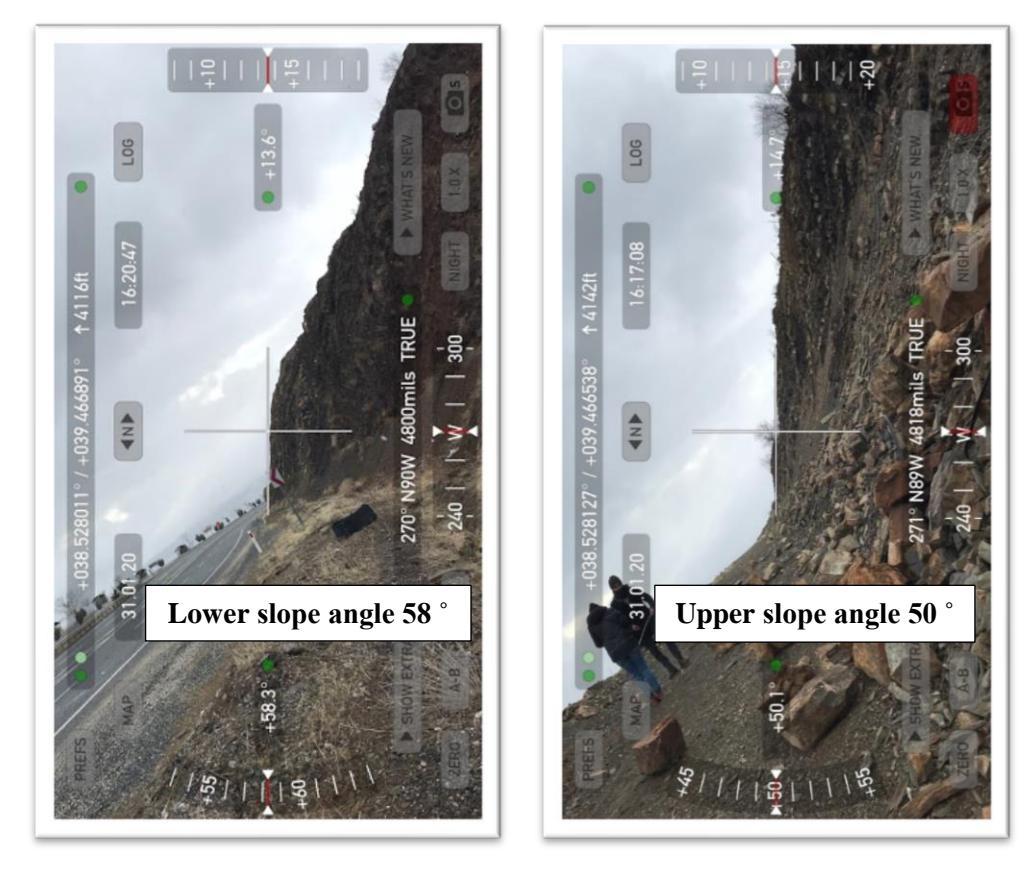
Figure 4.49 Rockfalls at 13<sup>th</sup> stop (Slope angle determination) (38°31'40.8"N 39°28'00.8"E / 31.01.2020 / 16:20 & 38°31'41.3"N 39°27'59.5"E / 31.01.2020 / 16:17)

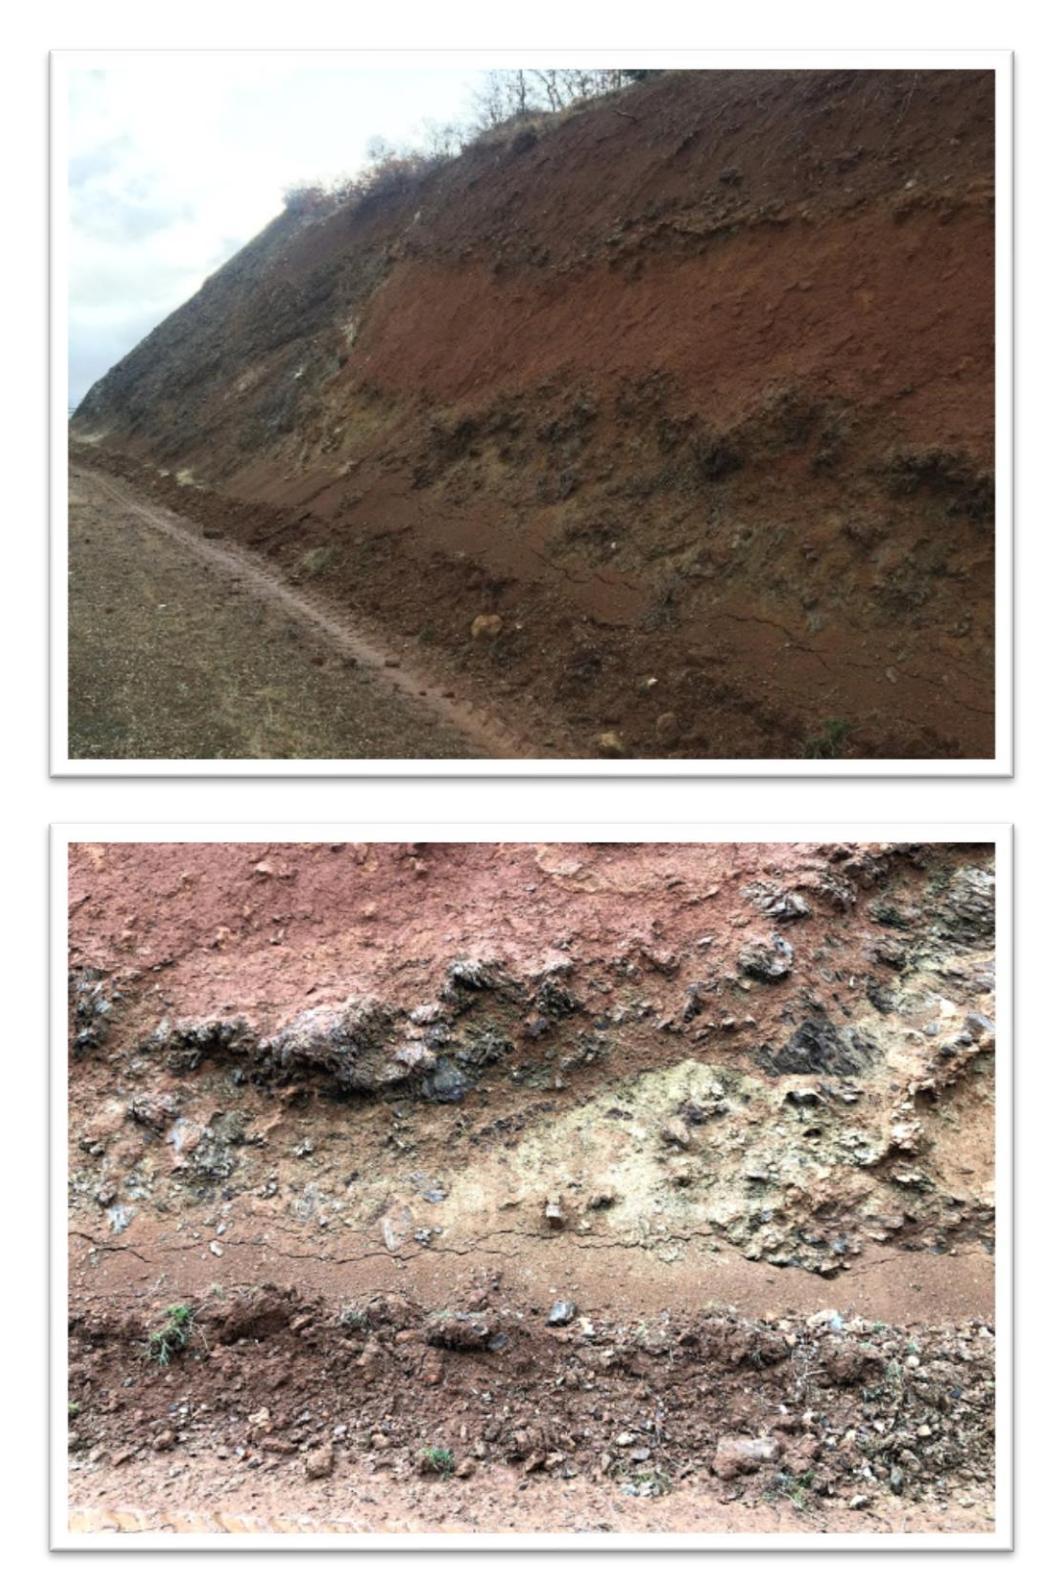
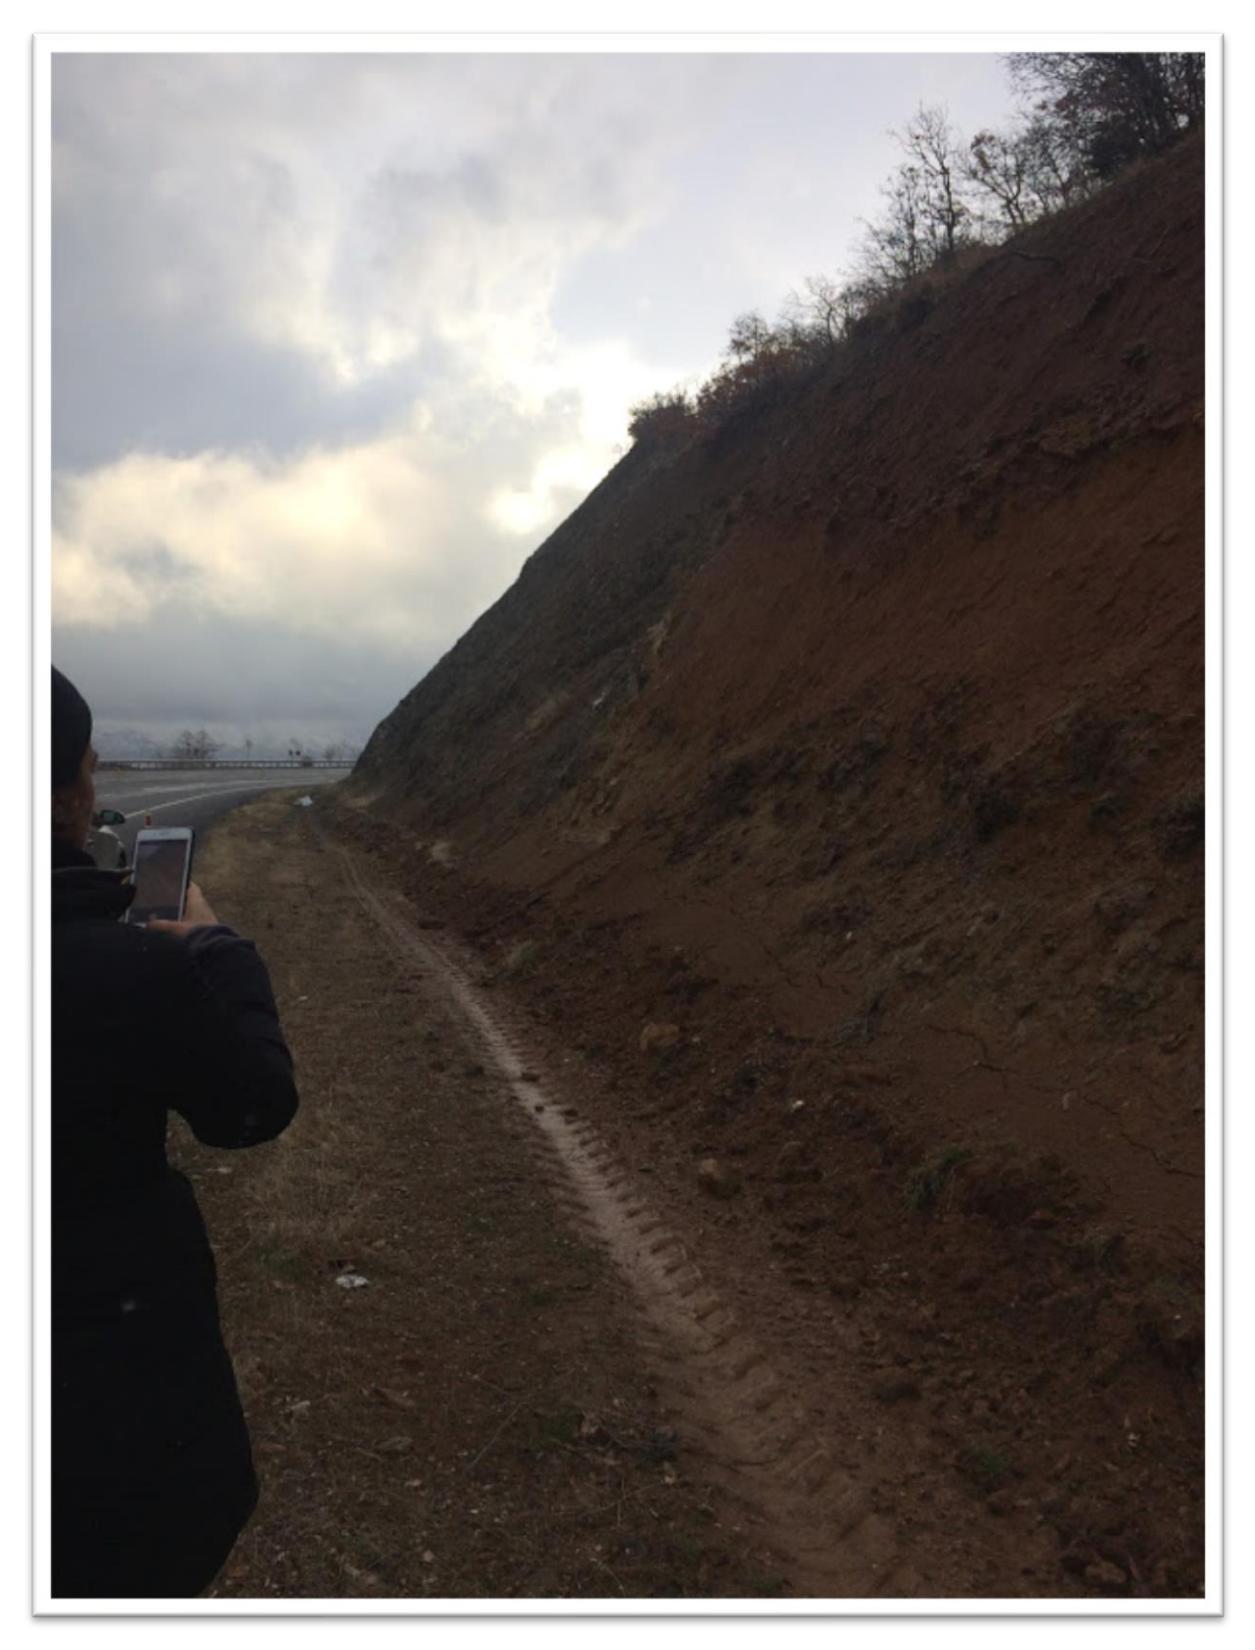
A  $65^{\circ}$  slope was documented to be stable as shown in Figures 4.50 and 4.51.

Figure 4.50 Side view of the slope (38°30'11.7"N 39°23'33.4"E / 31.01.2020 / 16:34 & 38°30'11.8"N 39°23'33.3"E / 31.01.2020 / 16:34)

Figure 4.51 Side view of the slope (38°30'11.6"N 39°23'33.7"E / 31.01.2020 / 16:34)

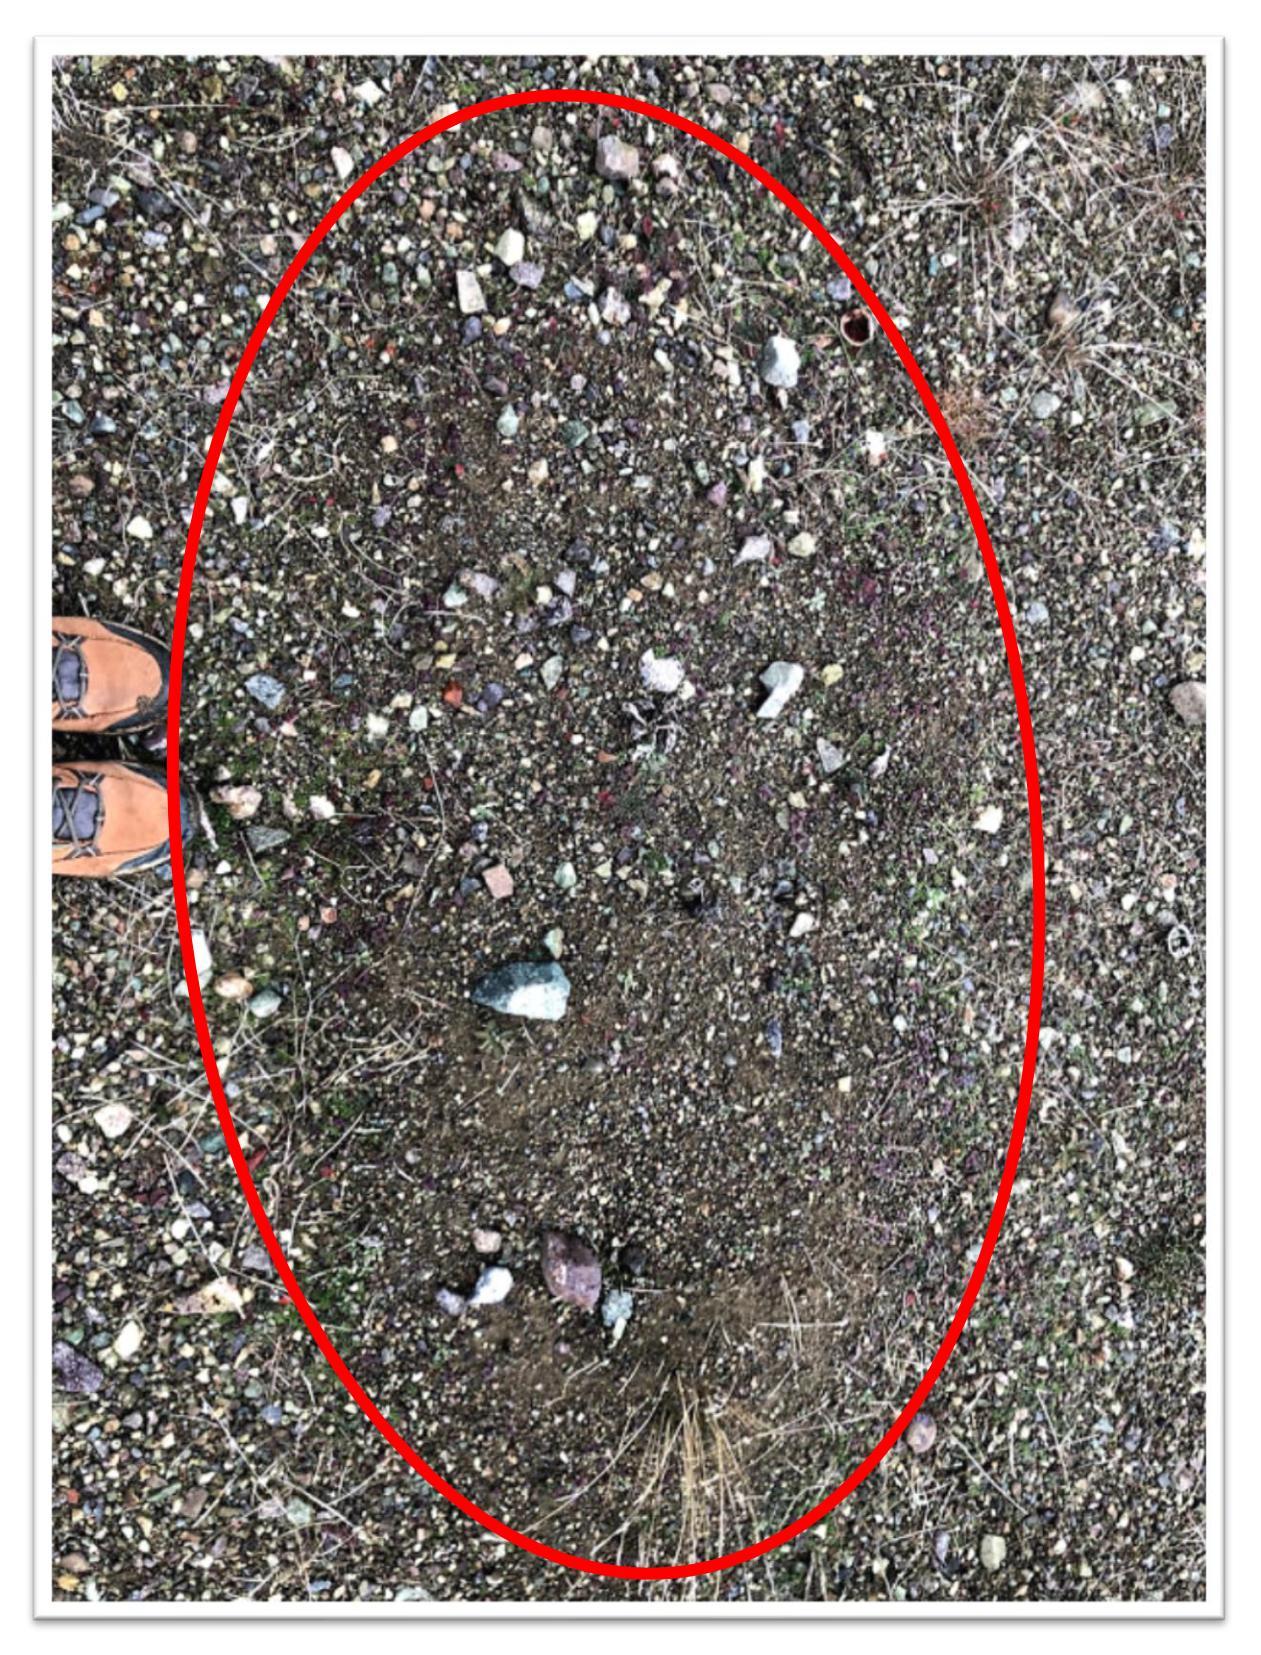
Seismically-induced liquefaction failure was observed in the form of sand boils at the 15<sup>th</sup> stop. Examples of sand boils in different forms are presented in Figures 4.53 to 4.55. Note that the plane tree leaves were covered by the sand boils in Figure 4.53.

Figure 4.54 Seismic soil liquefaction-induced sand boils (38°29'32.1"N 39°21'02.0"E / 31.01.2020 / 16:58)

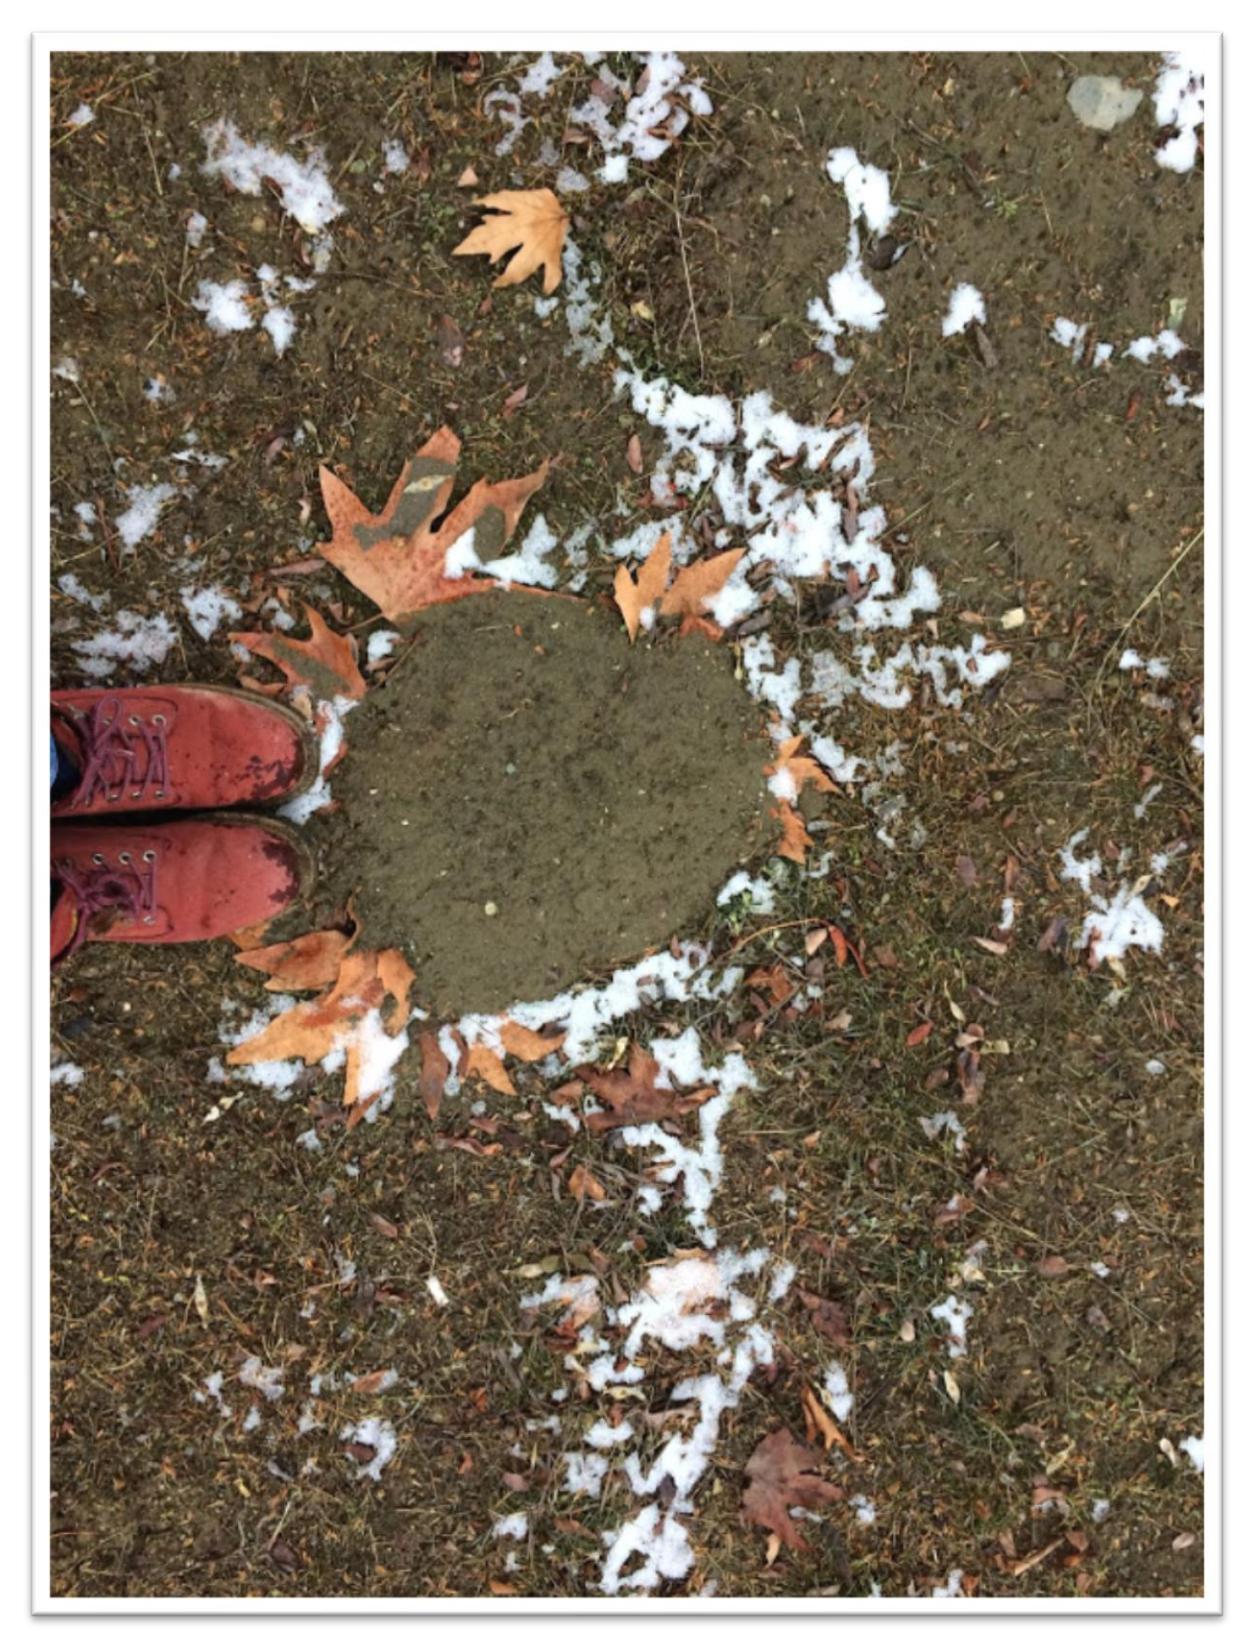
Figure 4.55 Seismic soil liquefaction-induced sand boils (38°29'34.5"N 39°21'03.7"E / 31.01.2020 / 17:12)

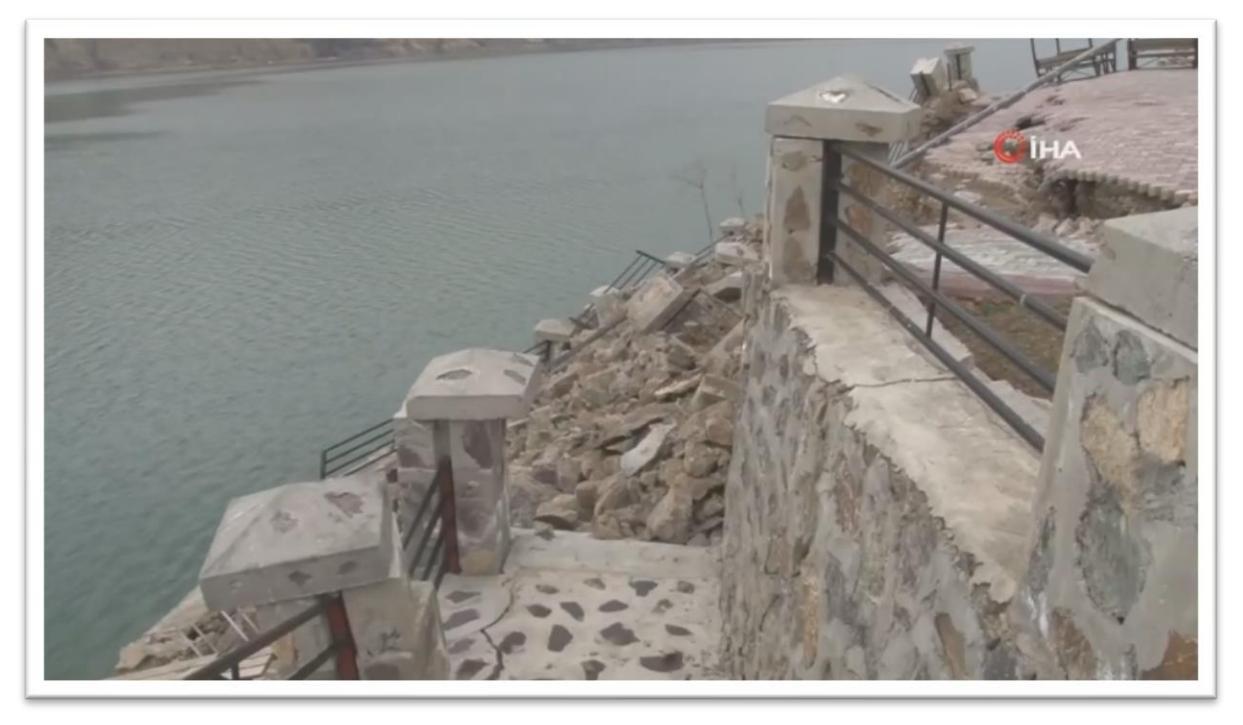
In the second day, our plan was to start the reconnaissance studies at Doğanyol, where a port failure was observed. Unfortunately, due to heavy snow, the highway to Doğanyol was closed. However, the port failure was documented based on a video shared by Ihlas Press Agency (IHA). Figure 4.56 shows the port failure, which was adapted from the IHA video shared in Youtube.

Figure 4.56 Doğanyol Port Failure adapted from IHA report (38°33'34.6"N 39°04'10.6"E)

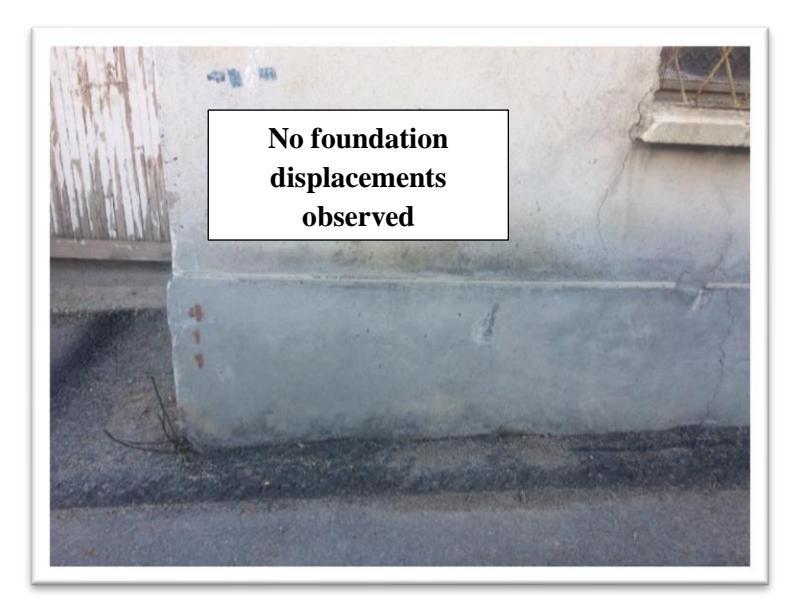
There are no foundation displacements observed at a residential building in Battalgazi village, as shown in Figures 4.59.

Figure 4.59 A foundation at a residential building in Battalgazi Village

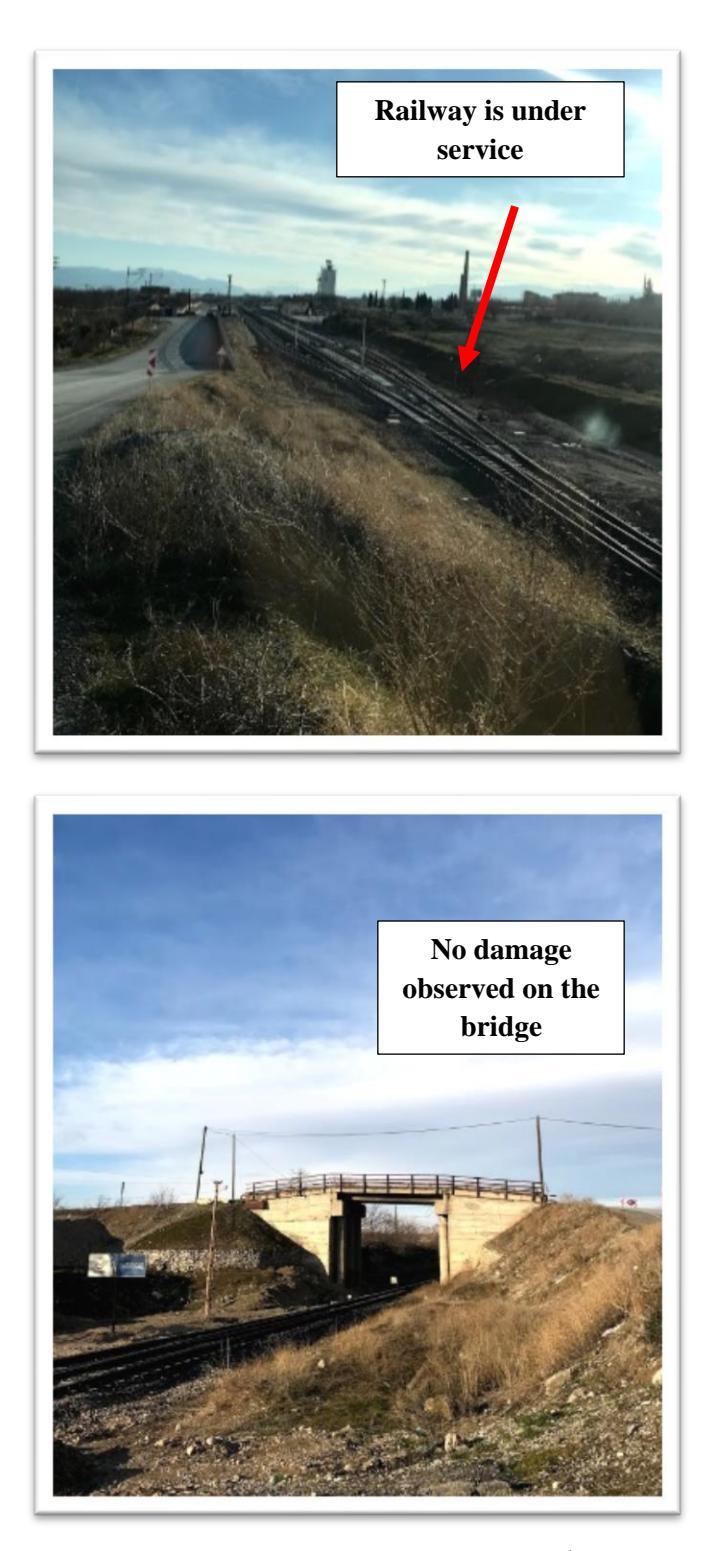
Railway tracks were observed to be not damaged at the 20<sup>th</sup> stop. The railway was under service as presented in Figure 4.67. In the same figure a small bridge is shown again with no signs of damage.

Figure 4.60 Railway and bridge at 20<sup>th</sup> stop (38°26'00.1"N 38°21'59.1"E / 01.02.2020 / 8:49 & 38°26'00.2"N 38°22'01.3"E / 01.02.2020 / 8:50)

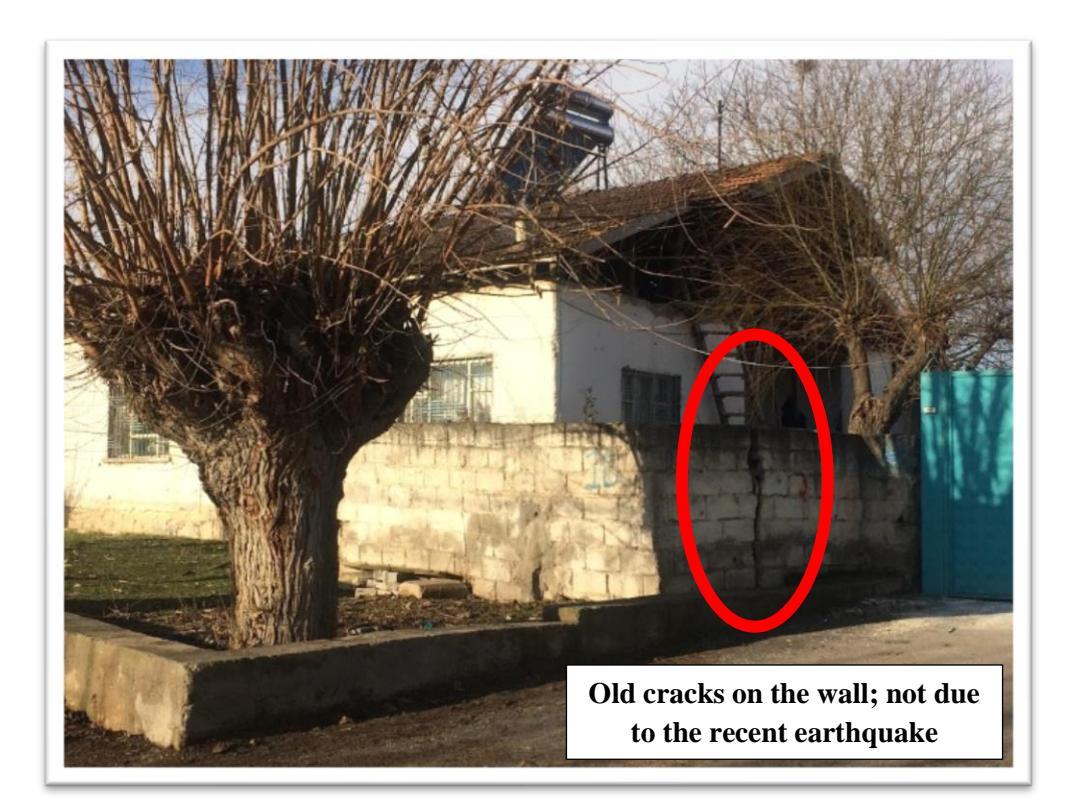
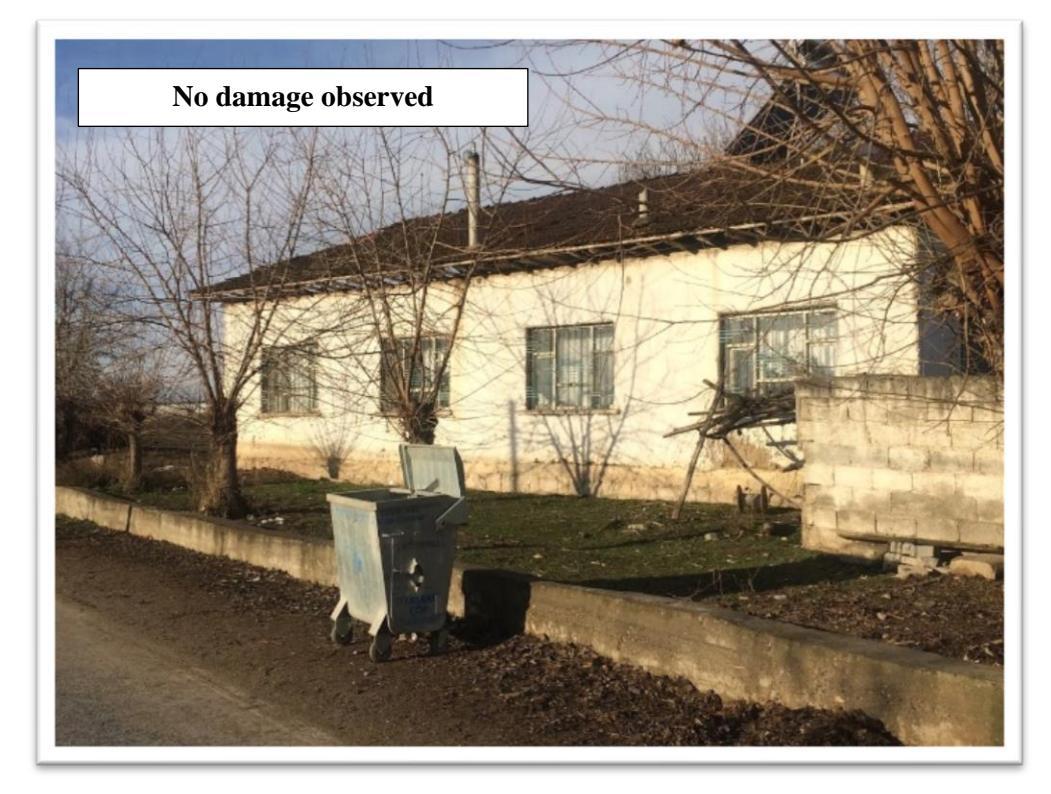
A number of structural damages were observed, mostly concentrating on masonry buildings in Bahçelievler district of Battalgazi village, as shown in Figure 4.61 and 4.62.

Figure 4.61 Residential buildings in the Bahçelievler district of Battalgazi village (38°26'51.2"N 38°22'19.2"E / 01.02.2020 / 8:52 & 38°26'51.1"N 38°22'19.2"E / 01.02.2020 / 8:53)
