## THE ELÂZIĞ-SİVRİCE EARTHQUAKE [24 JANUARY 2020 M<sub>w</sub>=6.8] FIELD OBSERVATIONS ON SEISMIC AND STRUCTURAL DAMAGE

REPORT NO: METU/EERC 2020-01

MARCH 2020 ANKARA

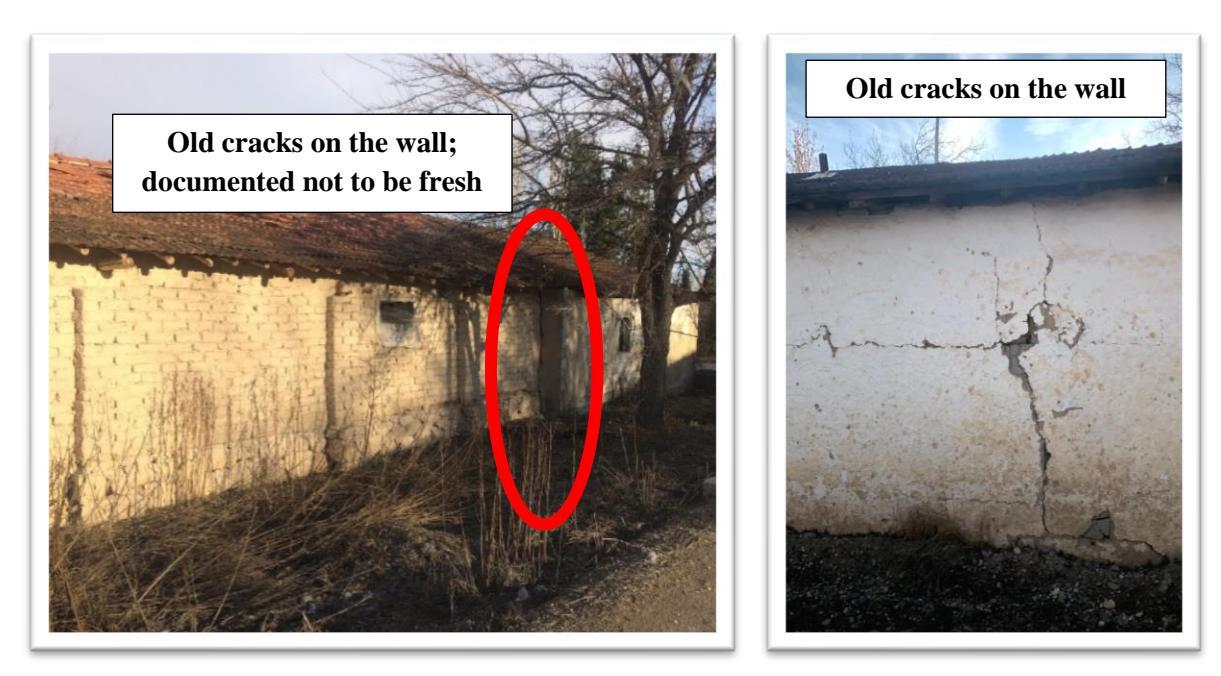
A number of structural damages were observed, mostly concentrating on masonry buildings in Bahçelievler district of Battalgazi village, as shown in Figure 4.61 and 4.62.

Figure 4.62 Cracks on the wall of a residential building in the Bahçelievler district of Battalgazi village (38°27'48.5"N 38°22'50.6"E / 01.02.2020 / 8:56 & 38°27'49.0"N 38°22'51.7"E / 01.02.2020 / 8:56)

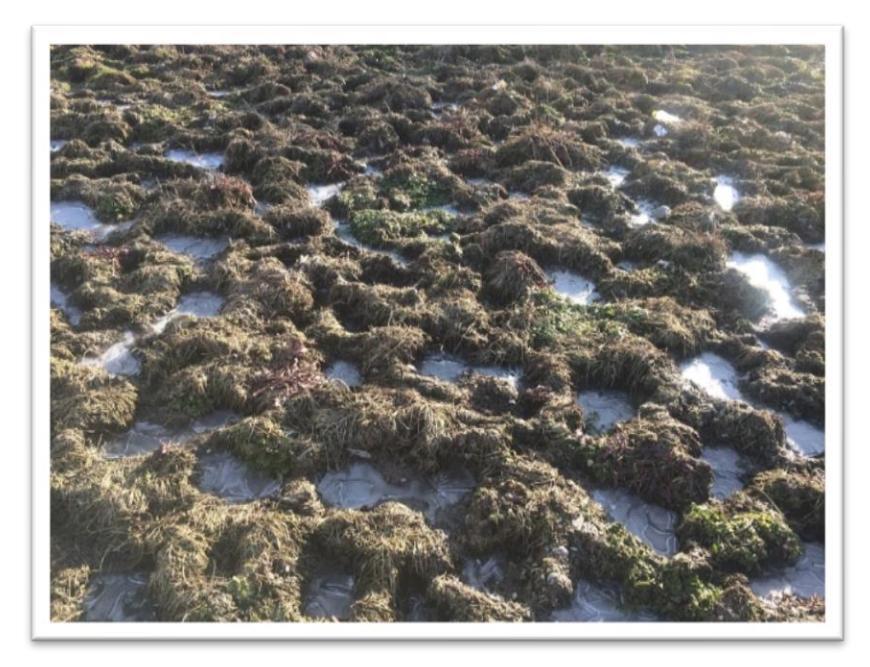
Although it is composed of alluvial deposits with potential for ground failure, no signs of it were observed. Surficial soils, observed to be of high plasticity clays, and frozen ground were listed as two factors, which might have impeded possible ground failure, as shown in Figures 4.63 and 4.64.

Figure 4.63 Views of frozen soil in Toygar district of Battalgazi village (38°28'38.6"N 38°23'27.1"E / 01.02.2020 / 9:03)

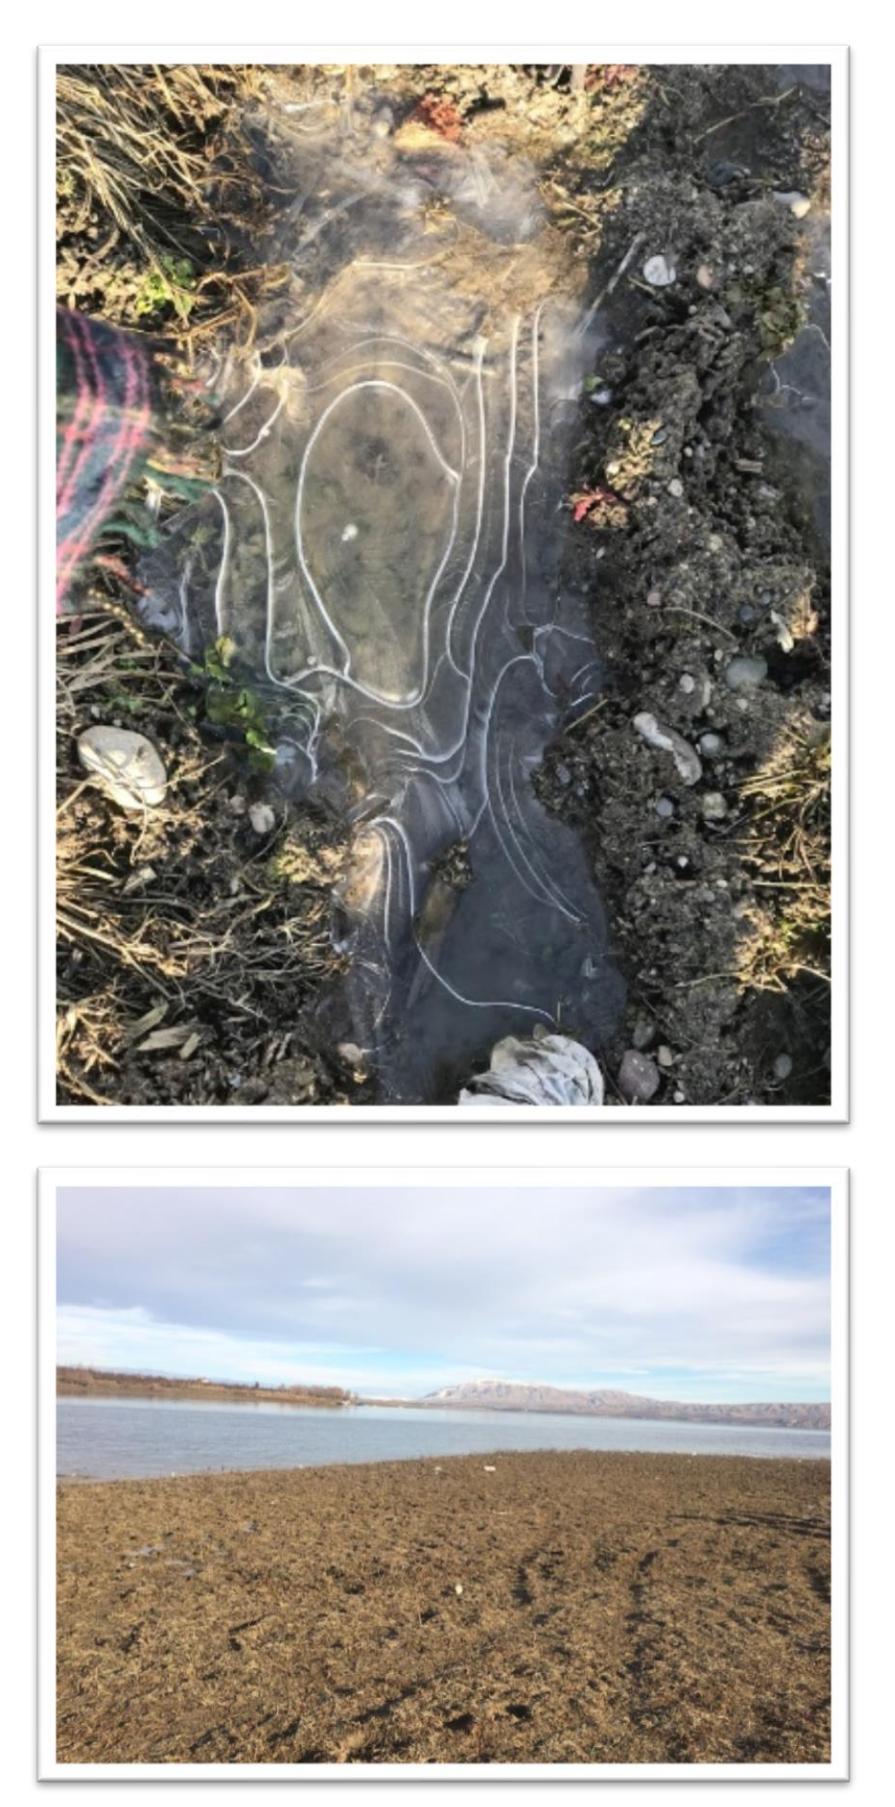
Figure 4.64 Views of frozen clayey soils in Toygar district of Battalgazi village (38°28'38.9"N 38°23'27.3"E / 01.02.2020 / 9:03 & 38°28'39.8"N 38°23'29.3"E / 01.02.2020 / 9:05)

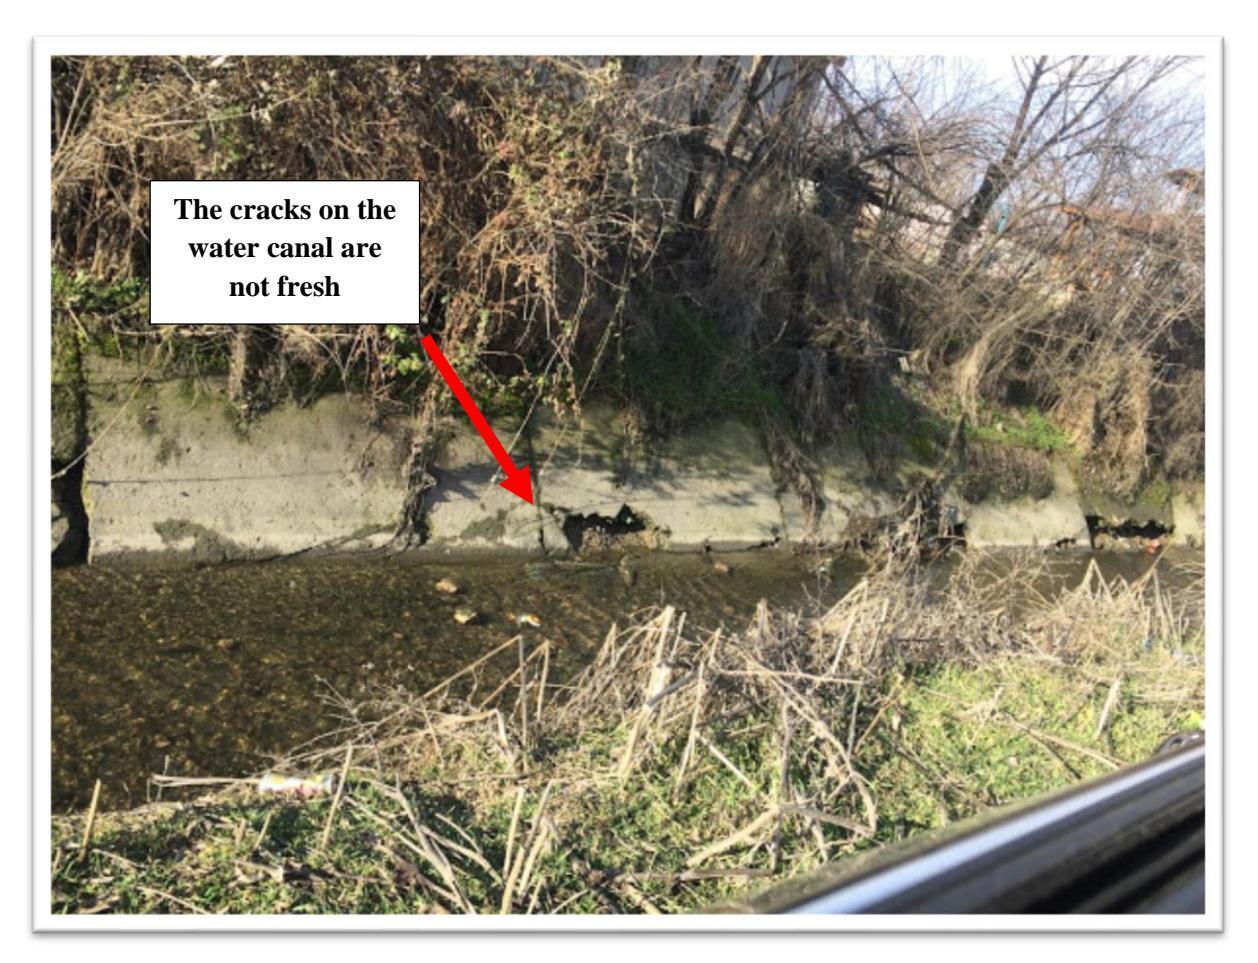
A water canal and the highway bridge were documented with no signs of damage, as shown in Figure 4.65 and Figure 4.66. Note that the observed cracks were dated older and are not associated with the recent earthquake event.

Figure 4.65 Water trench in Dolamantepe district of Battalgazi village (38°26'00.4"N 38°21'44.1"E / 01.02.2020 / 9:25)

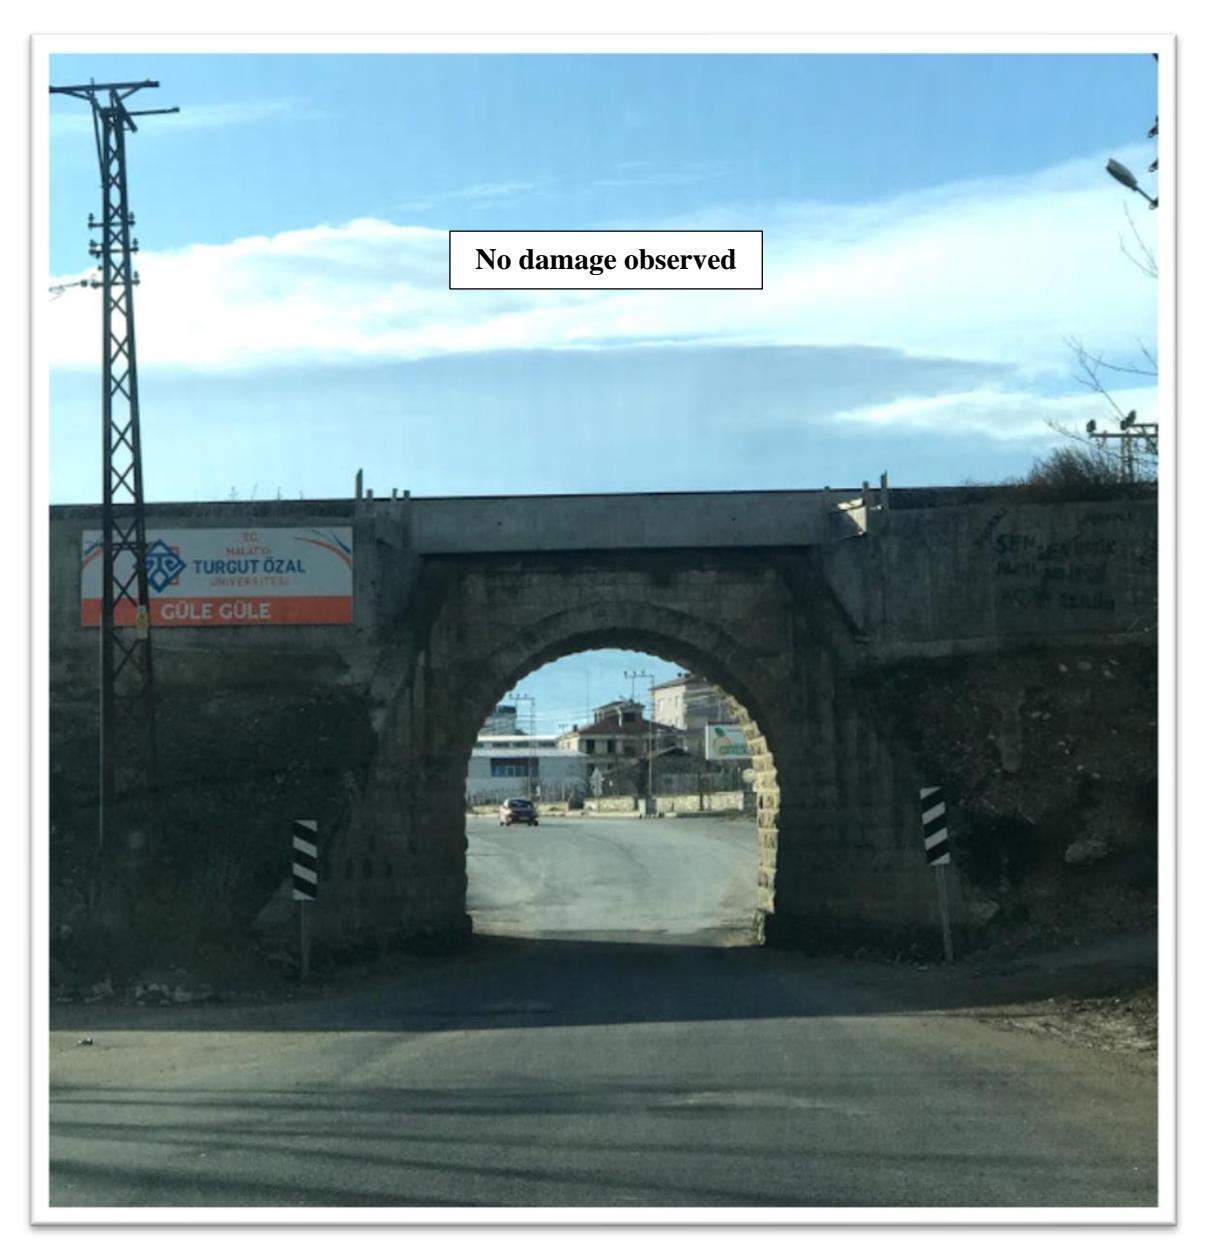
Figure 4.66 Dolamantepe district of Battalgazi village (38°25'59.9"N 38°21'41.5"E / 01.02.2020 / 9:26)

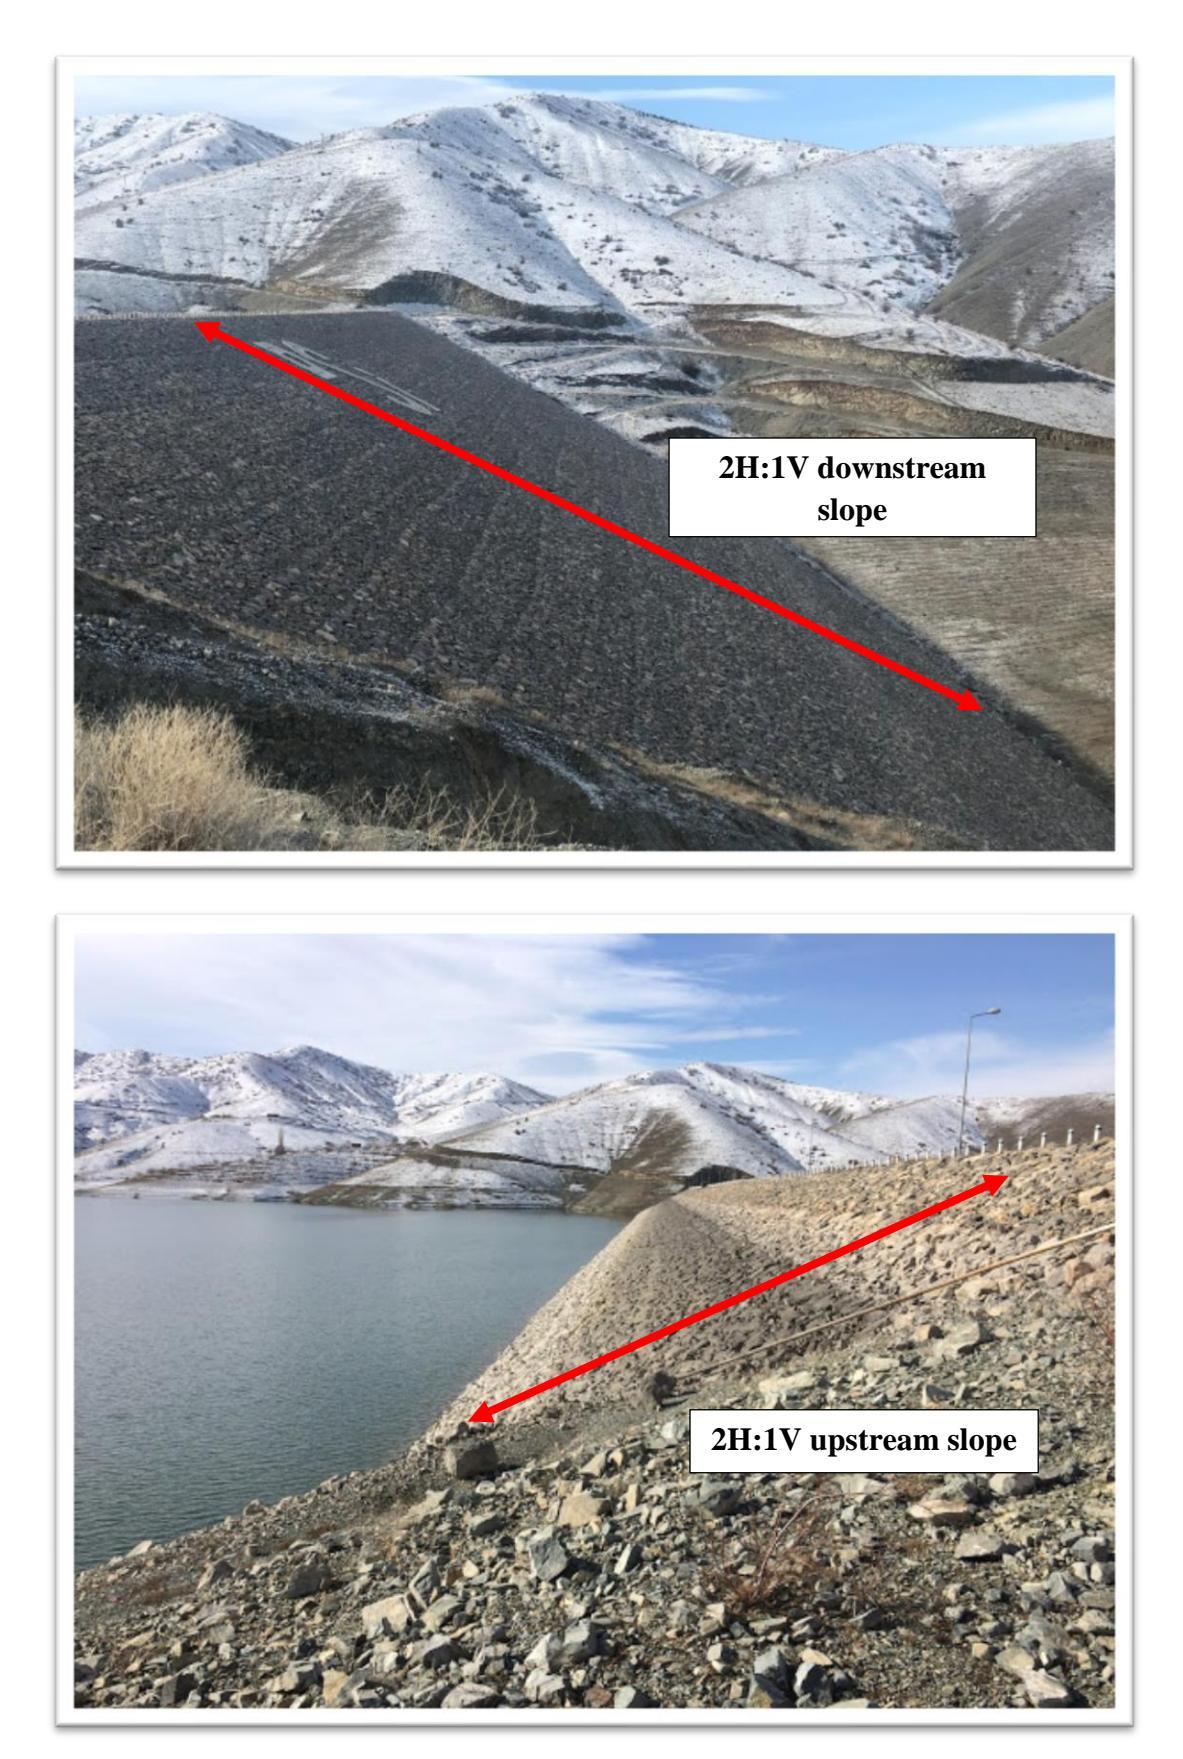
The dam was built on Memikhan River for irrigation purposes. It is an 89.5 m high clay core rockfill dam. The crest and normal water elevations were 868 m and 864.9, respectively. During our visit the water level was measured as 854.70 m. The right and left abutments along with the dam body itself were documented to be not affected from the shaking. Also, no damage to water in-take and spillways were observed. Pictures taken at the dam site can be seen in Figures 4.67 to 4.74.

Figure 4.67 Side views of Kapıkaya Dam (38°21'19.1"N 38°36'33.9"E / 01.02.2020 / 10:21 & 38°21'16.3"N 38°36'35.0"E / 01.02.2020 / 10:38)

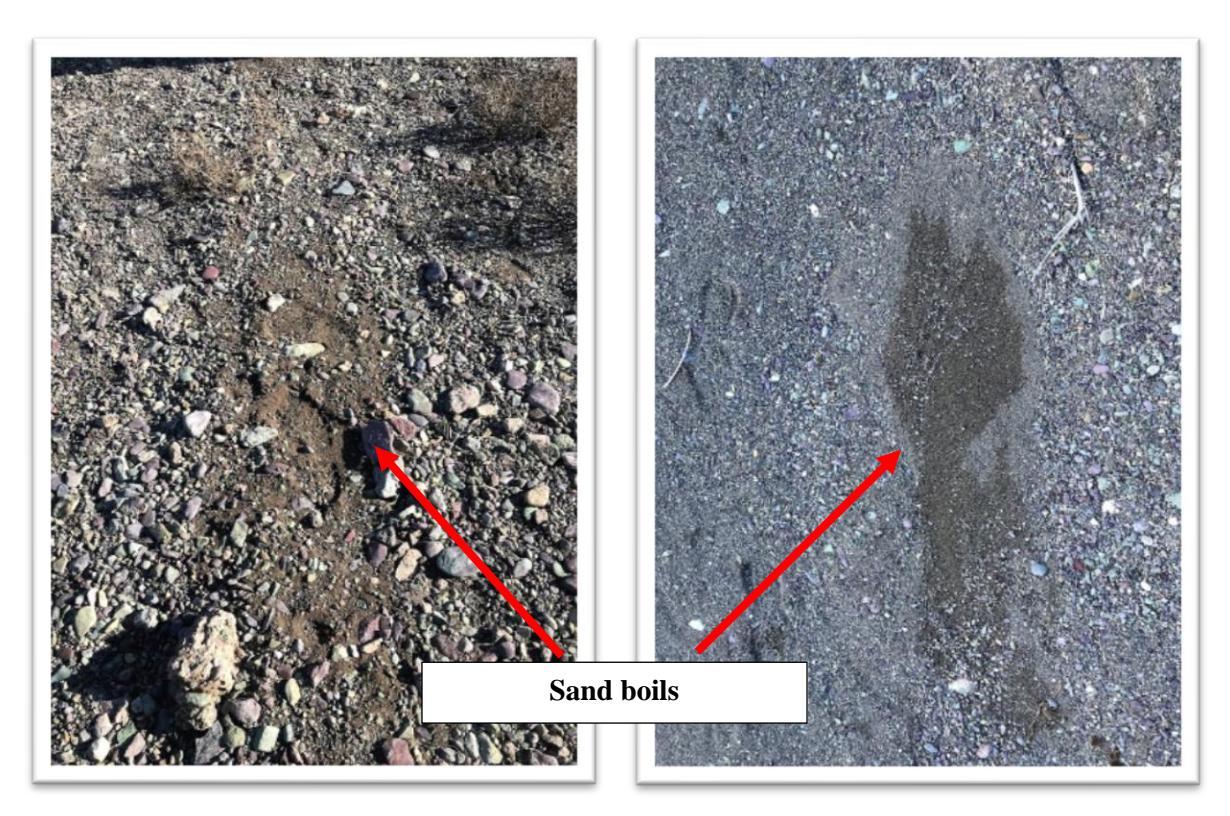
Seismically-induced liquefaction failure was observed in the Kale shores (Figure 4.75 and 4.76) in the form of sand boiling at 15<sup>th</sup> stop. A site view is shown in Figure 4.77. Pictures documenting sand boils are presented in Figures 4.78 to 4.82.

Figure 4.78 Seismic soil liquefaction-induced sand boils at Kale shore (38°25'19.9"N 38°45'33.2"E / 01.02.2020 / 12:25 & 38°25'14.6"N 38°45'24.7"E / 01.02.2020 / 12:45)

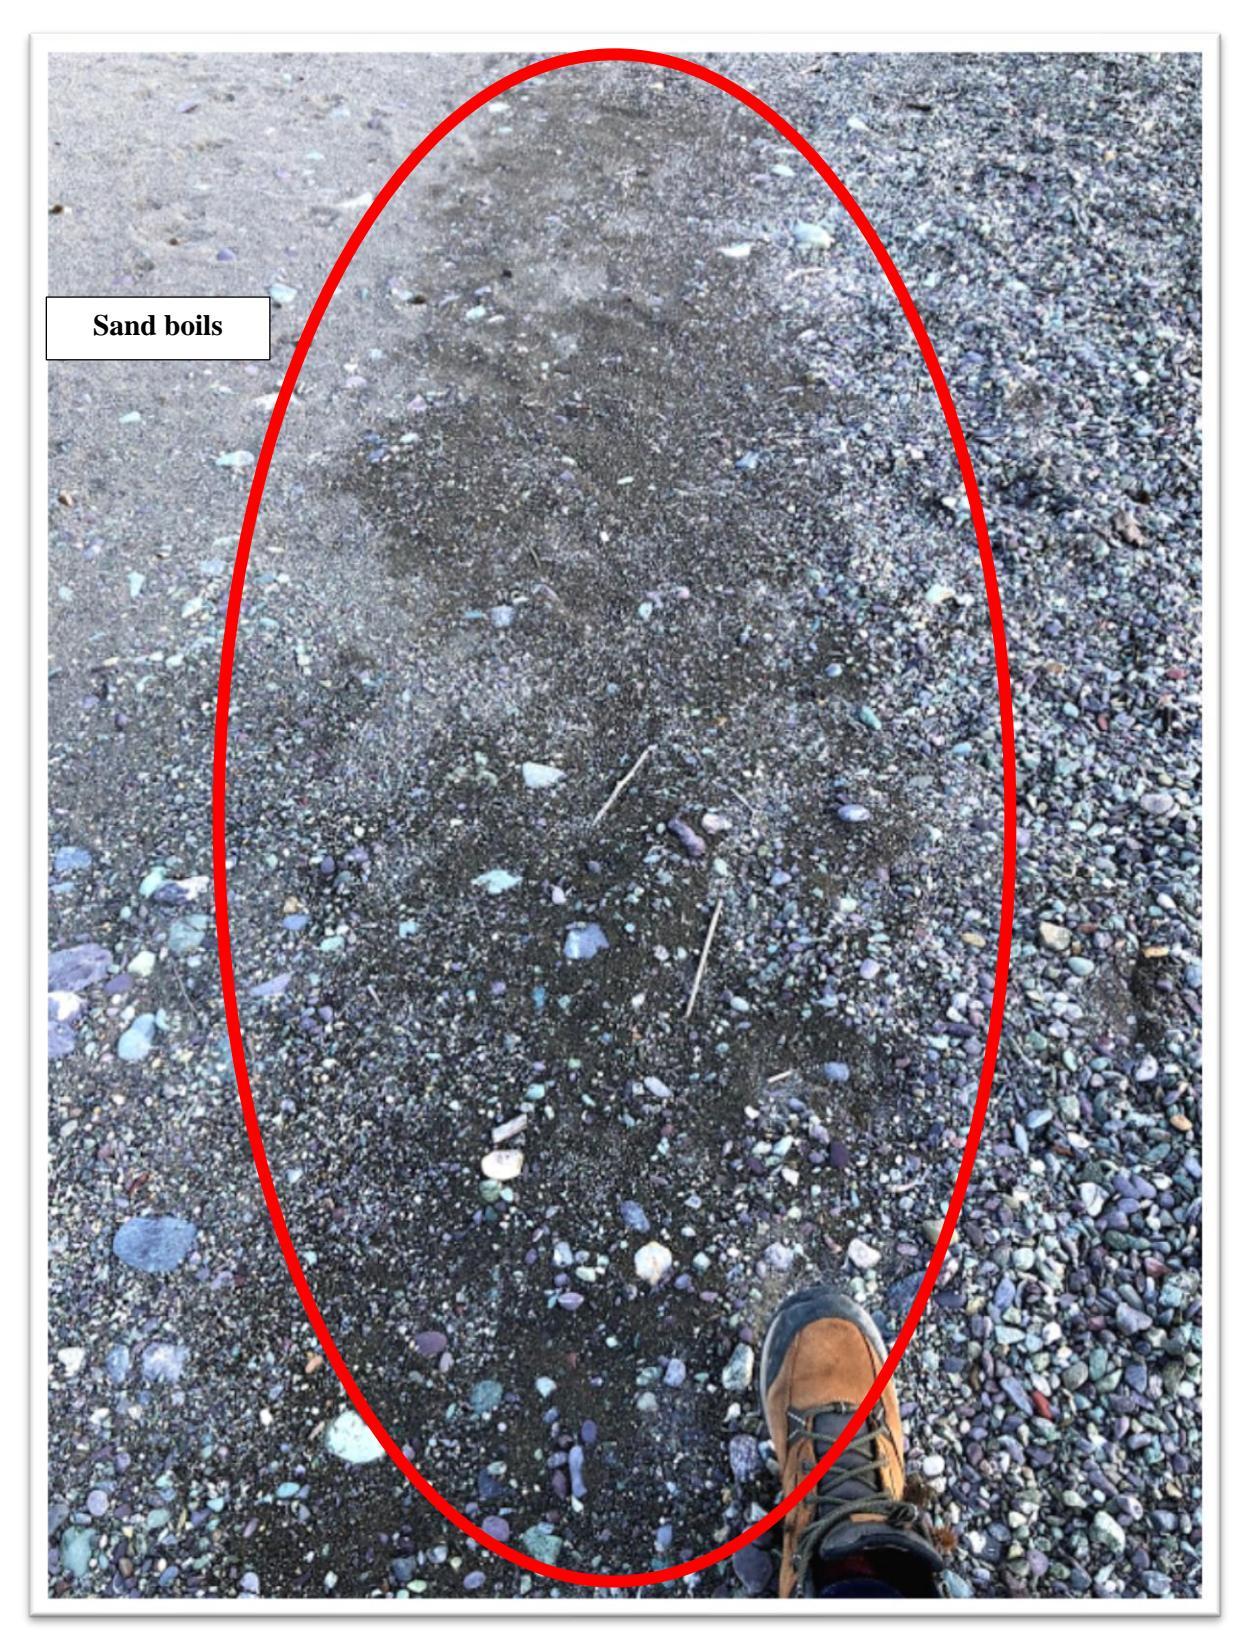
Figure 4.79 Seismic soil liquefaction-induced sand boils at Kale shore (38°25'15.2"N 38°45'24.1"E / 01.02.2020 / 12:45)

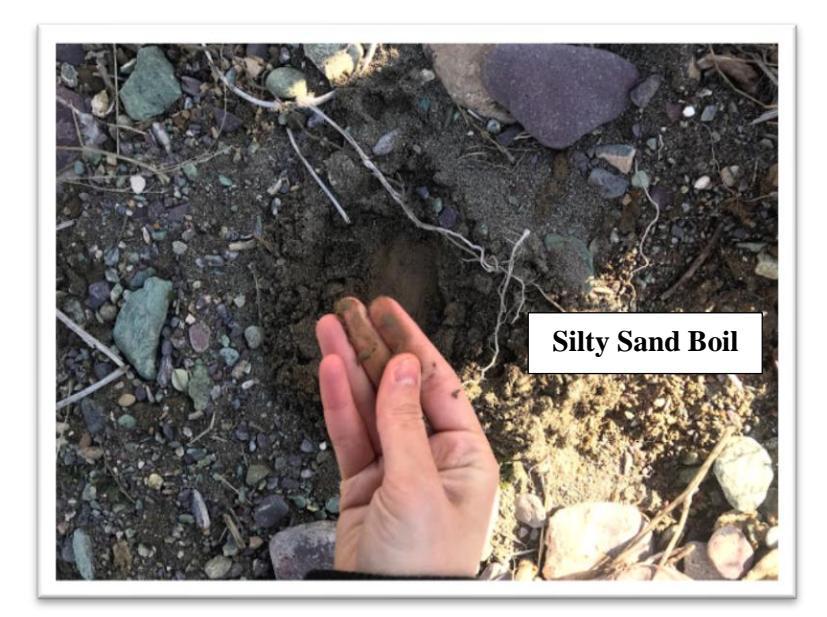
Figure 4.80 Seismic soil liquefaction-induced sand boils at Kale shore (38°25'22.8"N 38°45'38.4"E / 01.02.2020 / 12:21)

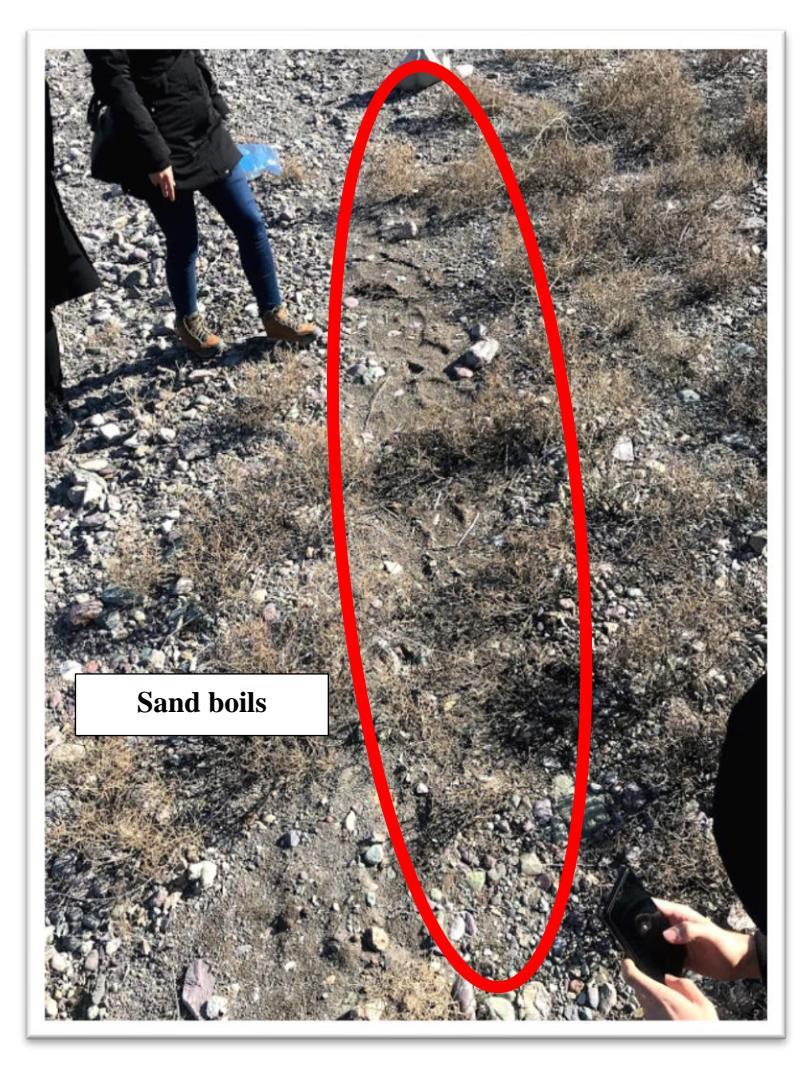
Figure 4.81 Seismic soil liquefaction-induced sand boils at Kale shore (38°25'19.9"N 38°45'32.1"E / 01.02.2020 / 12:27)

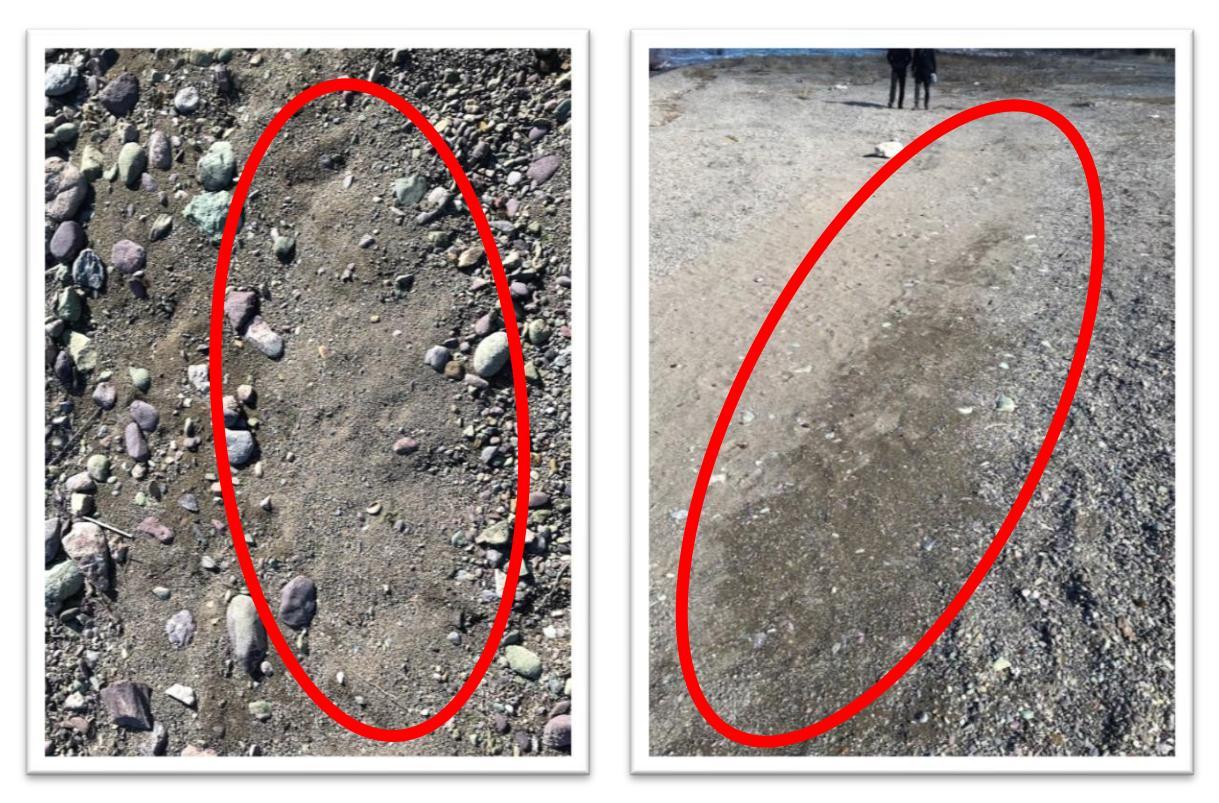
Figure 4.82 Seismic soil liquefaction-induced sand boils at Kale shore (38°25'15.2"N 38°45'32.2"E / 01.02.2020 / 12:32 & 38°25'15.2"N 38°45'23.9"E / 01.02.2020 / 12:45)

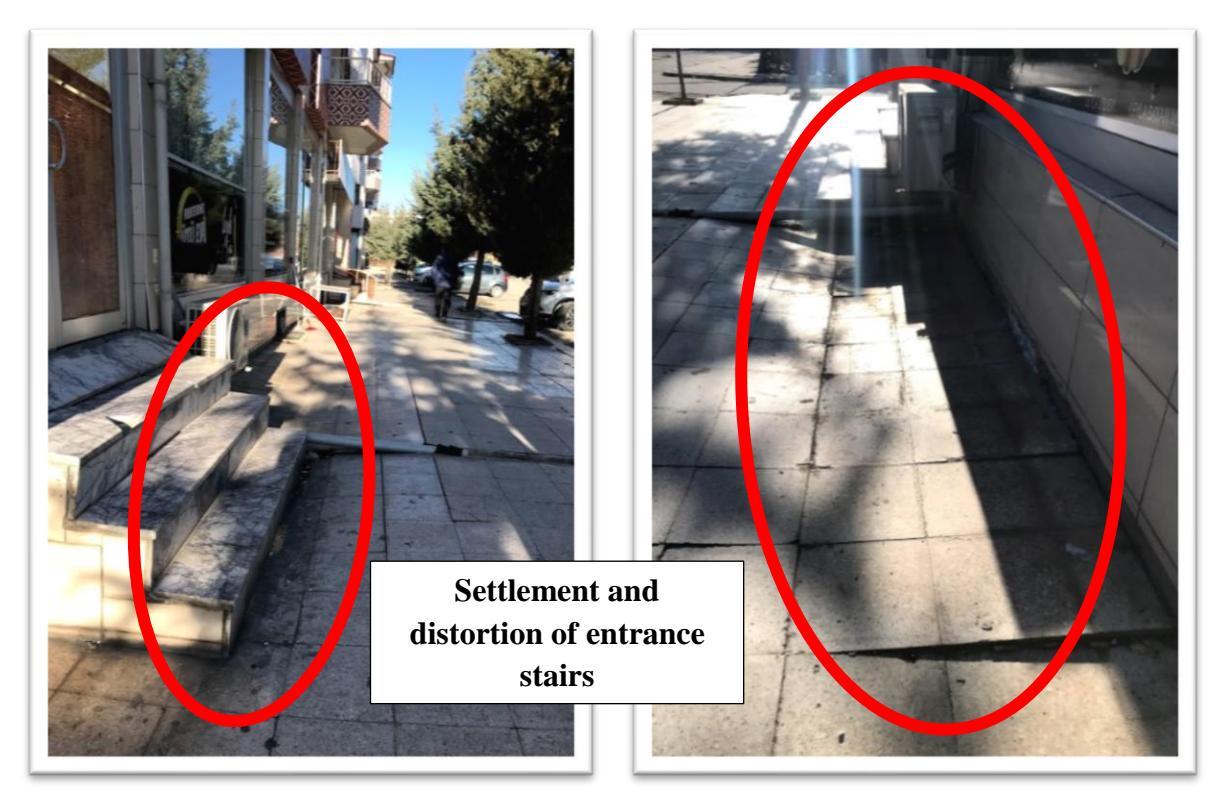
The most of the structural damage was concentrated in Elâzığ-Sürsürü district. Several structurally damaged residential buildings were documented, as shown in Figures 4.87 to 4.90. The level of damage varies in a large scale, from no damage to heavy damage. Cracks at the pavements, walls and foundations, due to cyclic and residual lateral and volumetric deformations were observed.

Figure 4.89 Settlements observed

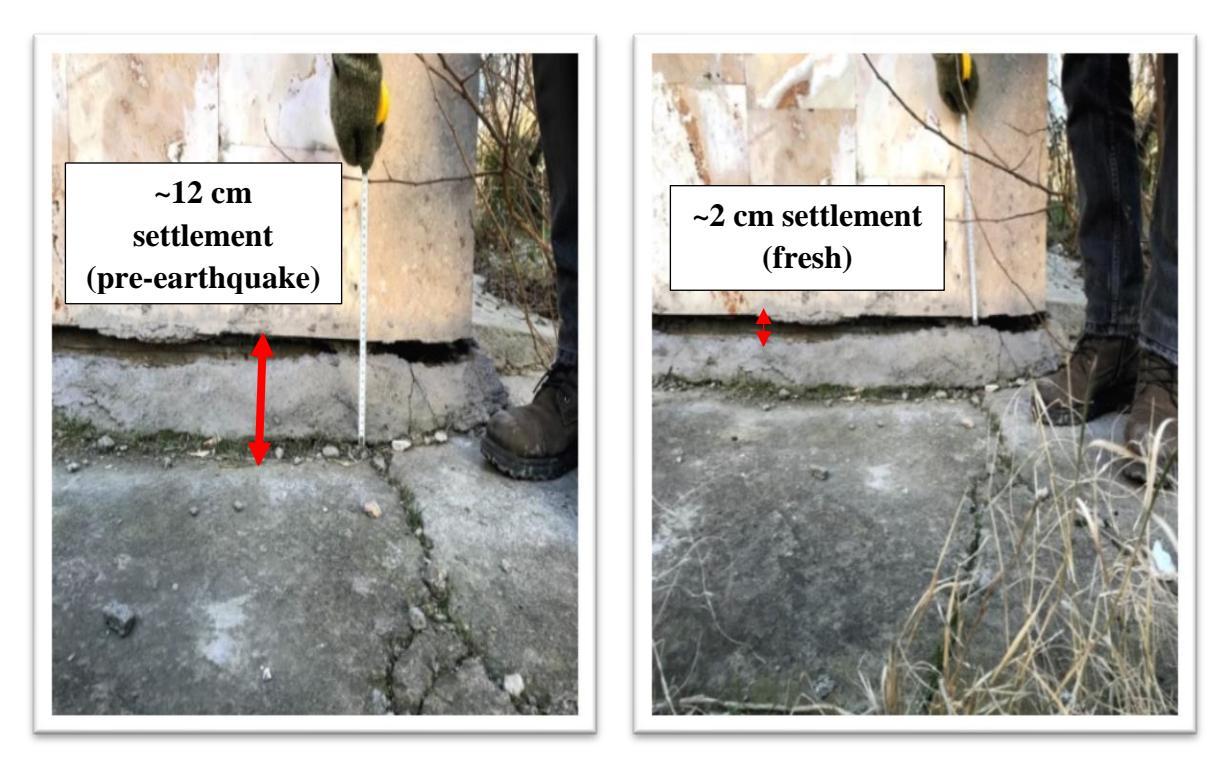
Figure 4.90 Settlement observed (38°40'07.0"N 39°11'04.8"E / 01.02.2020 / 15:47)

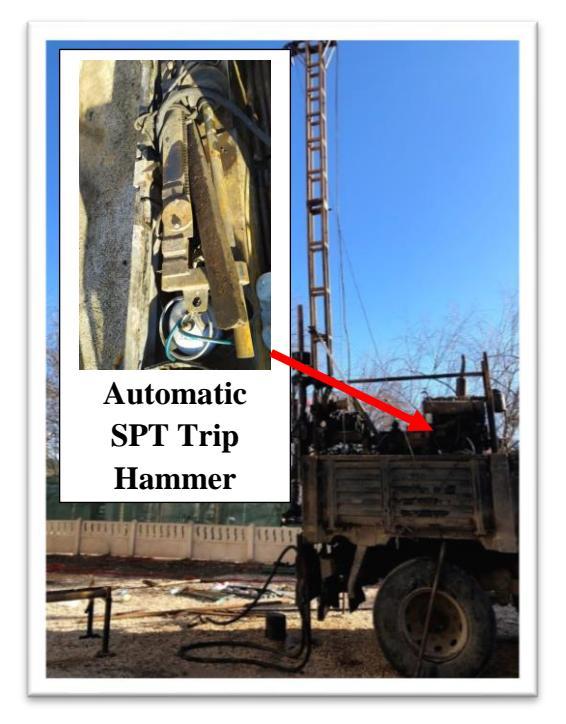
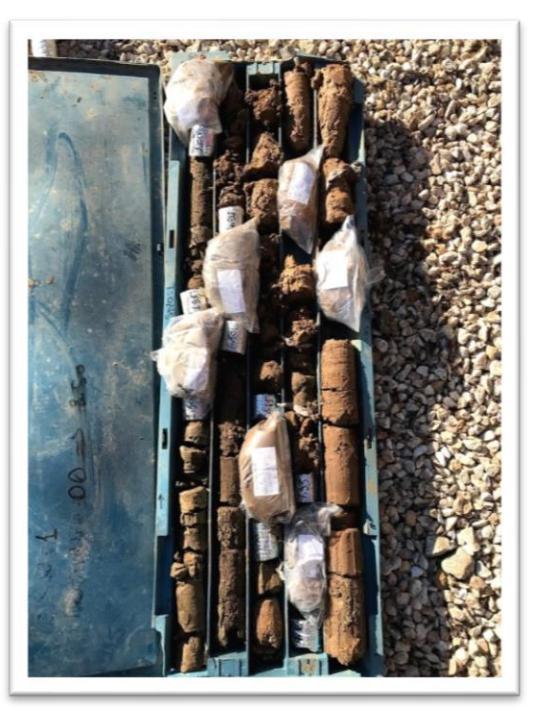
During the site visit, a site investigation study was witnessed. A soil sample was taken from the borehole for laboratory testing. An automatic SPT trip hammer was used as shown Figure 4.91. The available borelog up to the depth of 12 m was retrieved.

Figure 4.91 Drilling efforts (38°40'03.9"N 39°11'14.8"E / 01.02.2020 / 15:18 & 38°40'03.1"N 39°11'16.1"E / 01.02.2020 / 15:18)

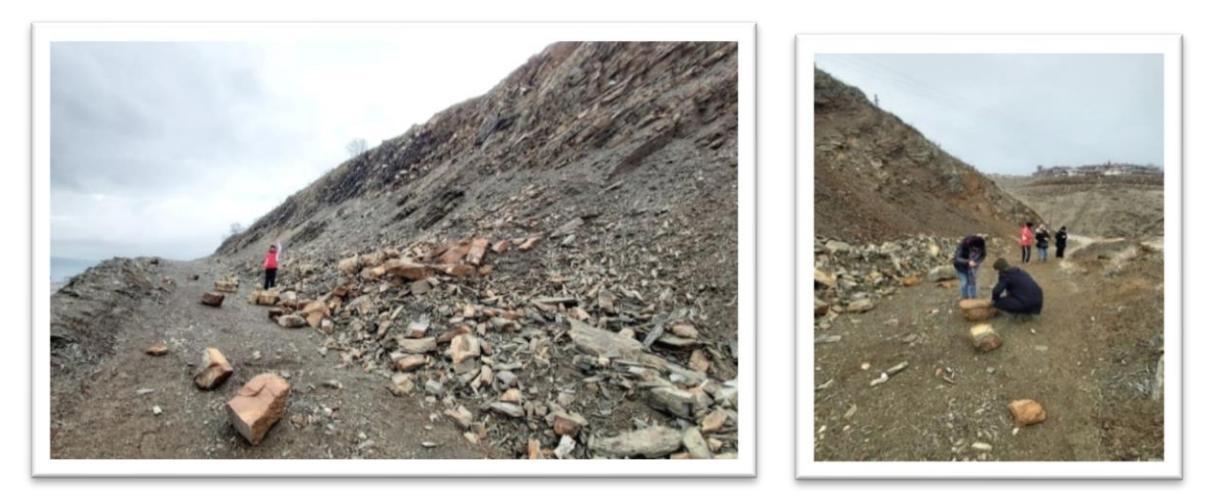
Field reconnaissance team observed rockfalls during their visit to the coast of Hazar Lake as shown in Figure 4.92 and 4.93. In this section, a more detailed discussion of these rockfalls will be presented.

At the first rockfall site, the surface geology reveals phllyites with schistocity texture. The cross section is 15 m high with a slope of 50°. The dimensions of the fallen rocks and the distance from the edge of the benches are mapped in the field. No fallen rocks were observed on the lower, second bench of the highway cut. Slope angle, length and height of different sections of

Figure 4.92 Rockfalls observed at the shores of Hazar Lake at 13<sup>th</sup> stop (38°31'40.0"N 39°28'01.5"E /31.01. 2020 / 16:08)

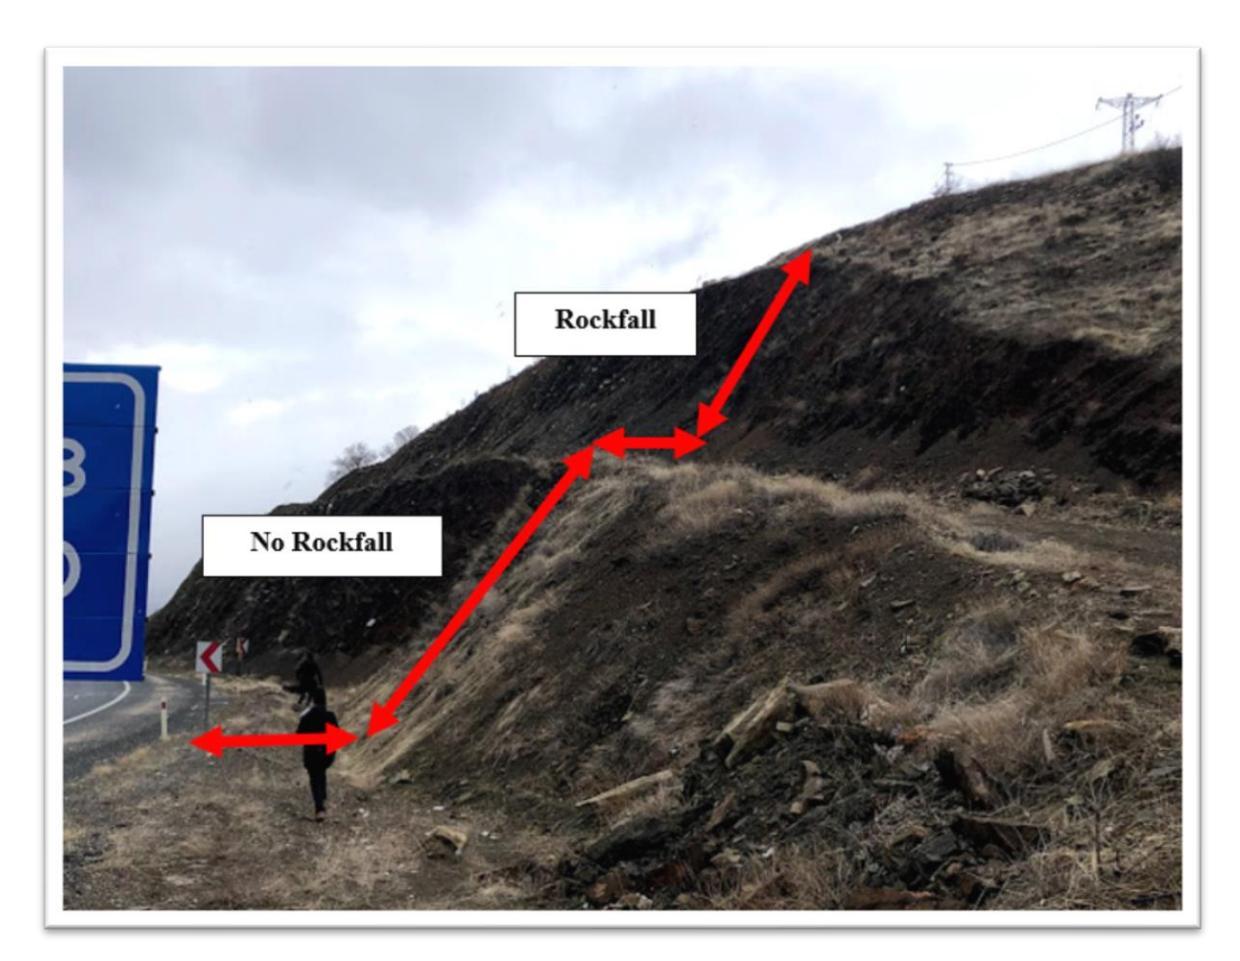
Figure 4.93 Cross section of the rockfall at 13<sup>th</sup> stop (38°31'40.3"N 39°28'02.9"E / 31.01.2020 / 16:20)

The dimensions of the some fallen rock blocks and the distance of these rocks to the toe of the upper bench are recorded in the field as also summarized in Table 4-1.

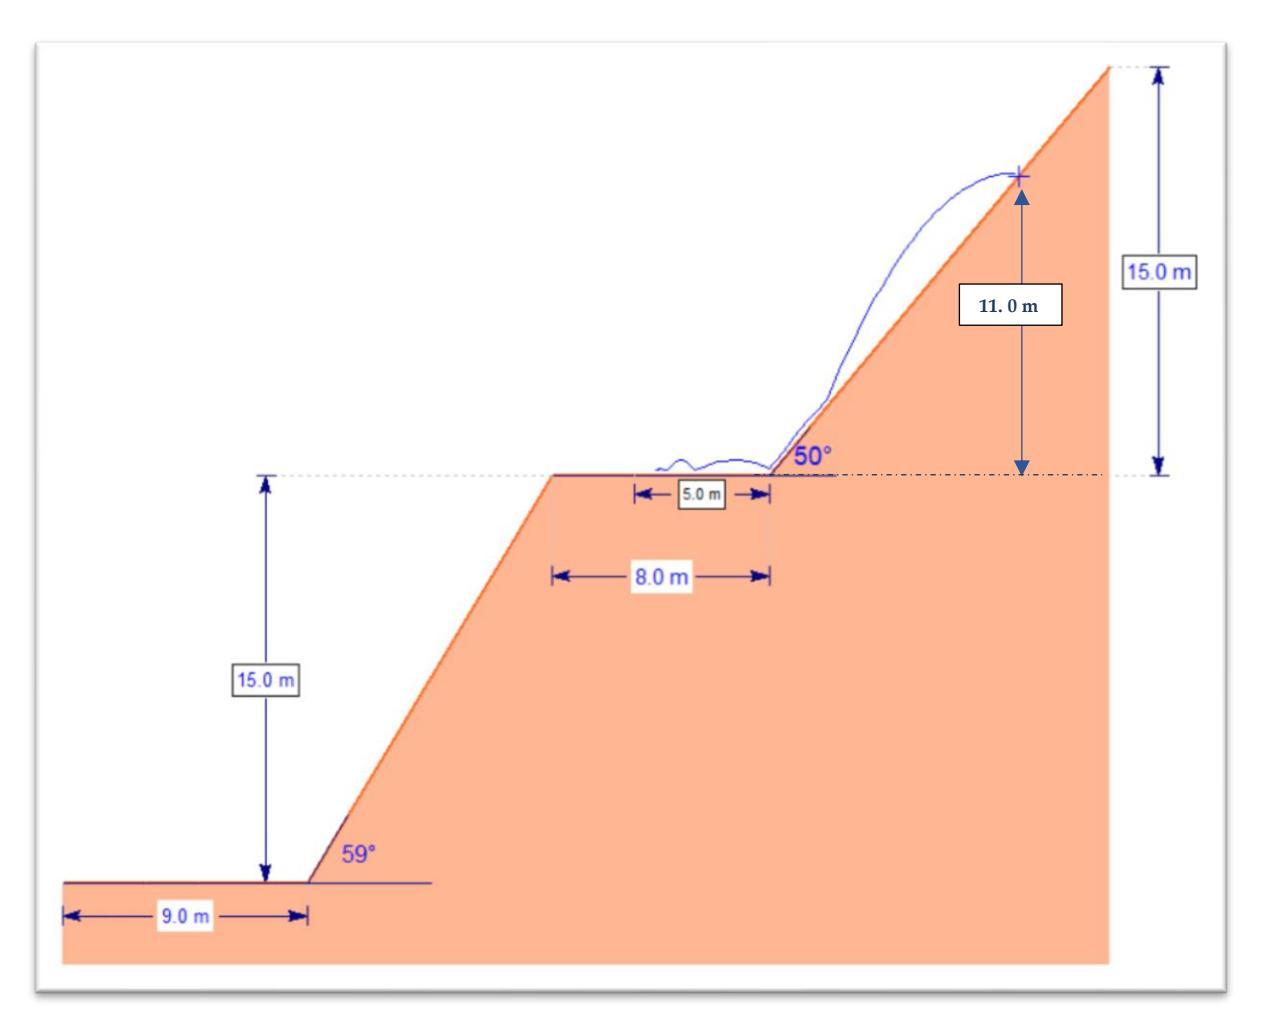
As seen in Figure 4.94, back analysis is performed to guess the initial velocity of the rock blocks to reach their final positions observed in the field. RocFall 2019 by RocScience is used for the purpose. Based on these very preliminary assessments, velocity range to trigger the fall and match with observed travel distances is calculated as 4 to 6 m/s.

Figure 4.94 Back analysis of rockfall with RocFall 2019

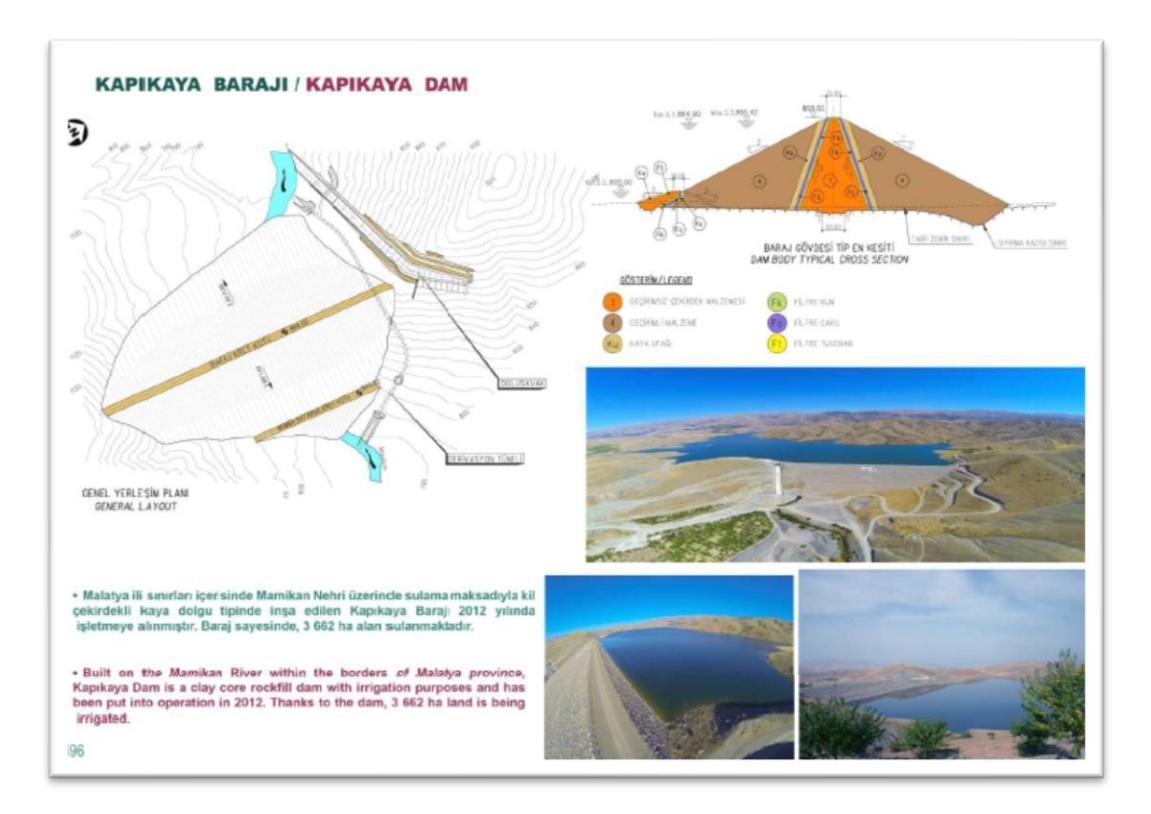
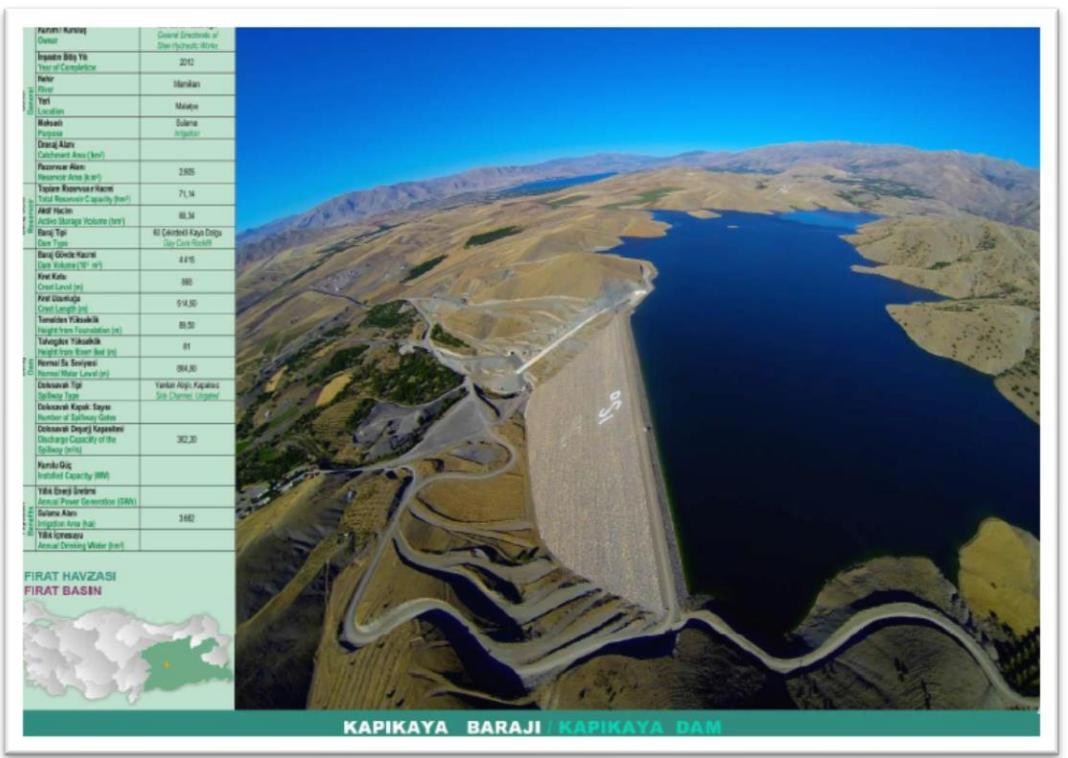
As briefly discussed earlier, Kapıkaya Dam was visited during the 2<sup>nd</sup> day of reconnaissance studies. The upstream and downstream slopes of the dam, as well as abutments, inlet, spillway,

dam body and crest were investigated in detail. No damage was observed at Kapıkaya Dam. Picture taken at Kapıkaya dam site were presented in Chapter 4.2.2, and will not be repeated again.

Figure 4.97 Kapıkaya Dam (DSİ)
