## THE ELÂZIĞ-SİVRİCE EARTHQUAKE [24 JANUARY 2020 M<sub>w</sub>=6.8] FIELD OBSERVATIONS ON SEISMIC AND STRUCTURAL DAMAGE

REPORT NO: METU/EERC 2020-01

MARCH 2020 ANKARA

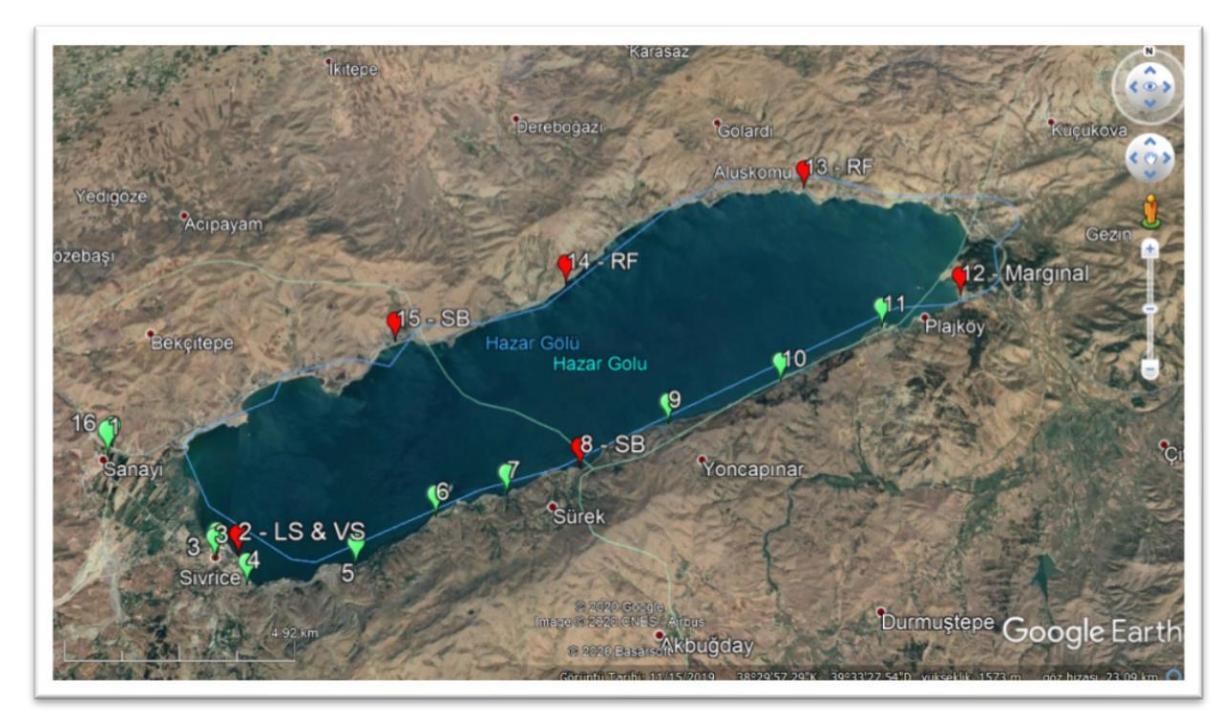
By the natural shores of Hazar Lake, seismically-induced lateral spreading, sand boils and excessive volumetric settlements were observed. A map, summarizing consolidated field observations along the shores of Hazar Lake is shown in Figure 4.102. In Figure 4.102, green pins indicate non-liquefied sites, red pins indicate sites with surface deformations along with abbreviations of type of ground failure; RF: Rock fall, LS: Lateral spread, VS: Volumetric settlement, SB: Sand Boil.

Figure 4.102 A summary of ground failure observations along the shores of Hazar Lake (Green pins indicate Non-Liquefied sites, Red pins indicate sites with surface deformations, RF: Rock fall, LS: Lateral spread, VS: Volumetric settlement, SB: Sand Boil)

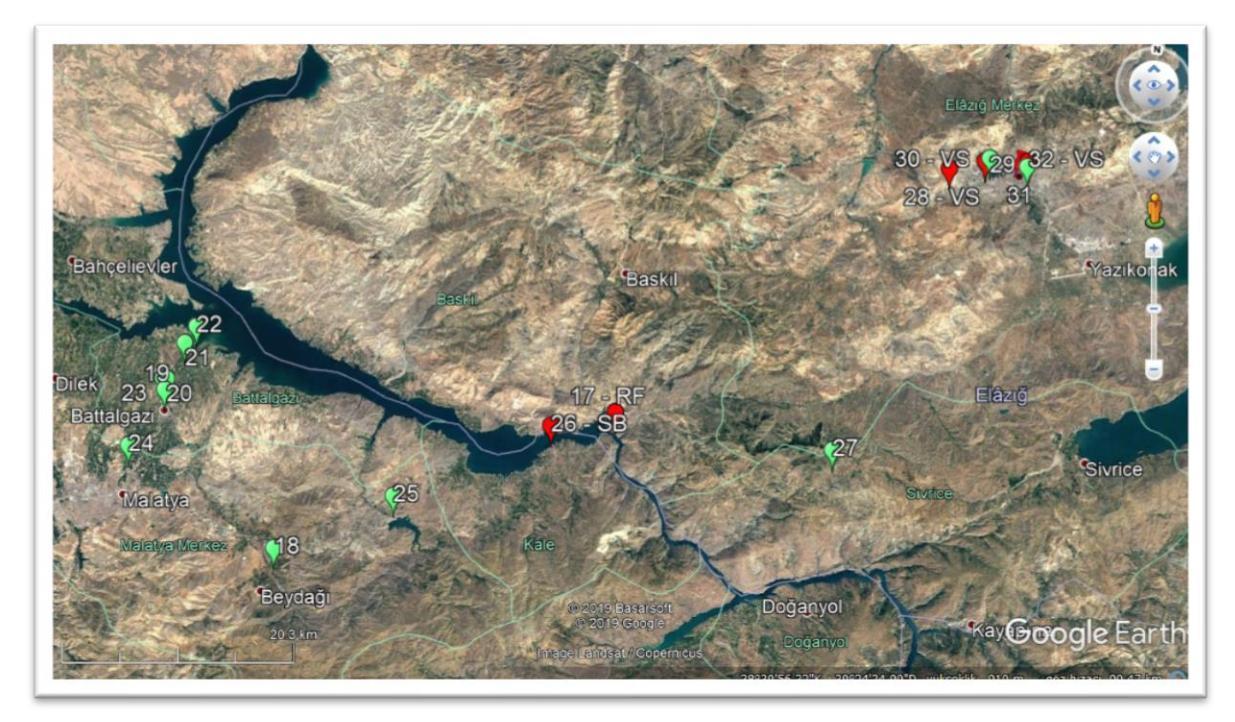
Figure 4.103 A summary of ground failure observations along the shores of Fırat River and Malatya-Elâzığ Route

By Kale Village, at the shores of Fırat River, surface manifestations of seismic soil liquefaction in the form of sand boils were observed. A map, summarizing consolidated field observations along the shores of Fırat River is shown in Figure 4.103.

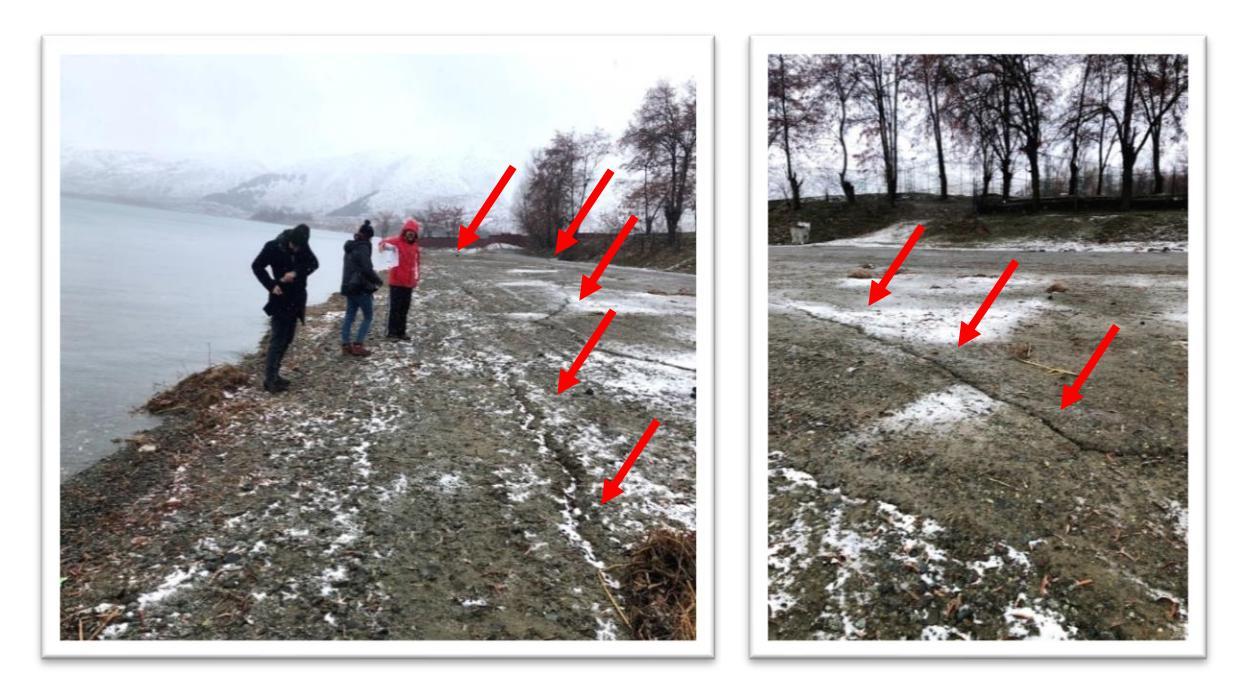
In day 1, surface manifestation of soil liquefaction in the form of sand boils and lateral spreading were mapped. The extent of lateral deformations was mapped as 3-5 cm along a 90 m long and 23 m wide zone at the second stop in the vicinity of Sivrice Dock, as shown in Figure 4.104. Figures 4.105 and 4.106 present the photos of lateral spreading site taken during field investigations.

Figure 4.105 Deformations and cracks due to lateral spreading observed along Hazar Lake (2<sup>nd</sup> stop) (38°26'50.7"N 39°18'56.9"E / 31.01.2020 / 12:21 & 38°26'50.5"N 39°18'56.9"E / 31.01.2020 / 12:28)

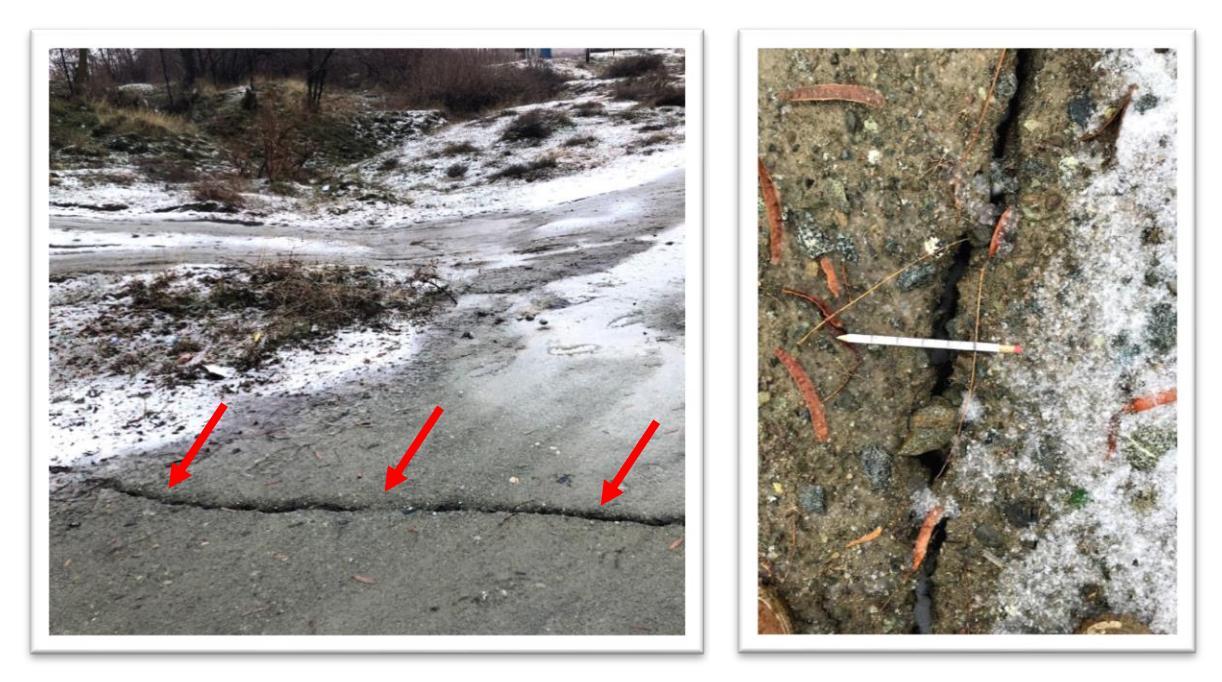
Figure 4.106 Deformations and cracks due to lateral spreading observed along Hazar Lake (2<sup>nd</sup> stop) (38°26'50.8"N 39°18'55.6"E / 31.01.2020 / 12:34 & 38°26'50.3"N 39°18'57.1"E / 31.01.2020 / 12:27)

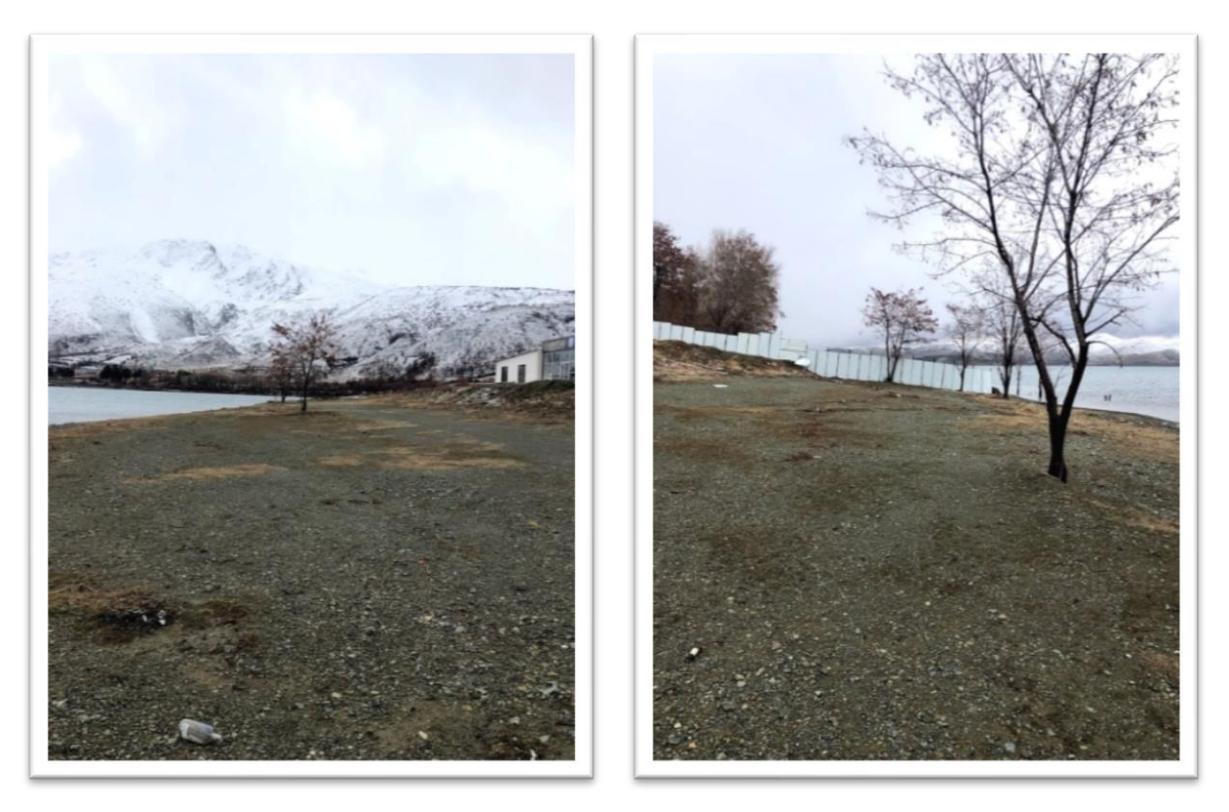
No signs of liquefaction were observed at a natural beach neighboring the lateral spreading site as shown in Figure 4.107. This beach was observed to have a milder slope when compared to the lateral spreading site shown in Figures 4.104-4.105.

Figure 4.107 No ground failure at the natural beach neighboring the lateral spreading (2<sup>nd</sup> stop) (38°26'48.9"N 39°18'59.4"E / 31.01.2020 / 13:08 & 38°27'58.0"N 39°20'42.4"E / 31.01.2020 / 13:08)

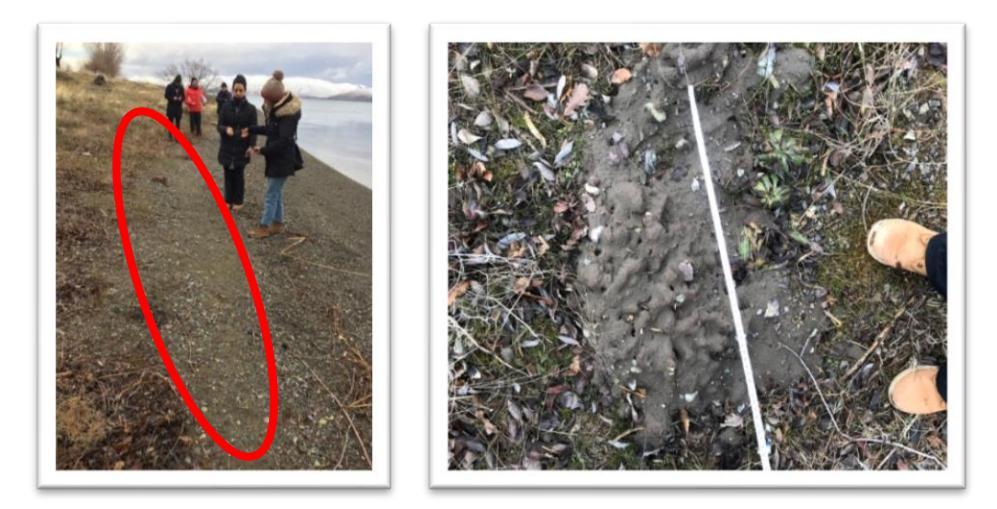
Ground deformations were observed due to liquefaction at 8<sup>th</sup> and 15<sup>th</sup> stops along Hazar Lake as shown in Figures 4.108 and 4.109. Sand boils were mapped, and soil samples were retrieved from these locations. A series of sieve analysis tests has been performed at METU Soil Mechanics Laboratory. Based on the results of these tests, samples were reported to be potentially liquefiable as also will be discussed in the next section.

Figure 4.108 Surface manifestations of soil liquefaction in Hazar Lake (8<sup>th</sup> stop) (38°27'49.7"N 39°24'03.3"E / 31.01.2020 / 14:16 & 38°27'50.0"N 39°24'02.5"E / 31.01.2020 / 14:20)

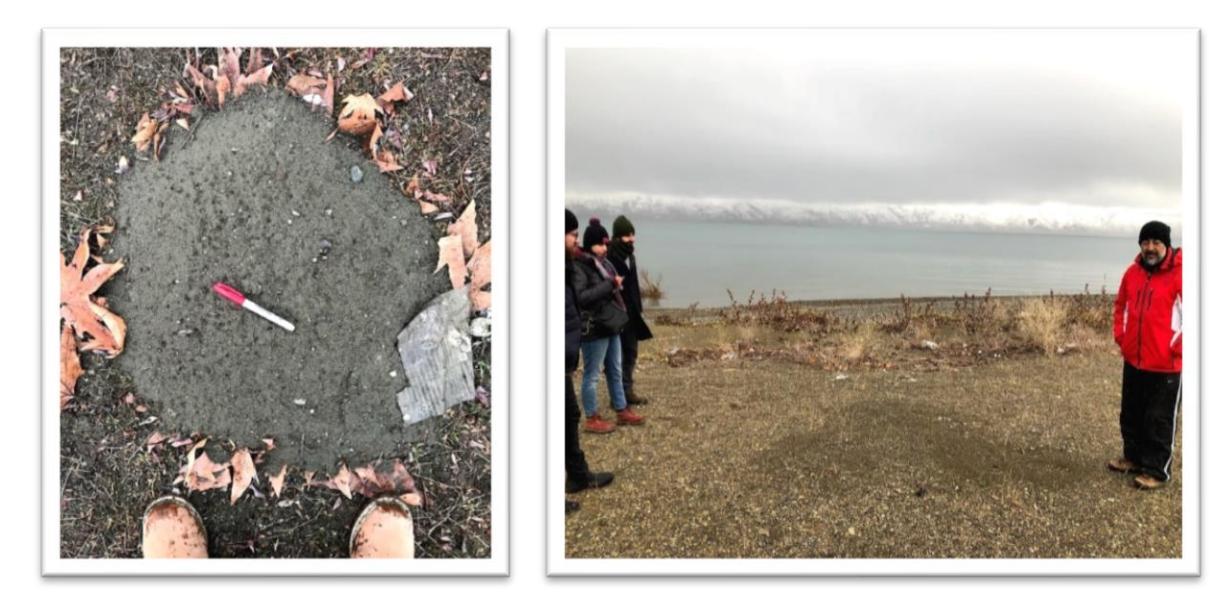
Figure 4.109 Surface manifestations of soil liquefaction in Hazar Lake (15<sup>th</sup> stop) (38°29'34.6"N 39°21'03.7"E / 31.01.2020 / 17:11 & 38°29'30.6"N 39°20'57.7"E / 31.01.2020 / 17:01)

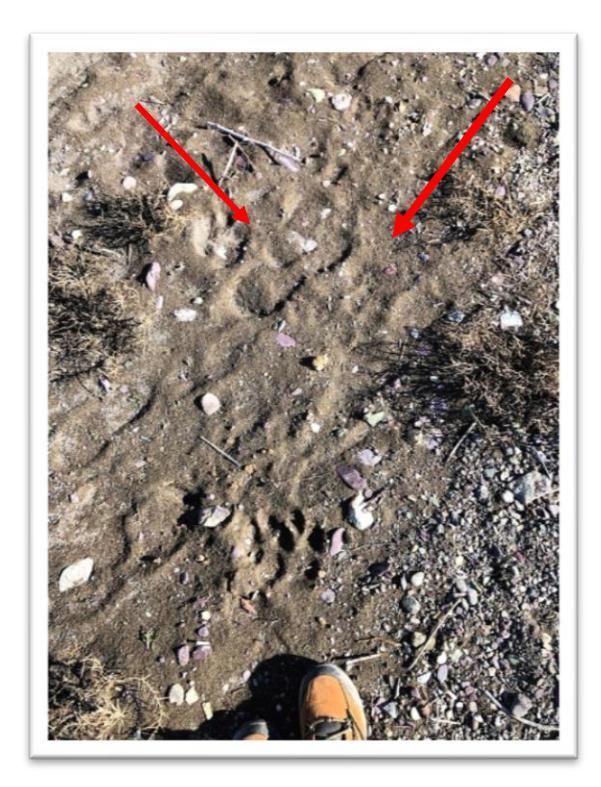
In day 2, surface manifestation of soil liquefaction in the form of sand boils were mapped along Kale shores. Figures 4.110 and 4.111 present the photos of the sand boils taken at the shores of Kale Village.

Figure 4.110 Surface manifestation of soil liquefaction at Kale Village shores (26<sup>th</sup> stop) (38°25'23.6"N 38°45'39.0"E / 01.02.2020 / 12:18)

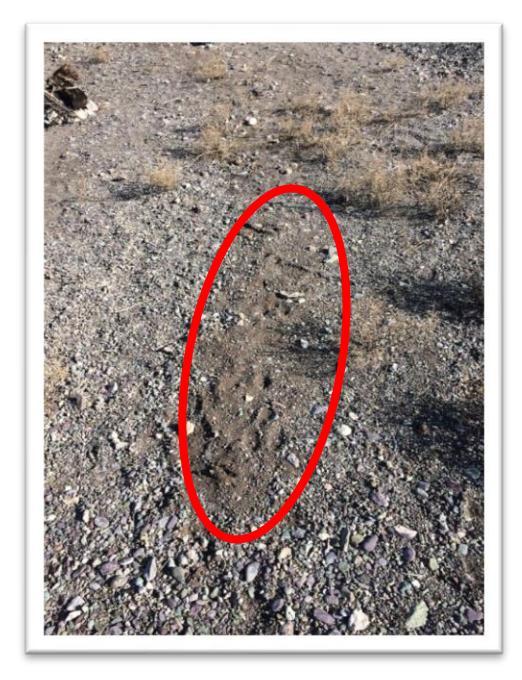
Figure 4.111 Surface manifestation of soil liquefaction at Kale Village shores (26<sup>th</sup> stop) (38°25'20.2"N 38°45'33.2"E / 01.02.2020 / 12:25)

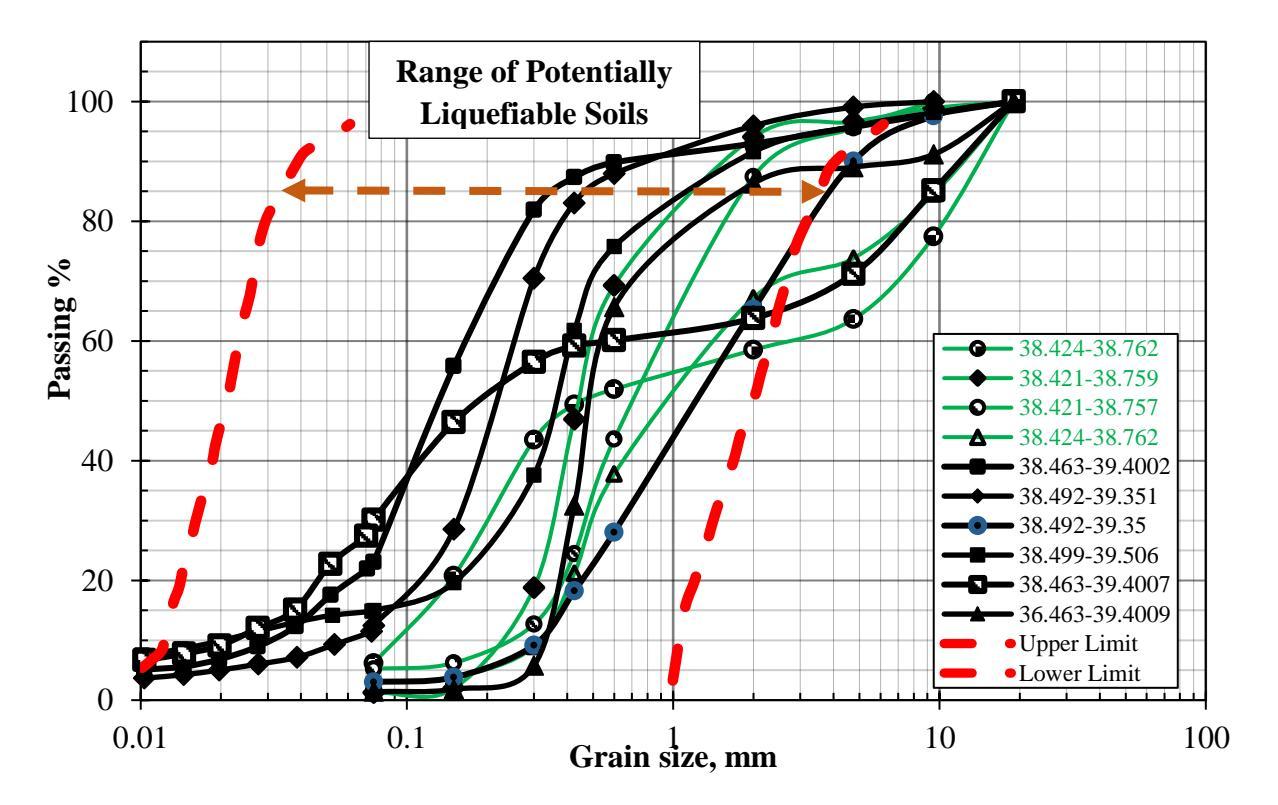
Disturbed samples were taken from the surface of the liquefied areas. The locations of sites from where 6 samples (Hazar Lake) and 4 samples (Kale Village) were taken, are shown in Figure 4.112 and 4.113. A map showing these locations are also presented in Figure 4.114. These samples were tested at METU Soil Mechanics Laboratory to determine the soil-type, grain size and consistency characteristics. The results are comparatively presented with the particle size distribution ranges common for potentially liquefiable soils (Tsuchida, 1970), as given in Figure 4.115. Sieve analysis test results are summarized in Table 4-3. Based on USCS, most of the samples retrieved from sand boils were classified as SP (poorly graded sand) and SM (silty sand).

Figure 4.115 Particles size distribution curves of the sand ejecta taken from liquefied sites (Black lines are obtained from Hazar Lake region and green lines from Kale Village side, respectively)

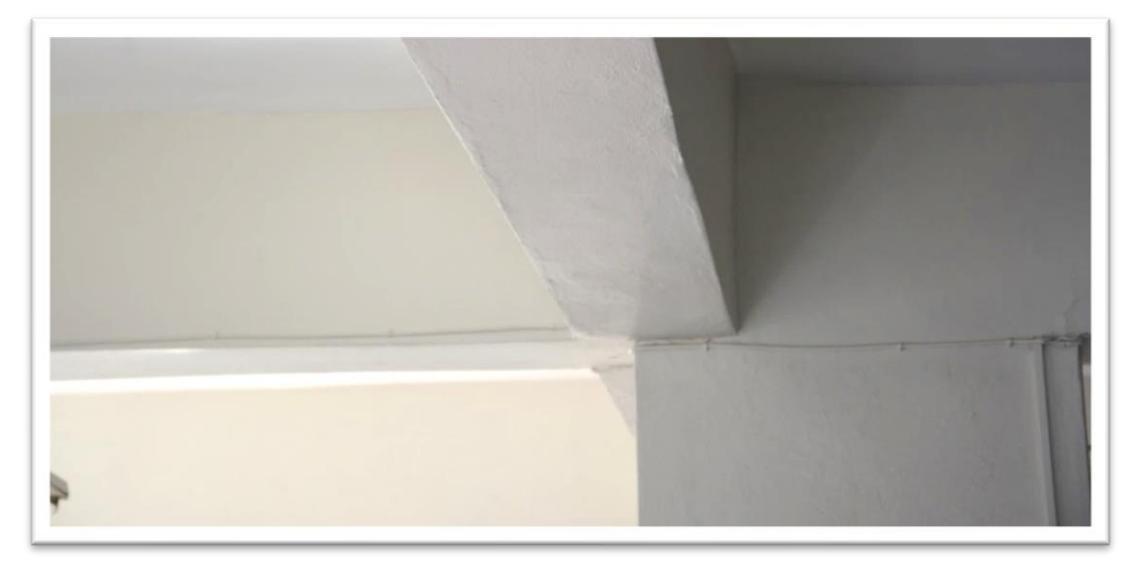
Figure 5.1 shows a beam spanning eccentrically to the column. Simply to comply with the architecture, such off-axis systems are designed. The structural system irregularity is very common since the civil engineer and the architect do not work together while preparing the preliminary project, and mostly, the architects decide on the structural system. Generally, a proper and continuous load path is not formed, and beams cross over with irregularities. Figure 5.2 shows a typical example of beam irregularity.

Figure 5.1 Eccentric beam

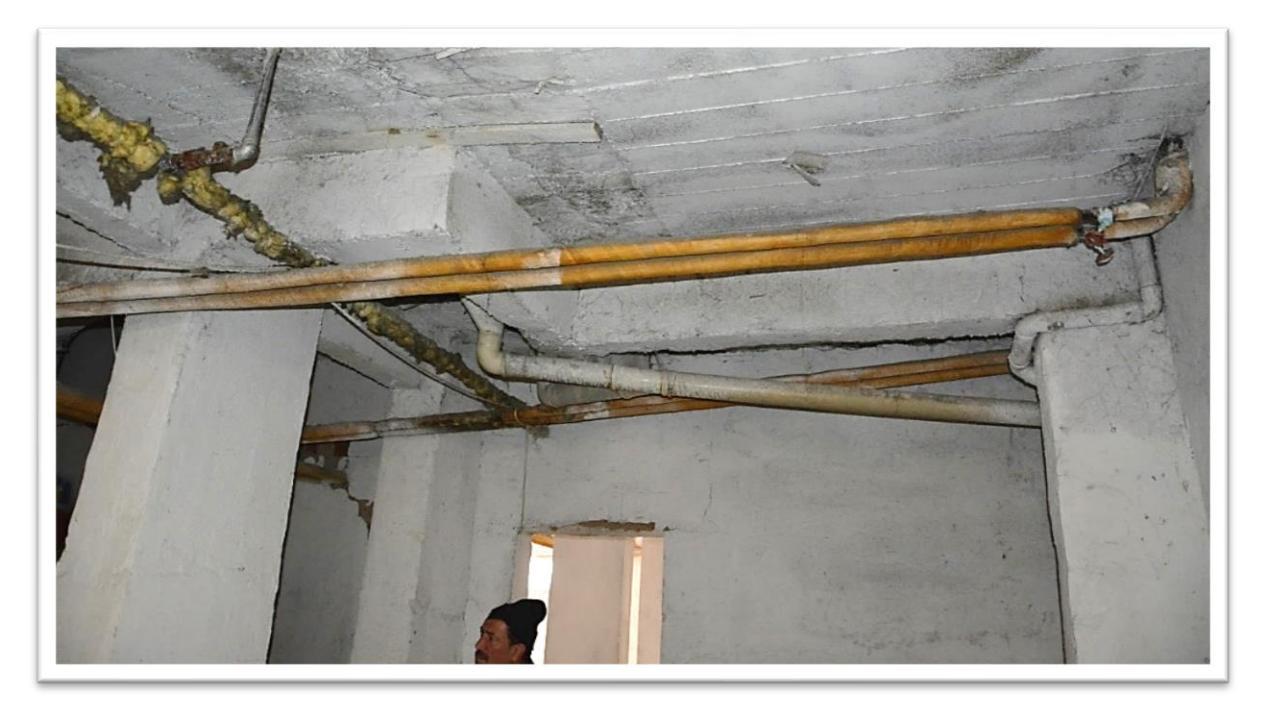
Figure 5.2 Beam irregularity

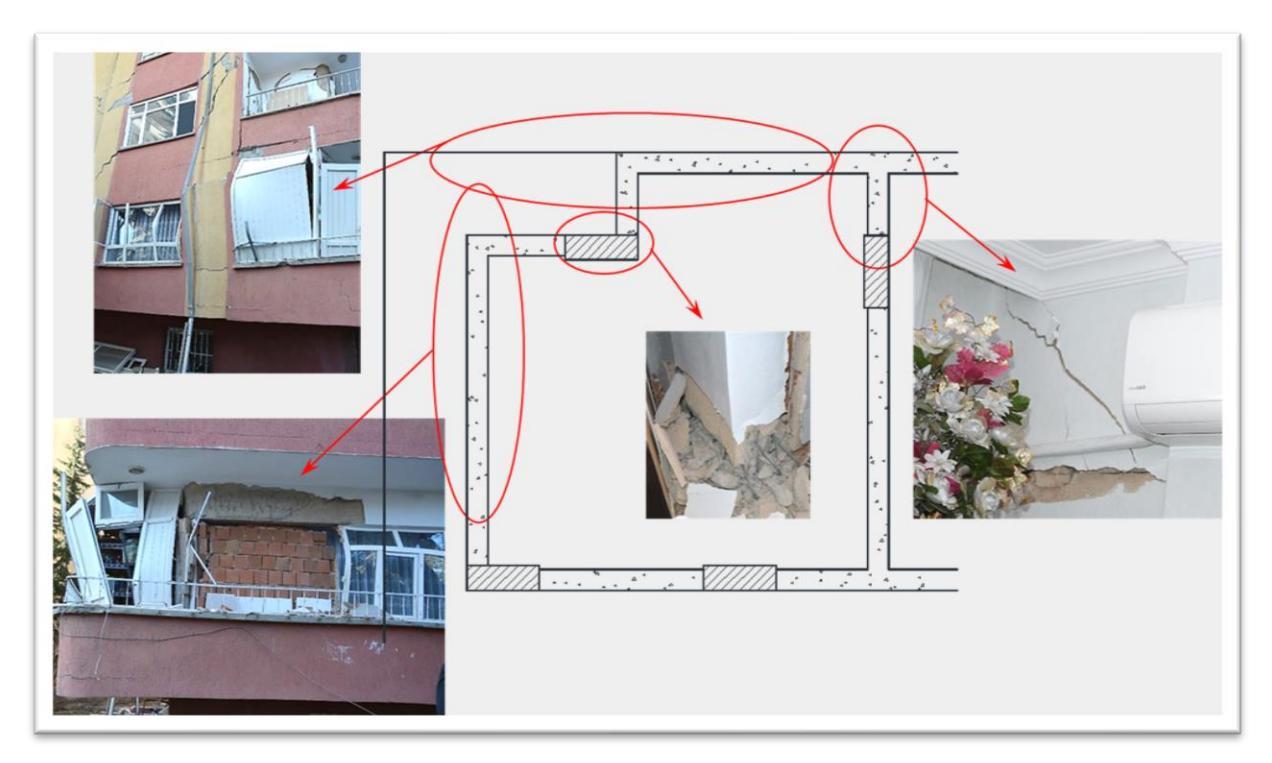
Irregular axis and beam system were found in all the buildings examined. An interesting irregularity is given in Figure 5.3. The cantilever balcony slab on the left of the figure is supported by the cantilever beam. In other words, a cantilever carries another cantilever. As a result, very serious damage occurred in the building.

Figure 5.3 System irregularity

The column damaged due to the irregularity given in Figure 5.3 is also presented in more detail in Figure 5.20. Another irregularity problem of this building is that it was designed as a star shape. The satellite image of the building is given in Figure 5.4. There is an elevator core in the middle section. However, there is no core shear here. Only the backside of the elevator is a shear wall, but the side faces are brick walls. Considering the current severely damaged state of the building, it can be said that the star shape does not provide a proper lateral load resisting system for the building during the earthquake.

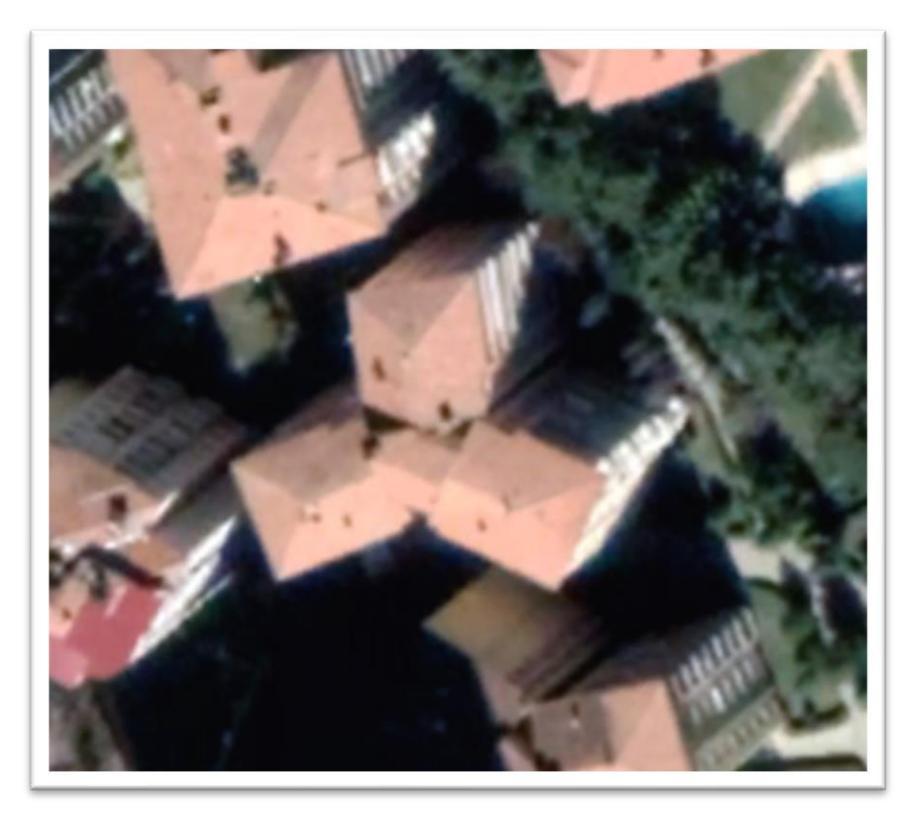
Figure 5.4 Aerial view of the building

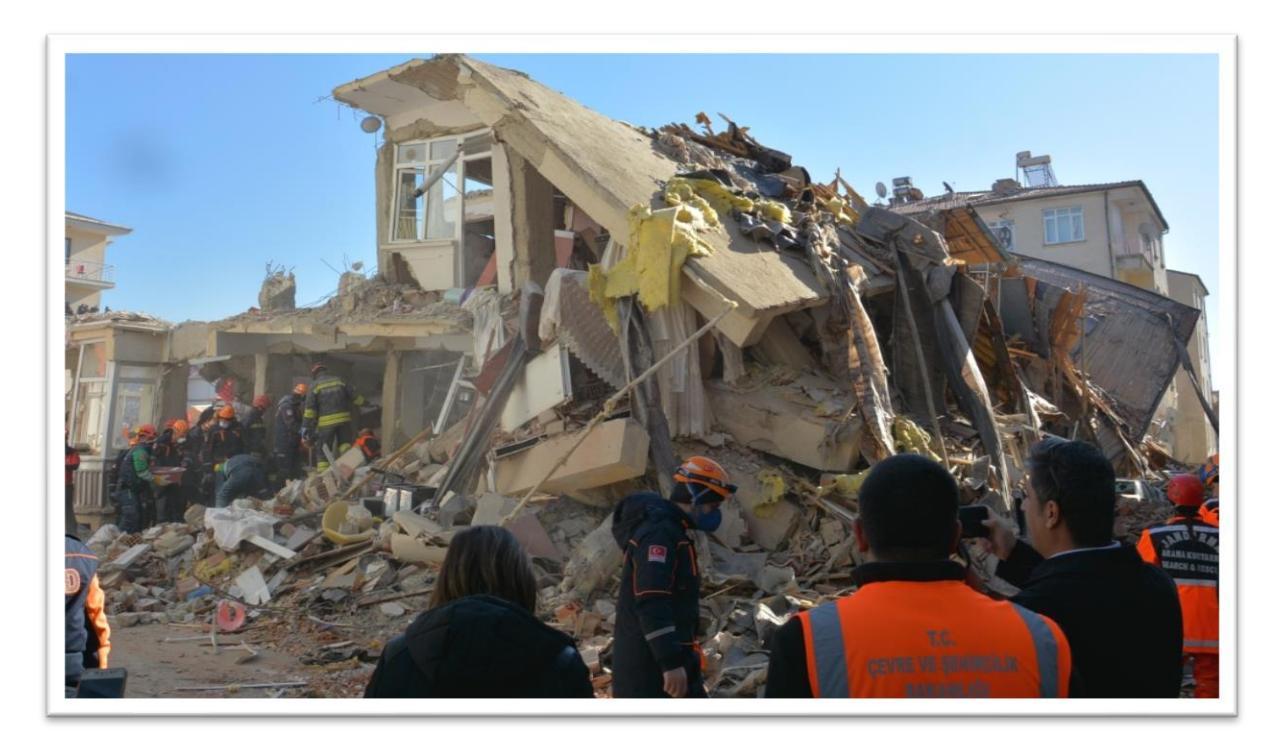
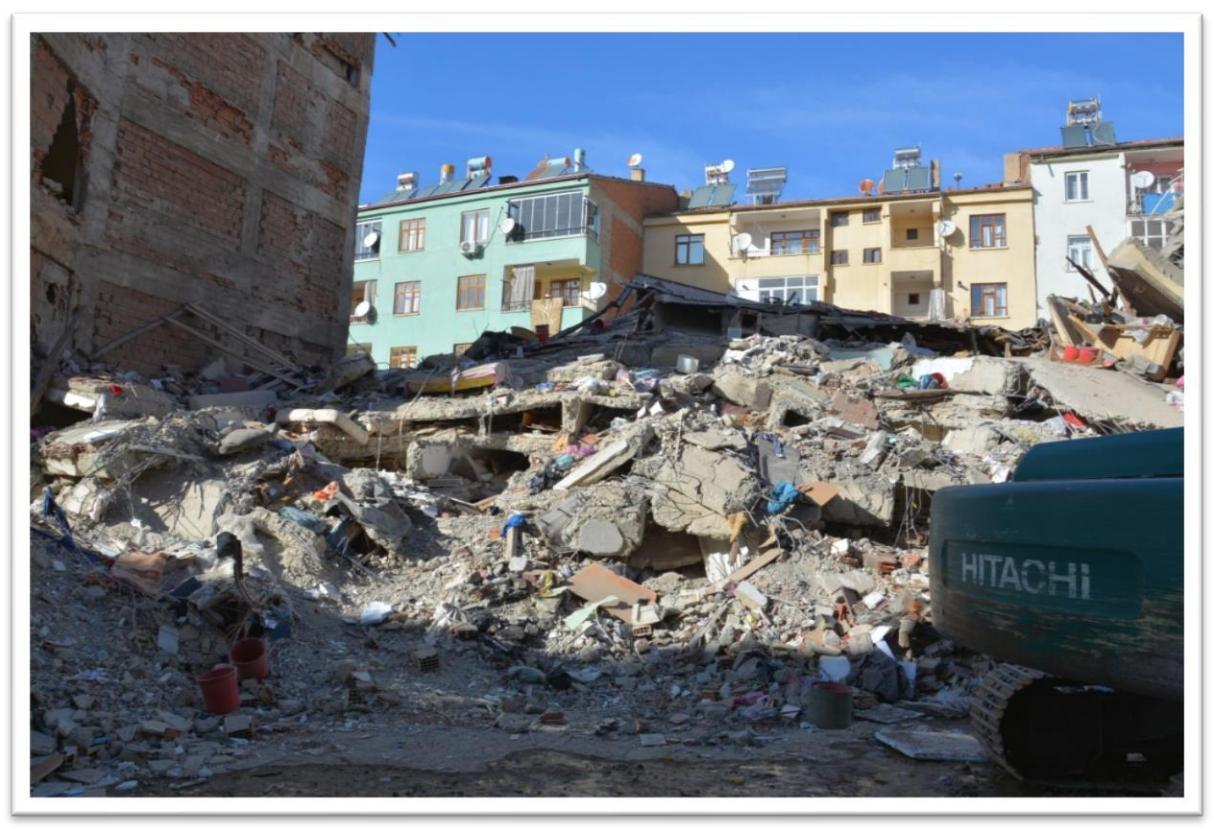
There are 3 buildings collapsed totally in the city center of Elâzığ, Figure 5.5 and Figure 5.6. Unfortunately, these buildings could not be examined closely since the search and rescue activities were continuing. After the search and rescue works, no significant clues for total collapse could be found since the buildings have already turned into debris. However, as a result of the observations made only from outside, the usual weaknesses were realized: low concrete quality, insufficient stirrups, 90° stirrup hooks, no cross-ties, weak column-strong beam, absence of shear walls, insufficient beam-column joints.

Figure 5.5 Total collapsed buildings in Elâzığ city center

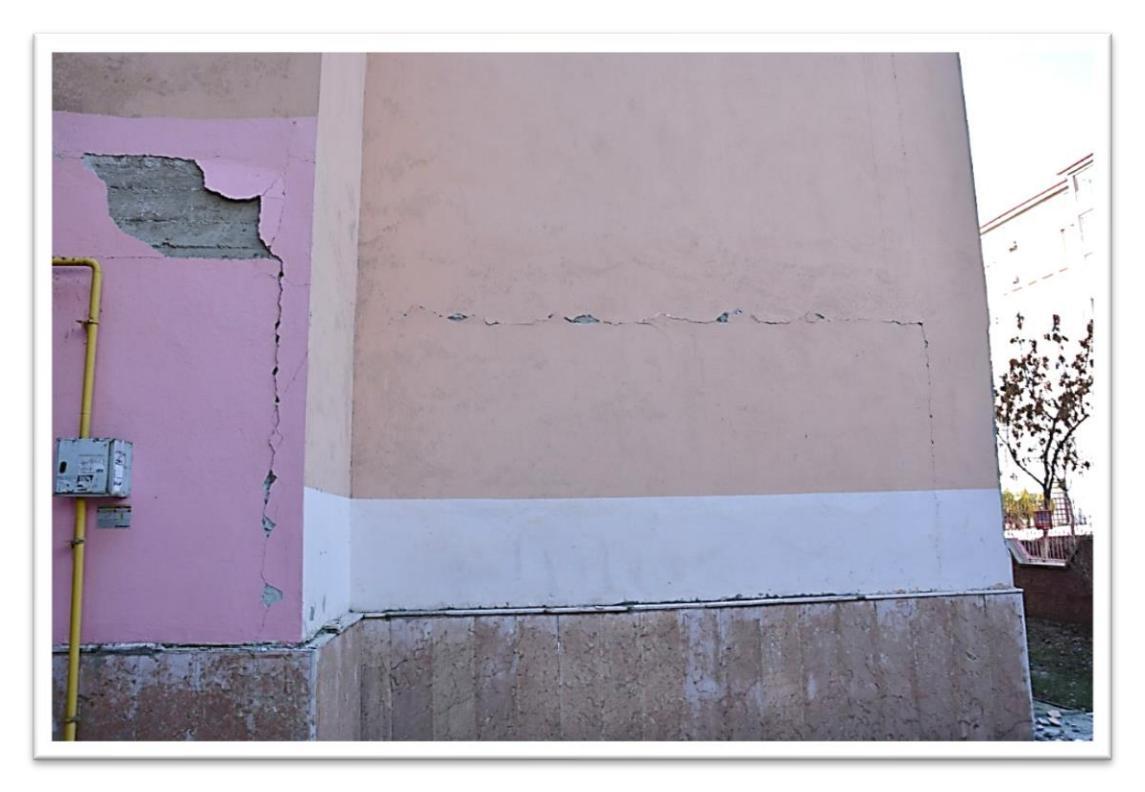
In Figure 5.7 and Figure 5.8, a general view of the partition wall damages is given from the exterior of the buildings. Typical partition wall cracks in the inspected buildings are given in Figure 5.9 and Figure 5.10. A heavy wall crack is given in Figure 5.11. Such wall separations have been much less common. As can be seen in Figure 5.12, it is highly probable that the exterior partition walls, which were especially made of double layers, fell down. The heat insulation material was placed between the two thin bricklayers. Walls on overhangs aggravates such wall damage. Figure 5.13 shows a completely damaged exterior wall due to out of plane deformations. This kind of collapses are one of the important types of damage that can cause loss of life and property.

Figure 5.7 Partition wall cracks on the beam-column boundary, exterior

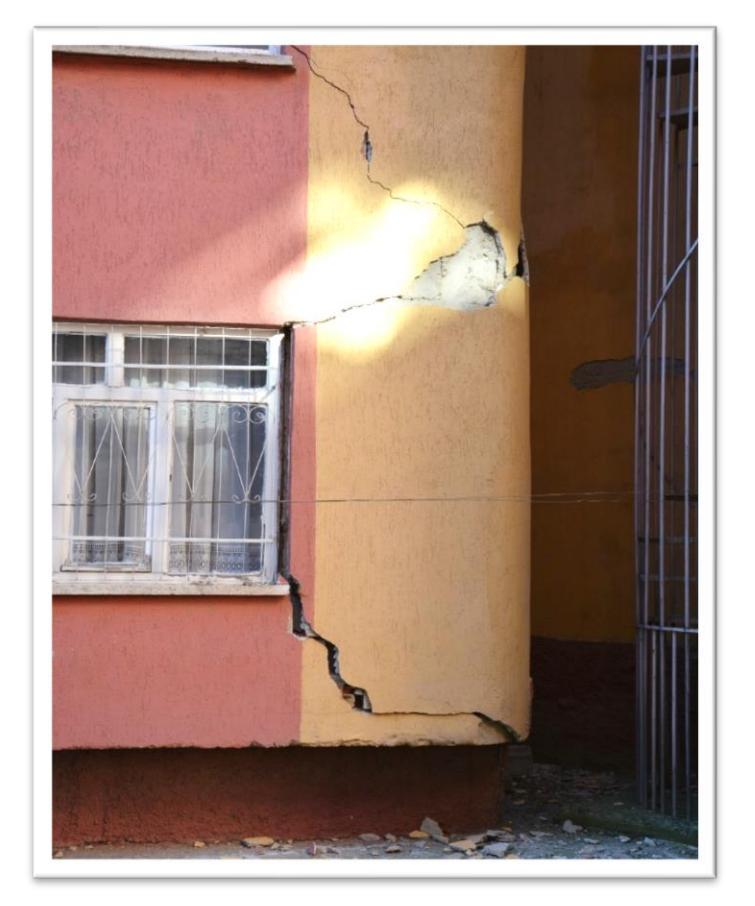
Figure 5.14 and Figure 5.15 show pictures of wall cracking observed at the corners of heavy overhangs. As can be seen in Figure 5.12 above, the exterior walls in the overhangs can fall. Such accidents can cause injury or even death.

Figure 5.15 Heavy overhang damages

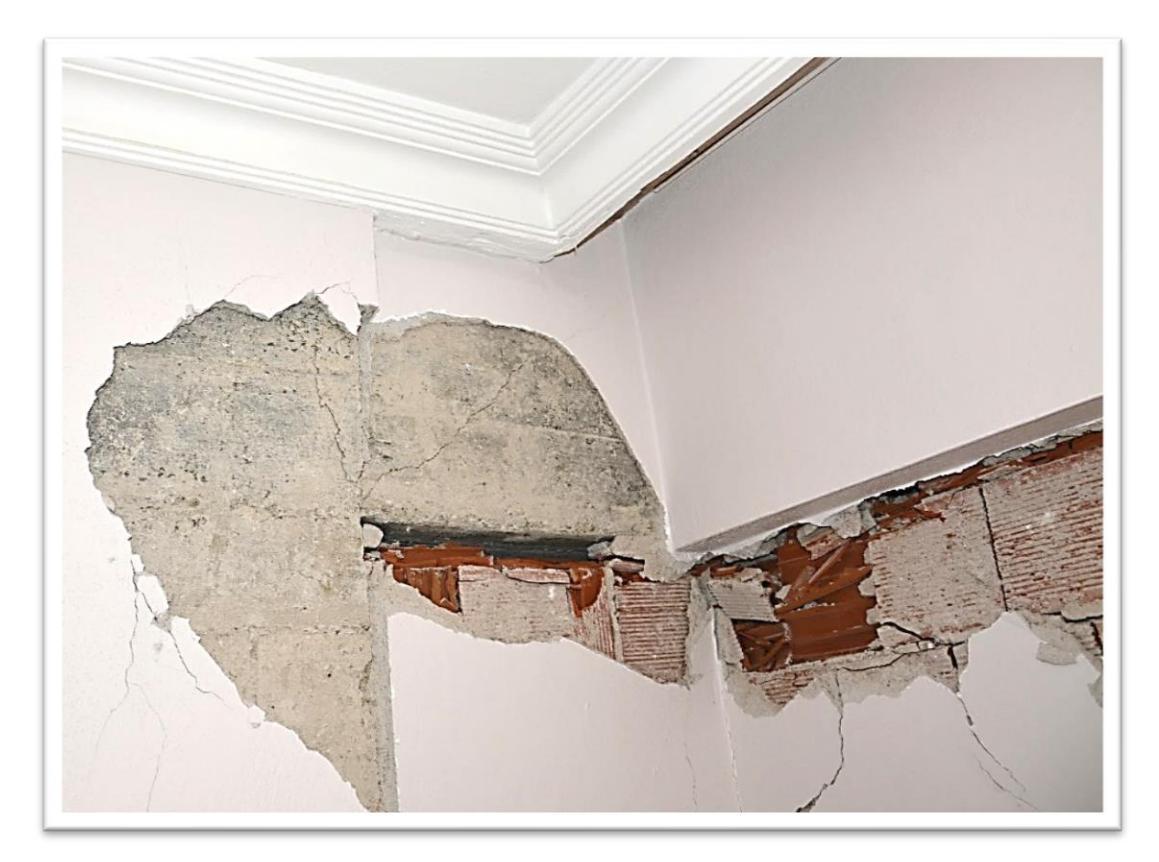
Figure 5.16 Cantilever beam damage of overhangs

Damages in heavy overhangs are not only limited to the partition walls but also the structural system. Bending and shearing cracks after an earthquake is a common problem in the beams of overhangs, Figure 5.16.

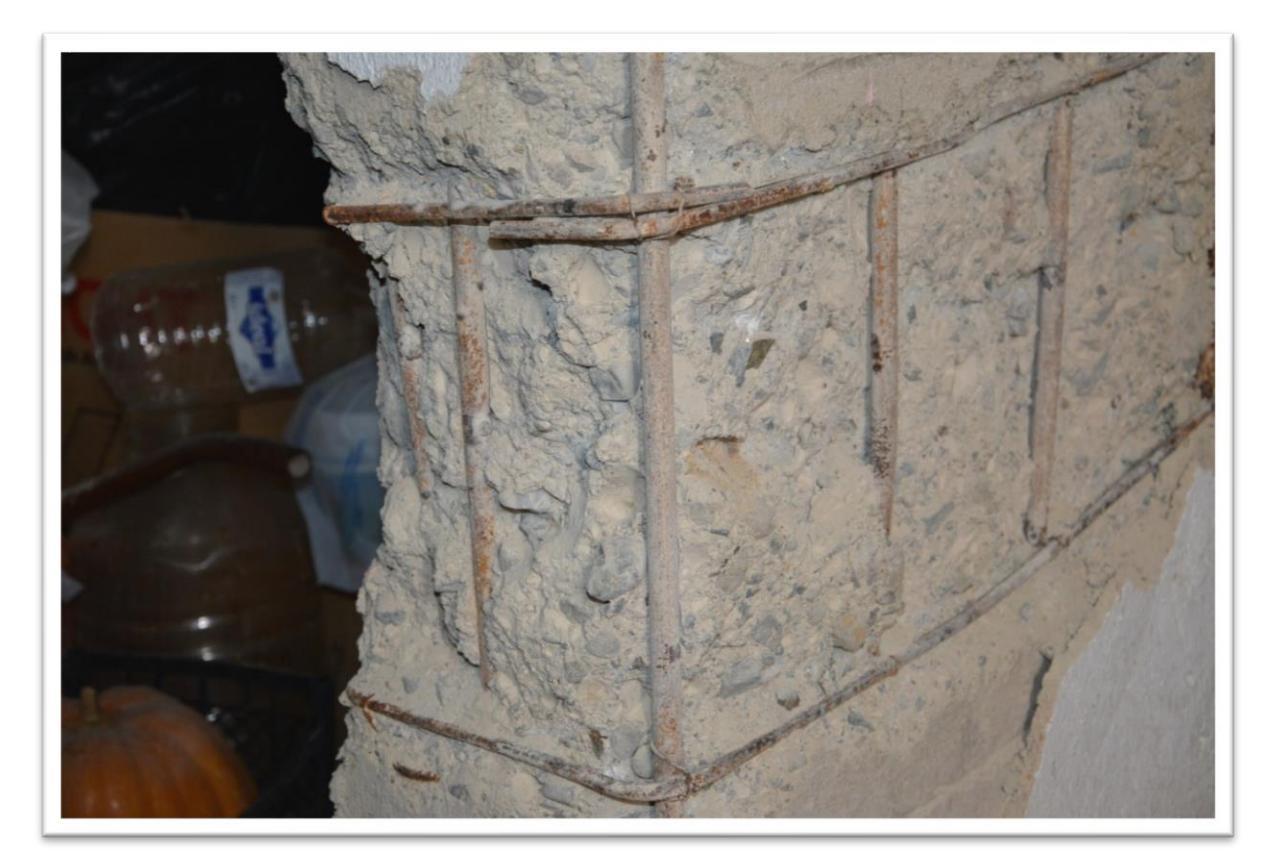
Figure 5.17 A typical column example

A rectangular column that sustained significant damage is given in Figure 5.17 as an example. All typical deficiencies regarding the column detailing are present in this picture. Plain bars are used, stirrup spacing is large, stirrups are not closely spaced at column ends, stirrup hooks are left at 90°, no cross-ties are used, and concrete quality is poor. Site prepared concrete with unwashed, dirty river sand and aggregate was used in the construction of this building.

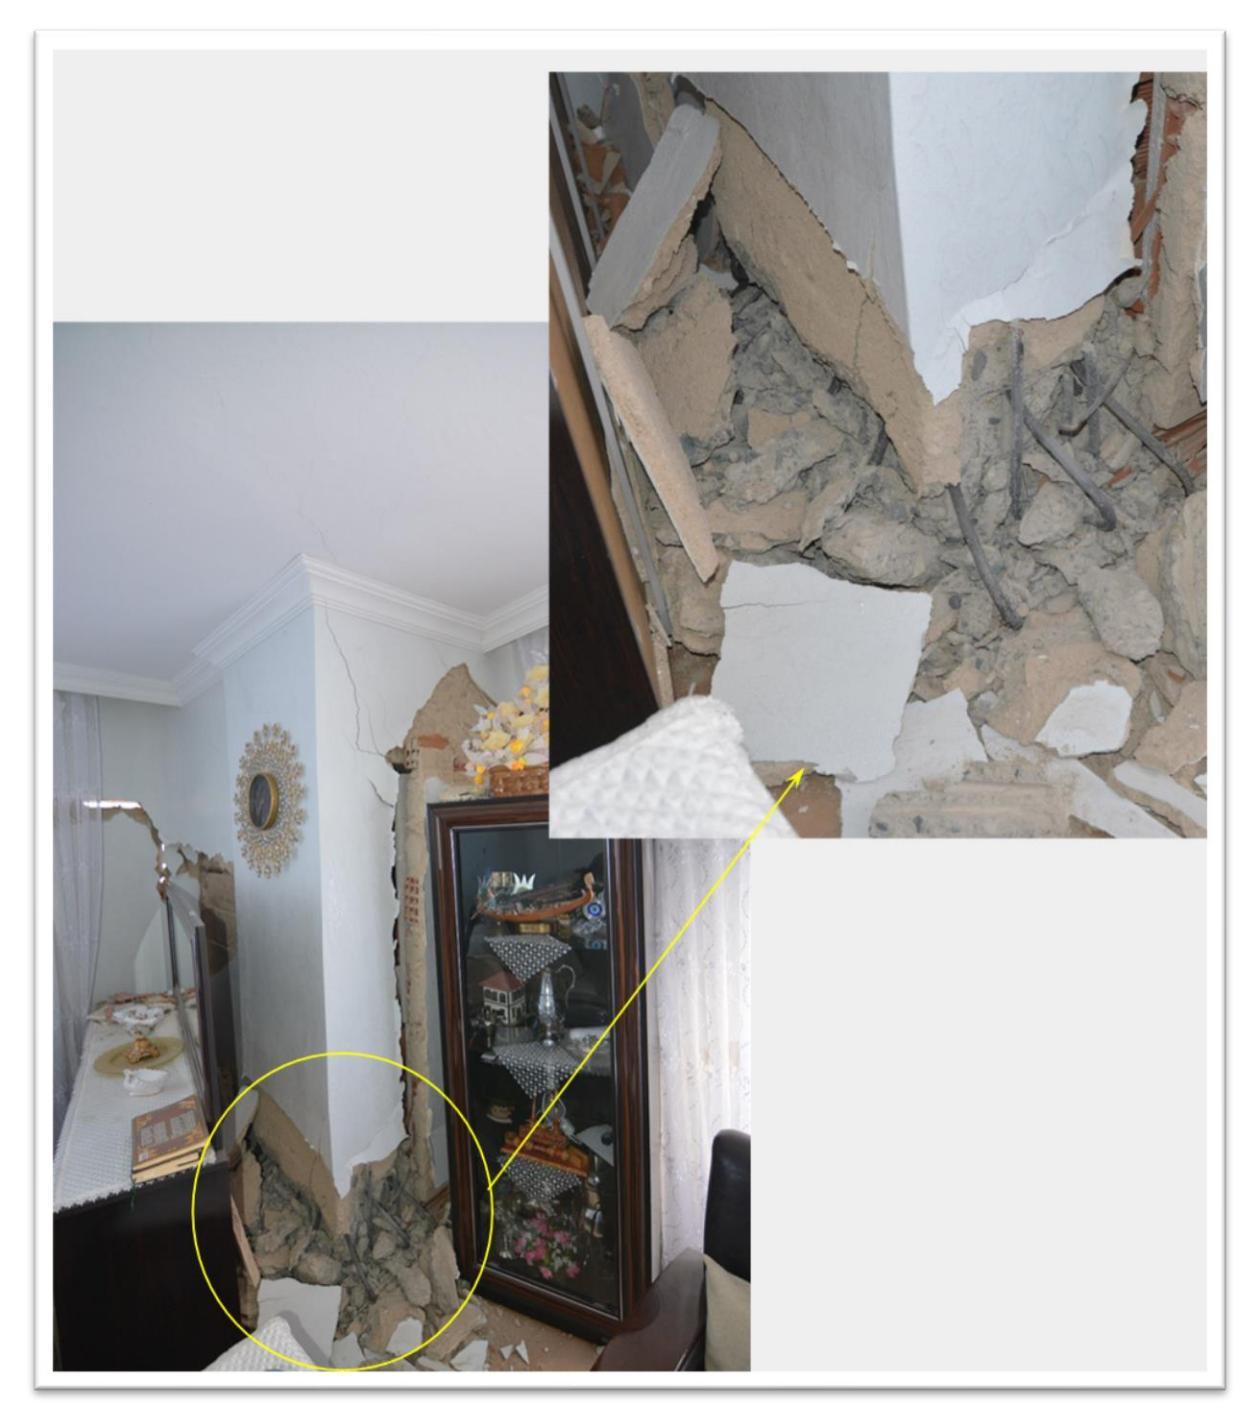
Figure 5.20 Collapse at the bottom of the column

Shear damage typically seen in columns due to insufficient transverse reinforcement is given in Figure 5.18. Since the stirrups were not closely spaced at the column ends, plastic hinging can be seen in the end regions as shown in Figure 5.19. Frame-wall interaction augmented this damage as well. This damage occurred due to the lack of sufficient confinement at the upper end of the column. Figure 5.20 shows heavy damage at the bottom of the column. The damage here is beyond plastic hinging, almost reaching the disintegration of the column.

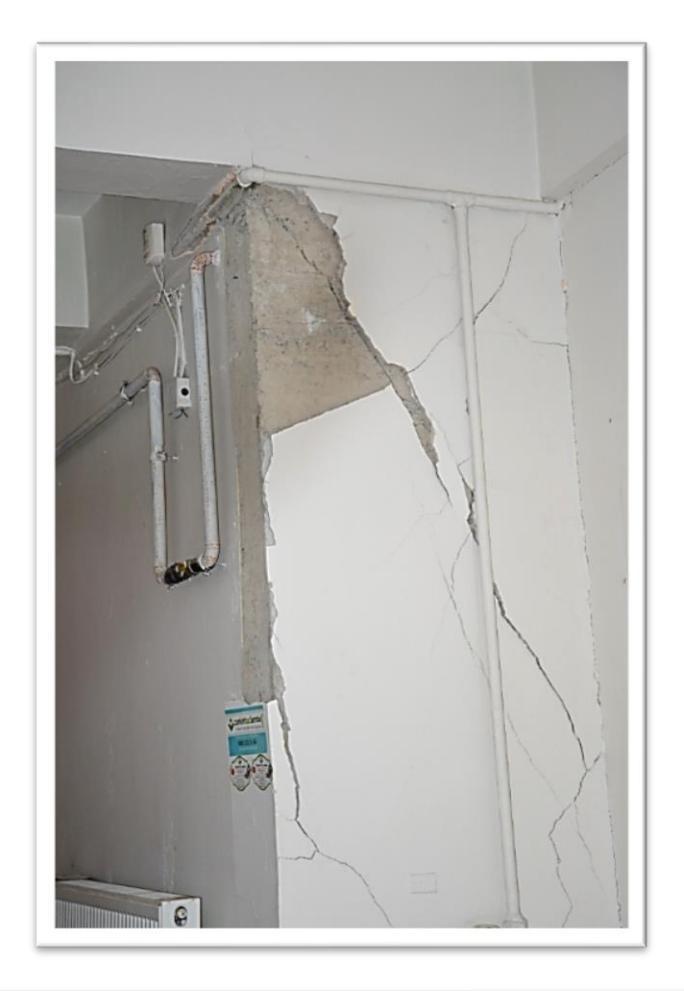
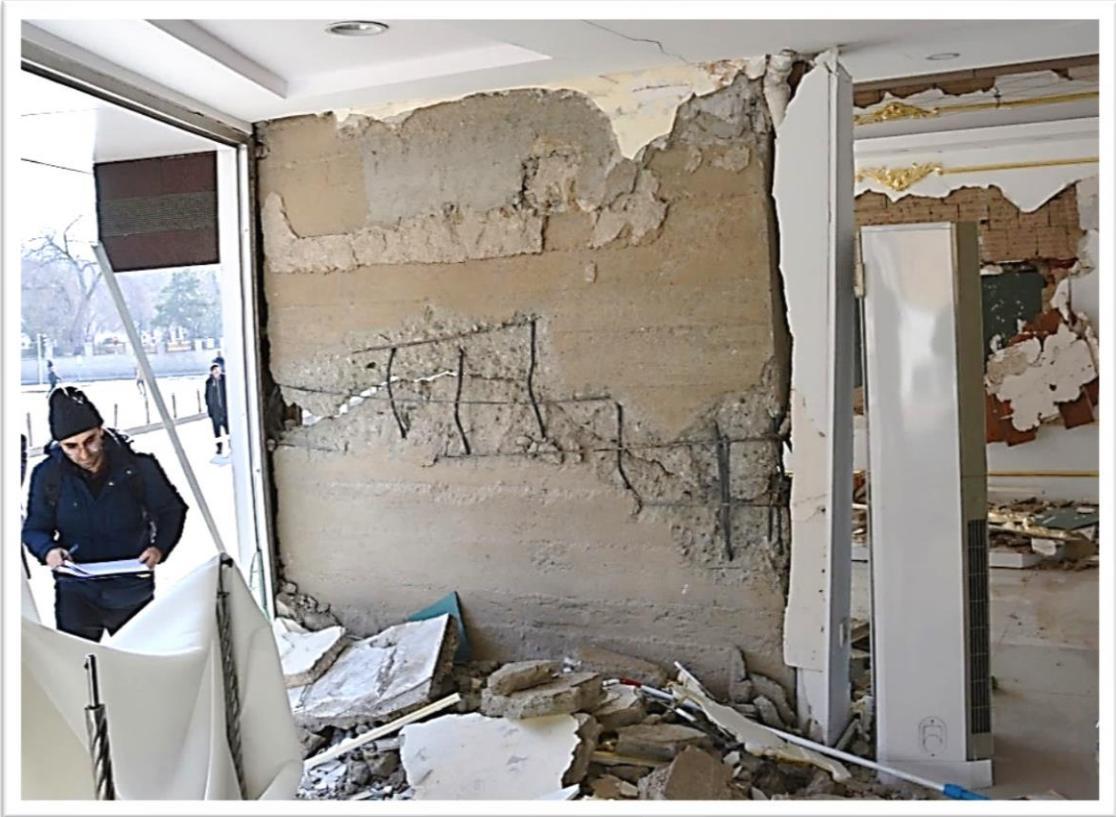
Figure 5.21 Shear wall damages

In a limited time, only the buildings that were reported to us as moderate or heavy damaged were tried to be inspected. Most of the buildings did not have shear walls. An example for the shear wall damage is given in Figure 5.21. The first photo contains typical shear damage. The second one shows a sliding movement. Most likely, the dowel bars from the foundation end at this level. Therefore, such sliding deformation appears at this level.
