## THE ELÂZIĞ-SİVRİCE EARTHQUAKE [24 JANUARY 2020 M<sub>w</sub>=6.8] FIELD OBSERVATIONS ON SEISMIC AND STRUCTURAL DAMAGE

REPORT NO: METU/EERC 2020-01

MARCH 2020 ANKARA

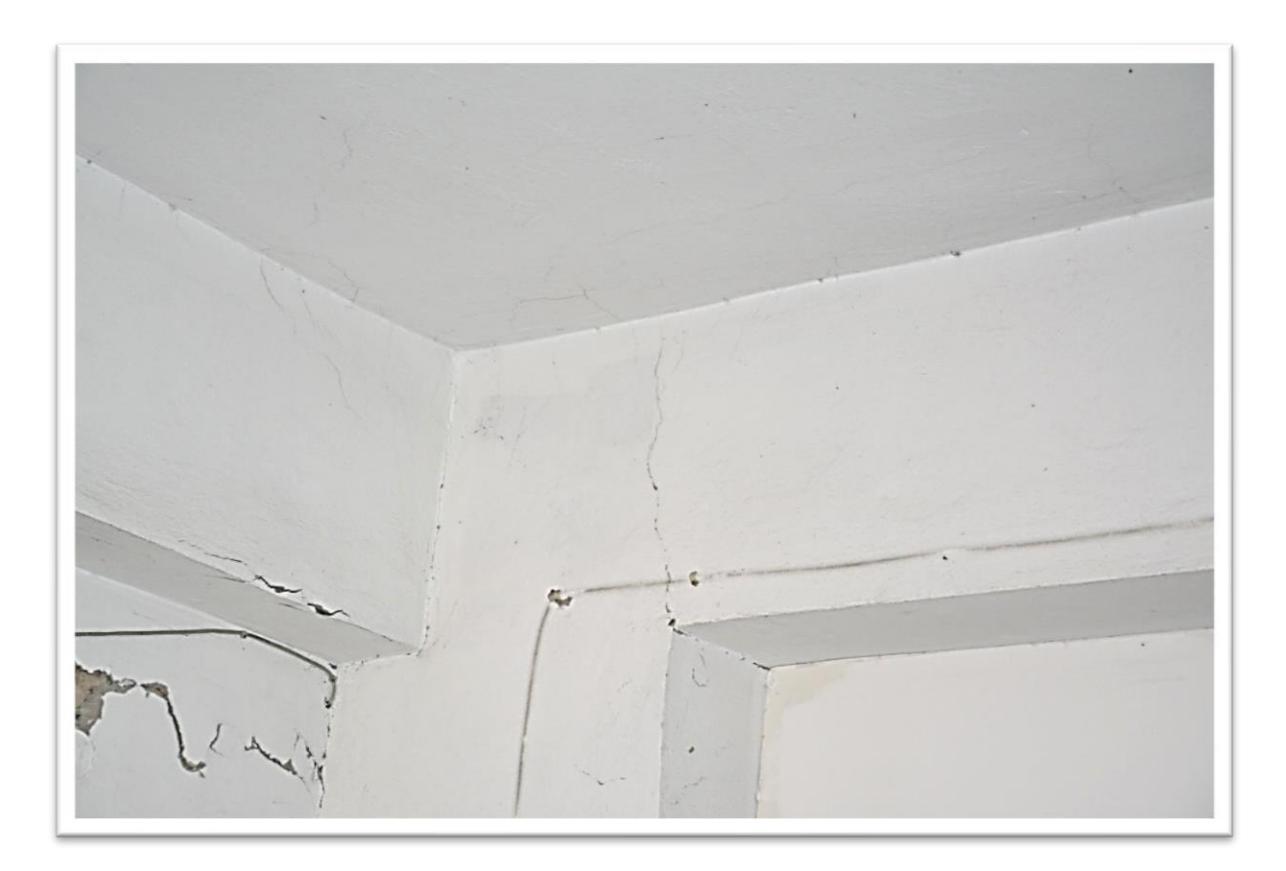
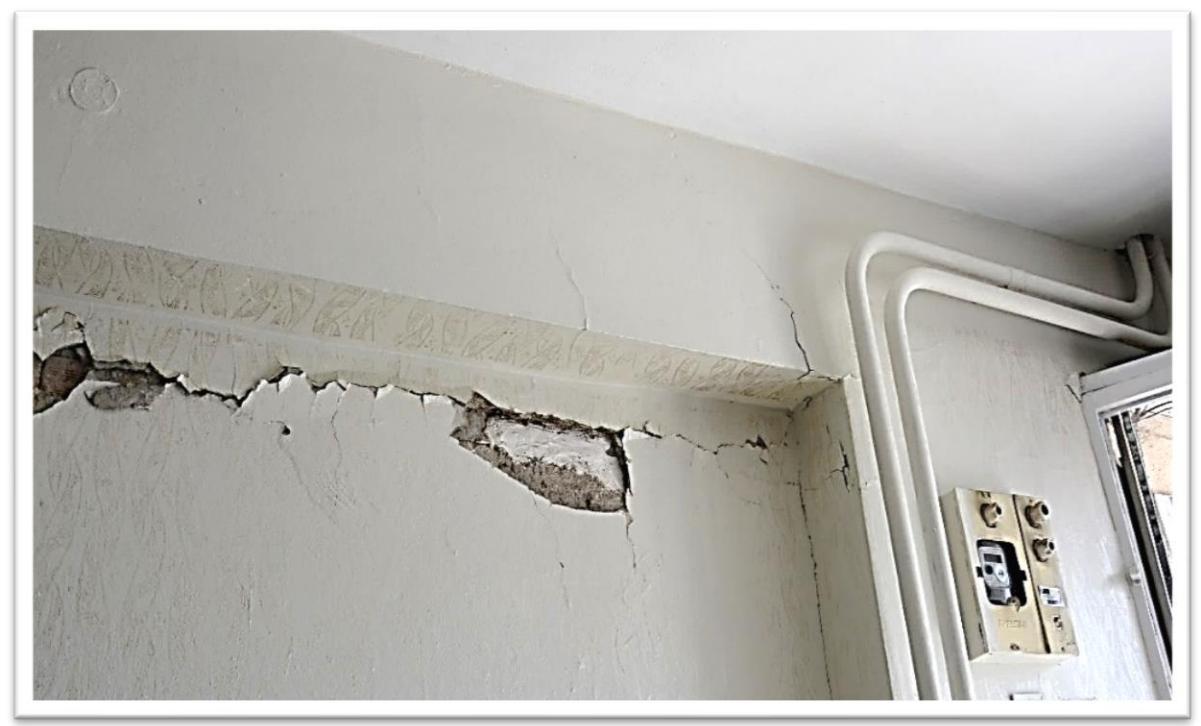
Figure 5.22 Beam bending cracks

Bending and shear damages are observed at the ends of the beams after the earthquake. Figure 5.22 shows bending cracks at the beam ends.

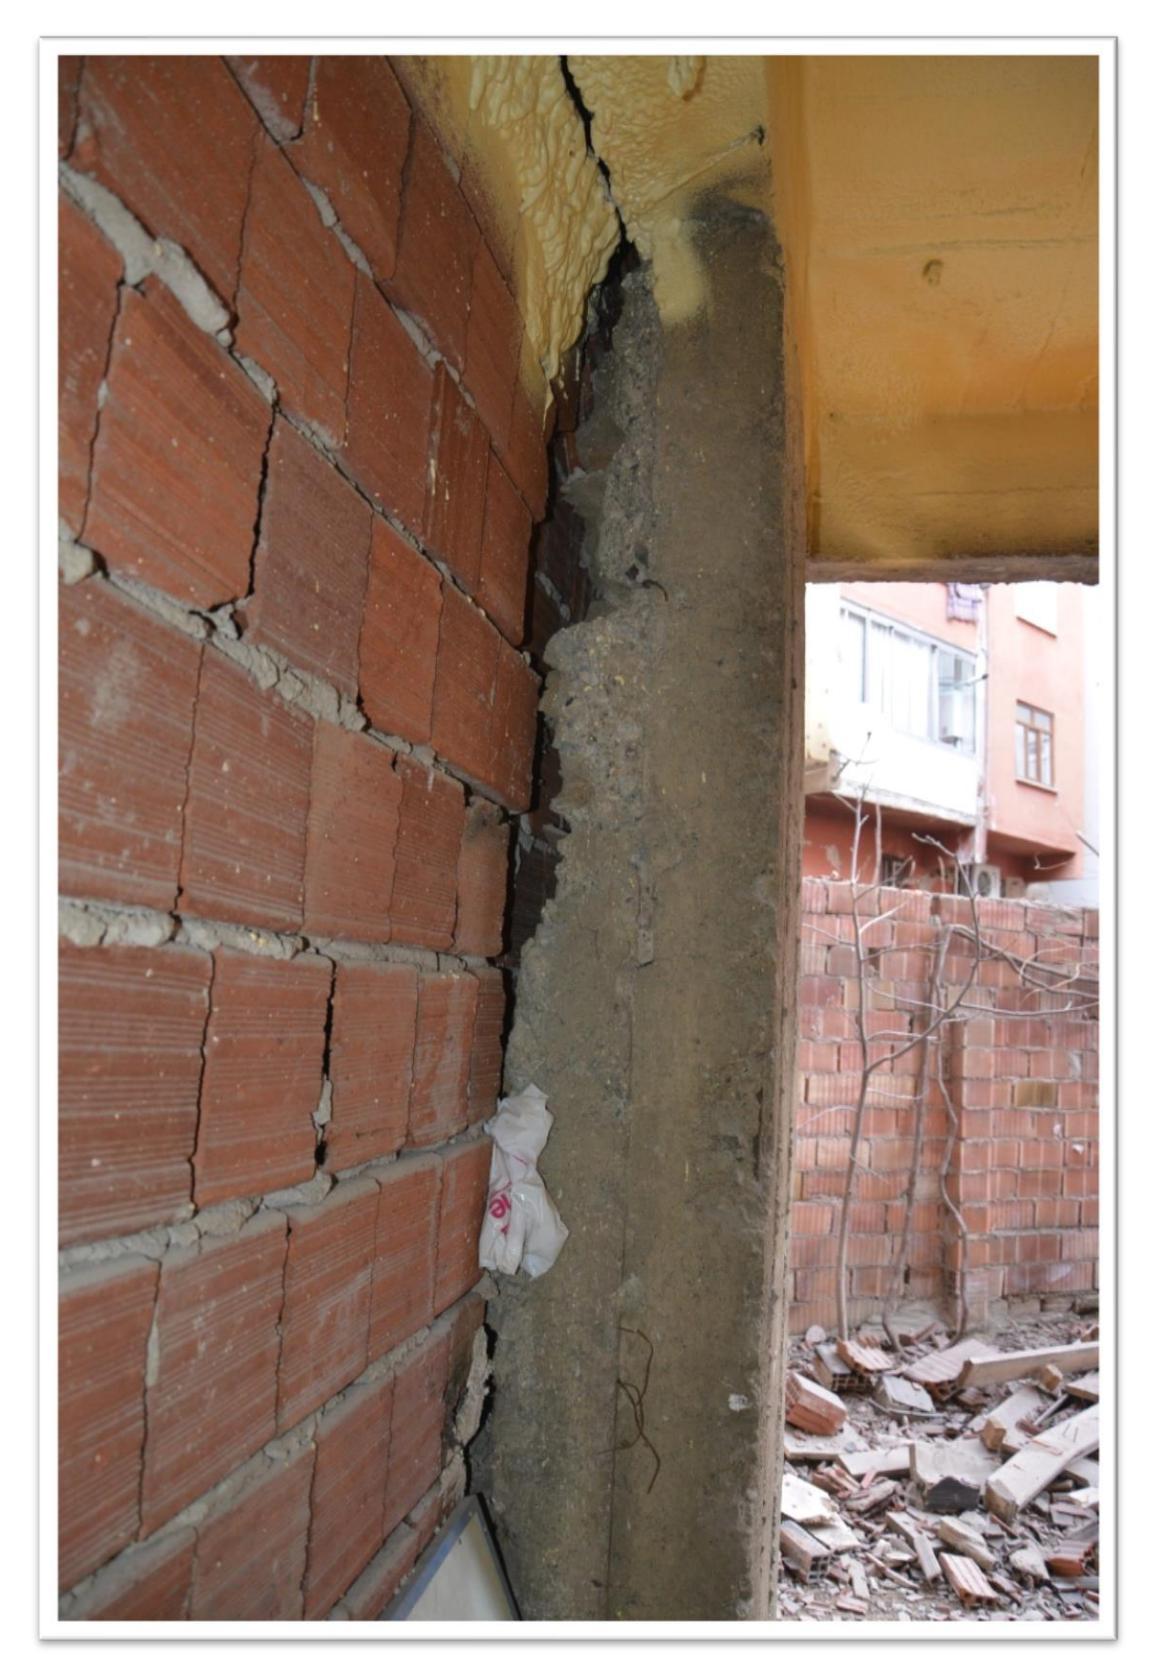
Figure 5.25 Column cast without formwork

Generally, buildings are constructed by leaving waste molds between buildings. Sometimes even the adjoining building is used as a formwork without proper formwork. Figure 5.25 shows a column cast without formwork between the adjacent building. Even the structure built later does not put up a wall but uses the wall of the next building.

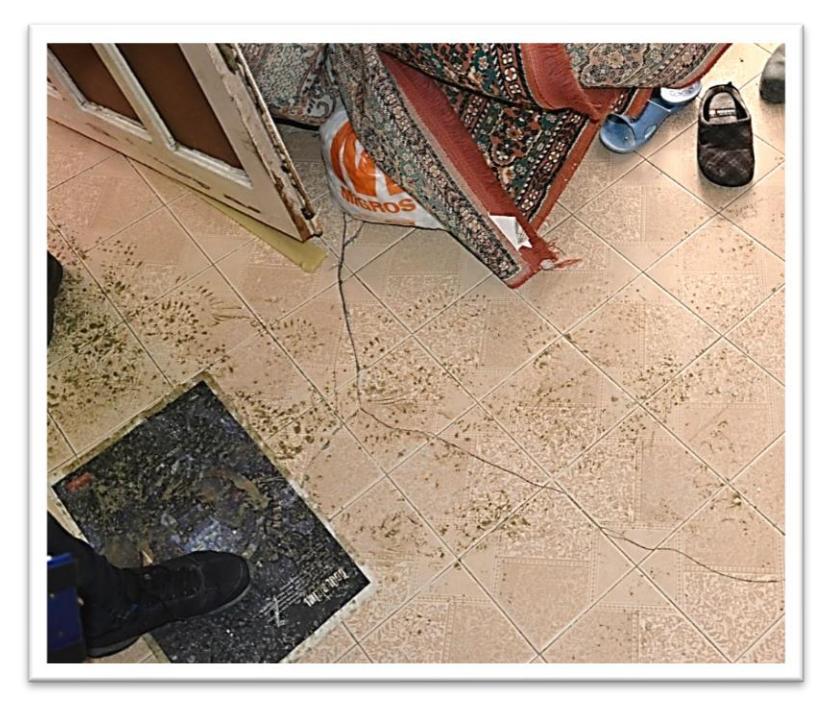
Figure 5.29 Damages caused by soil subsidence

A very limited number of soil settlements were observed after the earthquake. This damage was seen in the buildings where the ground floor was built by casting lean concrete directly onto the ground. Figure 5.29 shows the floor cracking caused by the soil subsidence. The sinking in this base floor slab sitting directly on the soil is approximately 10 cm. Figure 5.30 shows damage to the walls due to soil subsidence. Widespread heavy wall cracks due to this soil damage were observed on the ground floors of several buildings side by side, constructed in the same type.

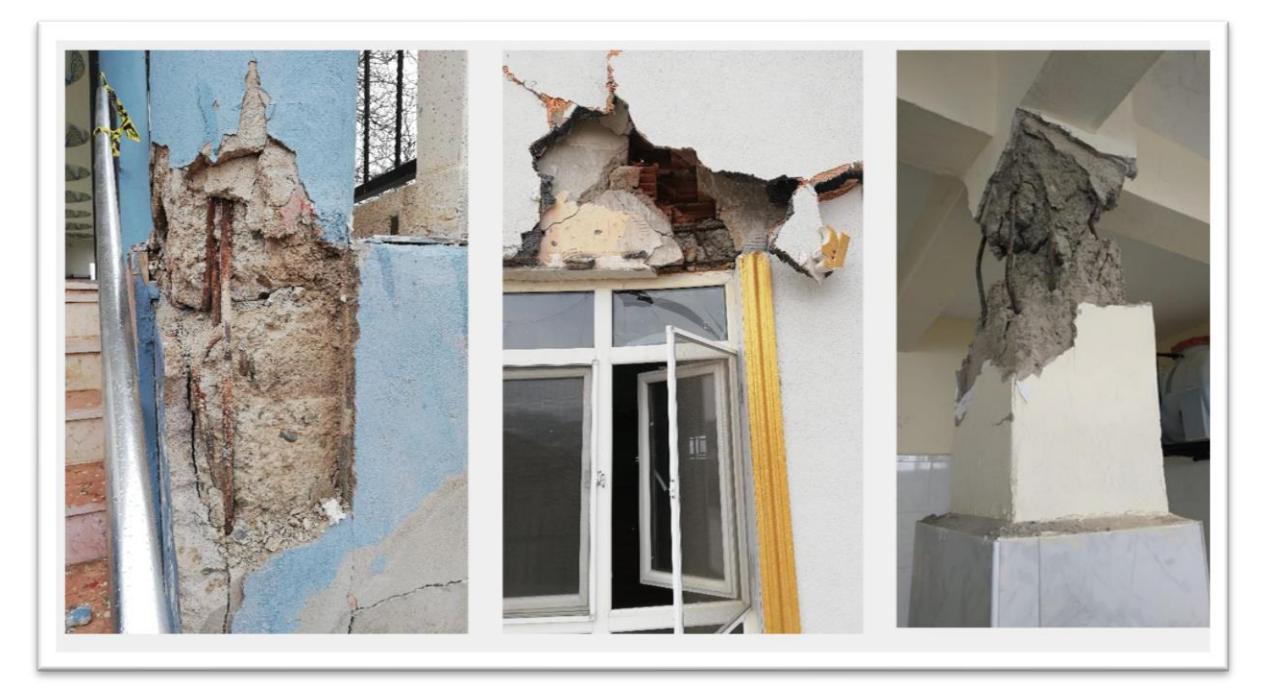
Figure 6.6 Observed damage in the Central Mosque of Sivrice

When the damaged mosque is examined thoroughly, it has been observed that the mosque possesses many structural deficiencies. The concrete strength seems to be low in all the loadbearing members (i.e. columns and beams), there is not adequate spacing between the lateral reinforcement and there is corrosion in the longitudinal reinforcement (Figure 6.6). In addition, on the basement floor of the mosque, there is heavy damage to some of the columns in terms of hinge formation at the member ends due to the short column effect (Figure 6.6).

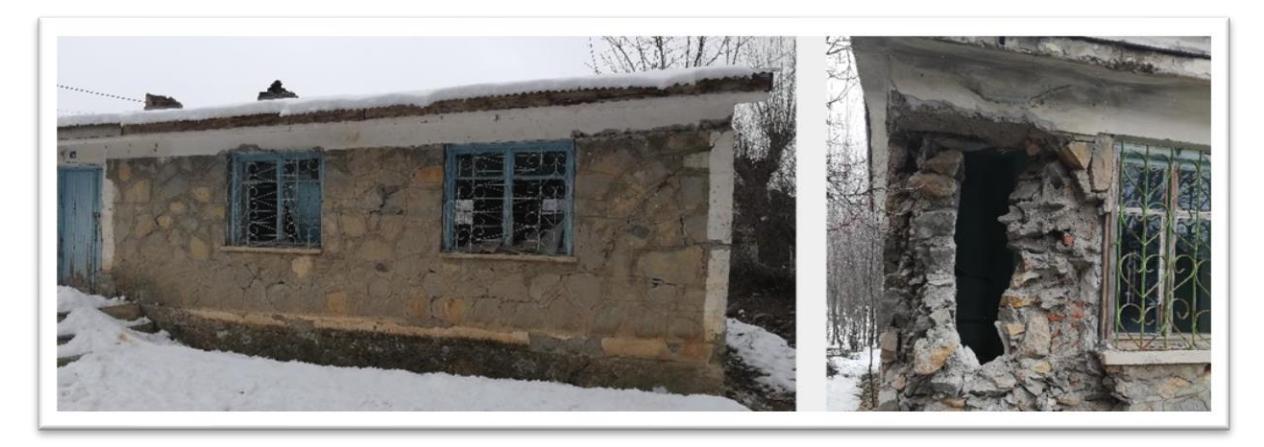
Figure 6.7 Two stone masonry buildings in Kürk village which were used as school building and its lodging in the past

Kürk village, which is located on the southeast of Sivrice, is on the north of the ruptured fault line. In the north part of the village, there are two identical stone masonry buildings, which were occupied as the school building and its lodging in the past, according to the residents of the village (Figure 6.7). The structures are very similar to the stone masonry building that was collapsed in Palu during the 2010 Elâzığ-Karakoçan earthquake (Figure 6.8). In one of these abandoned buildings, there has been a partial collapse in the corner due to poor wall-to-wall connection during the earthquake.

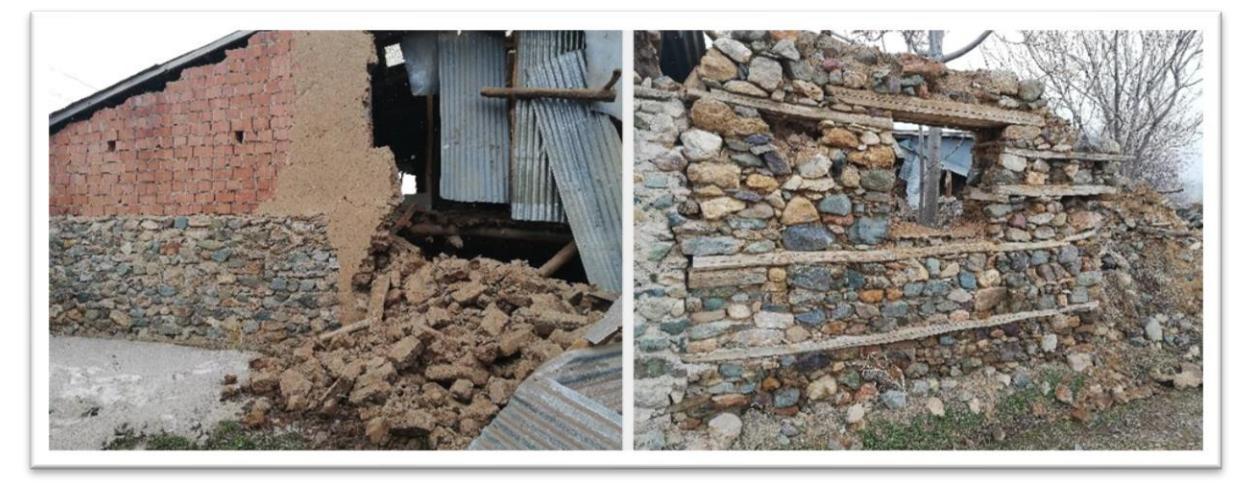
Figure 6.10 Non-homogeneous nature of the collapsed masonry walls in Kürk village

Further investigations in the village revealed that the non-engineered stone and adobe masonry buildings were generally heavily damaged or collapsed (Figure 6.9). The main reason is the low strength and quality of the masonry units and mortar that have been used to construct the load-bearing walls. In addition, the use of different materials in the same wall causes loss of integrity and homogeneity in masonry walls (Figure 6.10).

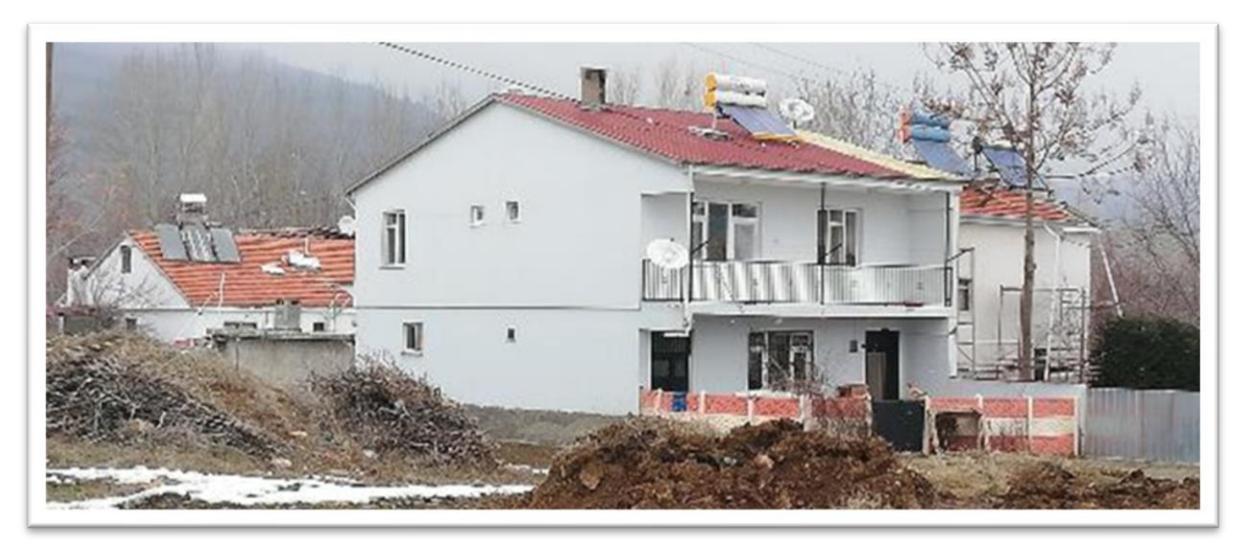
Figure 6.11 Low-rise concrete building with light damage in Kürk village

In addition to the heavily damaged and collapsed buildings in the village, there also exist lightly damaged structures (Figure 6.11). These buildings seem to have been constructed more recently, mostly by using reinforced concrete frame system. They have fewer structural deficiencies than the collapsed non-engineered buildings. This proves the observation that for structures for which seismic intensity level is almost the same, the seismic performances can be totally different depending on the structural characteristics and vulnerabilities of these structures.

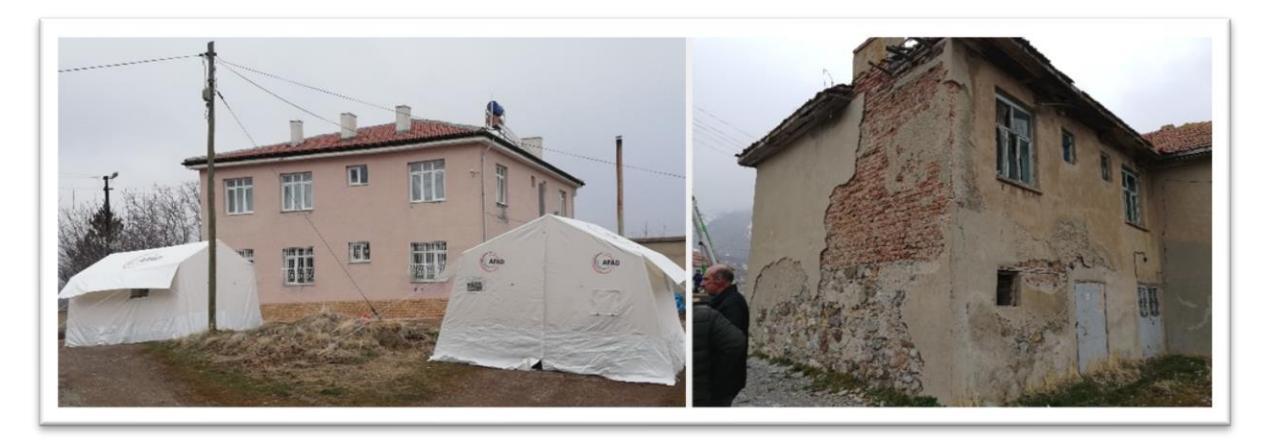
Figure 6.12 The condition of the buildings in Sanayi district after the earthquake

The field observations in Sanayi district have revealed that the structures in the region have not experienced severe damage during the earthquake (Figure 6.12). As the building quality seems to be better than the previous village investigated (i.e., Kürk village), the buildings have mostly experienced light damage. One of the most critical damage is the fall of the top of the minaret in the mosque, as seen in Figure 6.13.

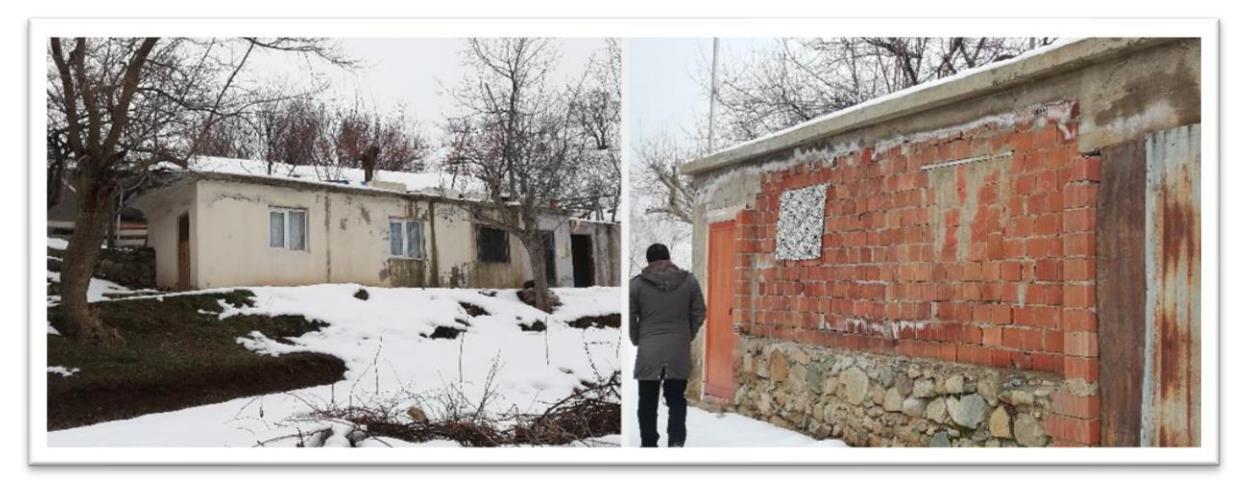
Figure 6.14 The condition of the buildings in Akpınar village after the earthquake

Akpinar village is located close to Sivrice sub-province, just like Sanayi district, but at a higher elevation. The building stock in this village is composed of single-story masonry buildings (Figure 6.14). Some of these structures, which have been built with stone and adobe units as masonry material, have experienced damage during the earthquake. On the other hand, brick masonry structures are observed to have better performance in this village. It should also be mentioned that there are no completely collapsed buildings in Akpinar.

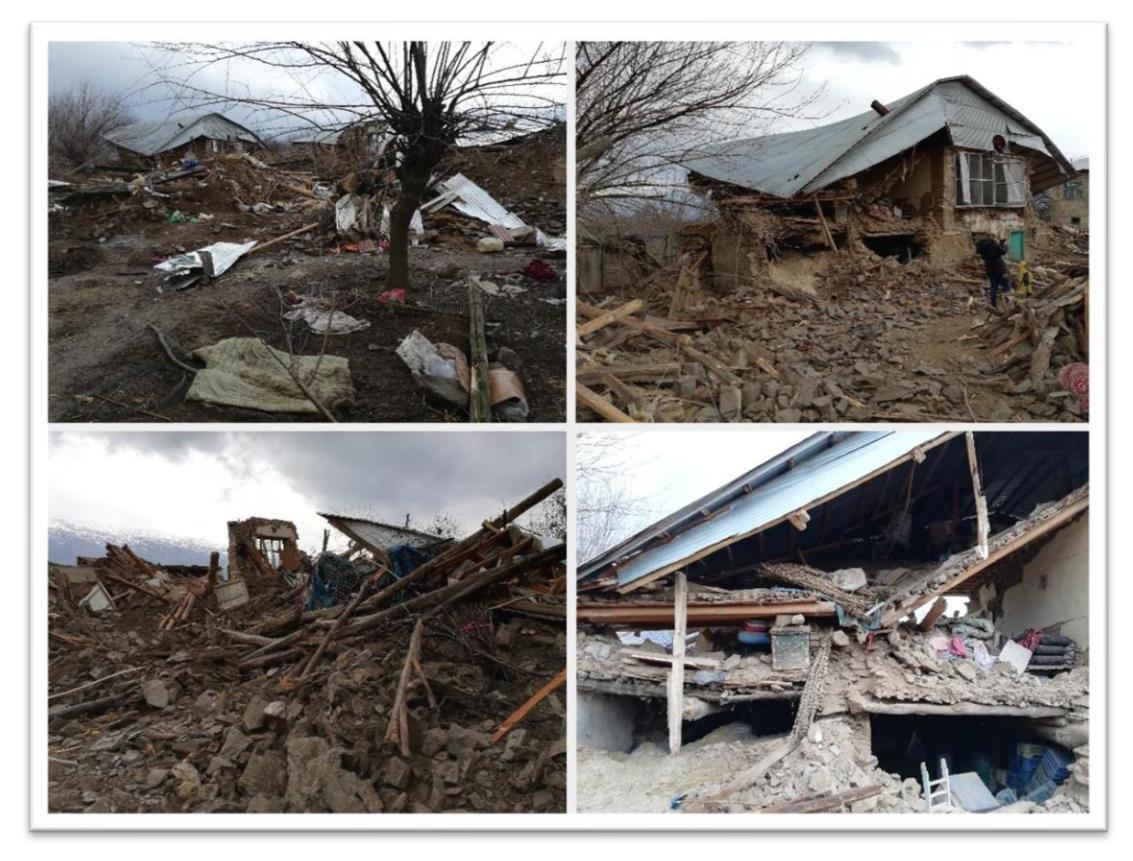
Figure 6.21 Completely collapsed buildings along the riverside in Çevrimtaş village

Cevrimtas village is the closest residential area to the epicenter of the earthquake along the fault line. The village is located in two regions: along the riverside and along the hillside (Figure 6.20). Although the distance between these two districts is at most 300-400 meters, the damage distribution is totally different. All the structures along the riverside were collapsed, and people lost lives (Figure 6.21). However, it is possible to encounter buildings with varying states of damage (light, moderate, severe damages and collapse) along the hillside (Figure 6.22). No casualties were reported in this district. A comparison of the structures in these two districts (riverside and hillside) reveals that they have very similar structural properties but totally different performances during the earthquake. The main reason is that the buildings along the riverside are very close to, probably just on the fault line, whereas the ones along the hillside are a little bit far away from the fault line. The total devastation of structures only on the fault line has already been experienced in past major earthquakes, particularly the 17 August 1999 Kocaeli earthquake. Such observations in this earthquake as well as in past earthquakes encourage taking measures about a safety area along the fault line on which no construction is allowed. In addition, the ruins close to the riverside district prove that once the village had been constructed in a nearby location but then it had been abandoned, probably after another major historical earthquake (Figure 6.23).

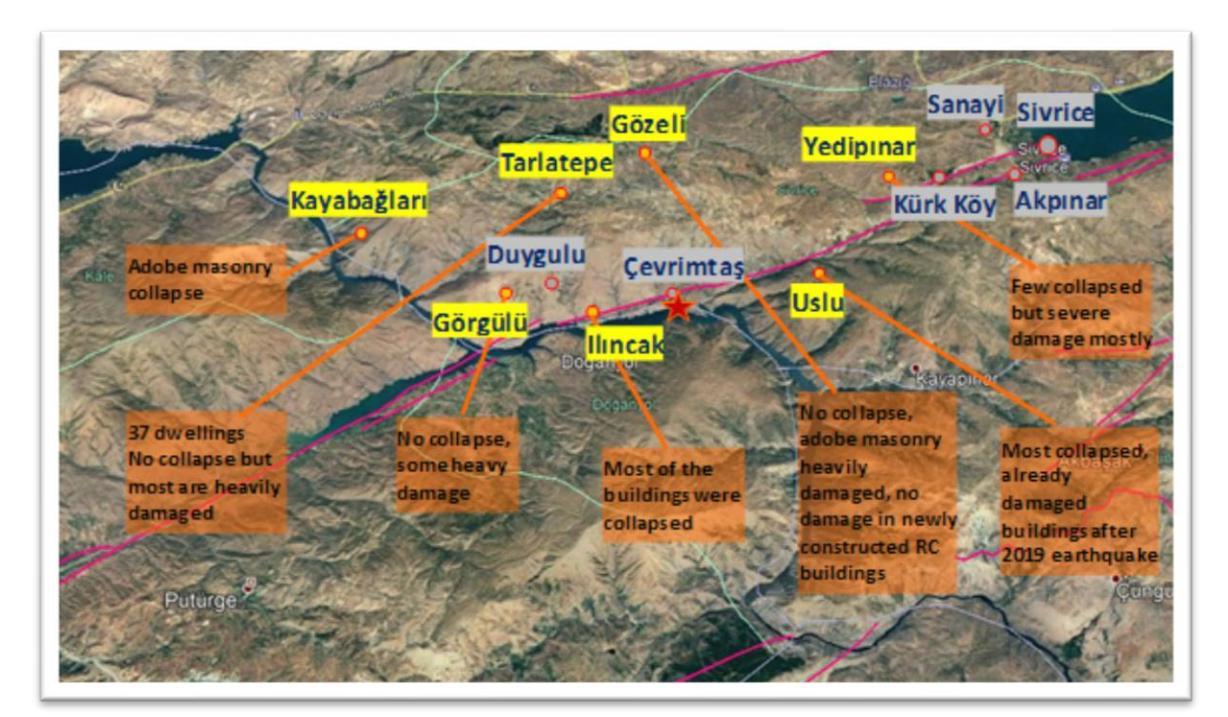
Figure 6.24 Damage distributions in some of the villages near the fault line

The limited information regarding the damage distribution in some of the nearby villages in addition to the ones that have been investigated in detail, as explained in the above sections, is presented in Figure 6.24. The supplied data reveals that the damage increases getting closer to the fault line, and the epicenter of the earthquake, stone, and adobe masonry structures have generally experienced severe damage and collapse, whereas brick masonry and concrete structures have responded to the earthquake with better performance.

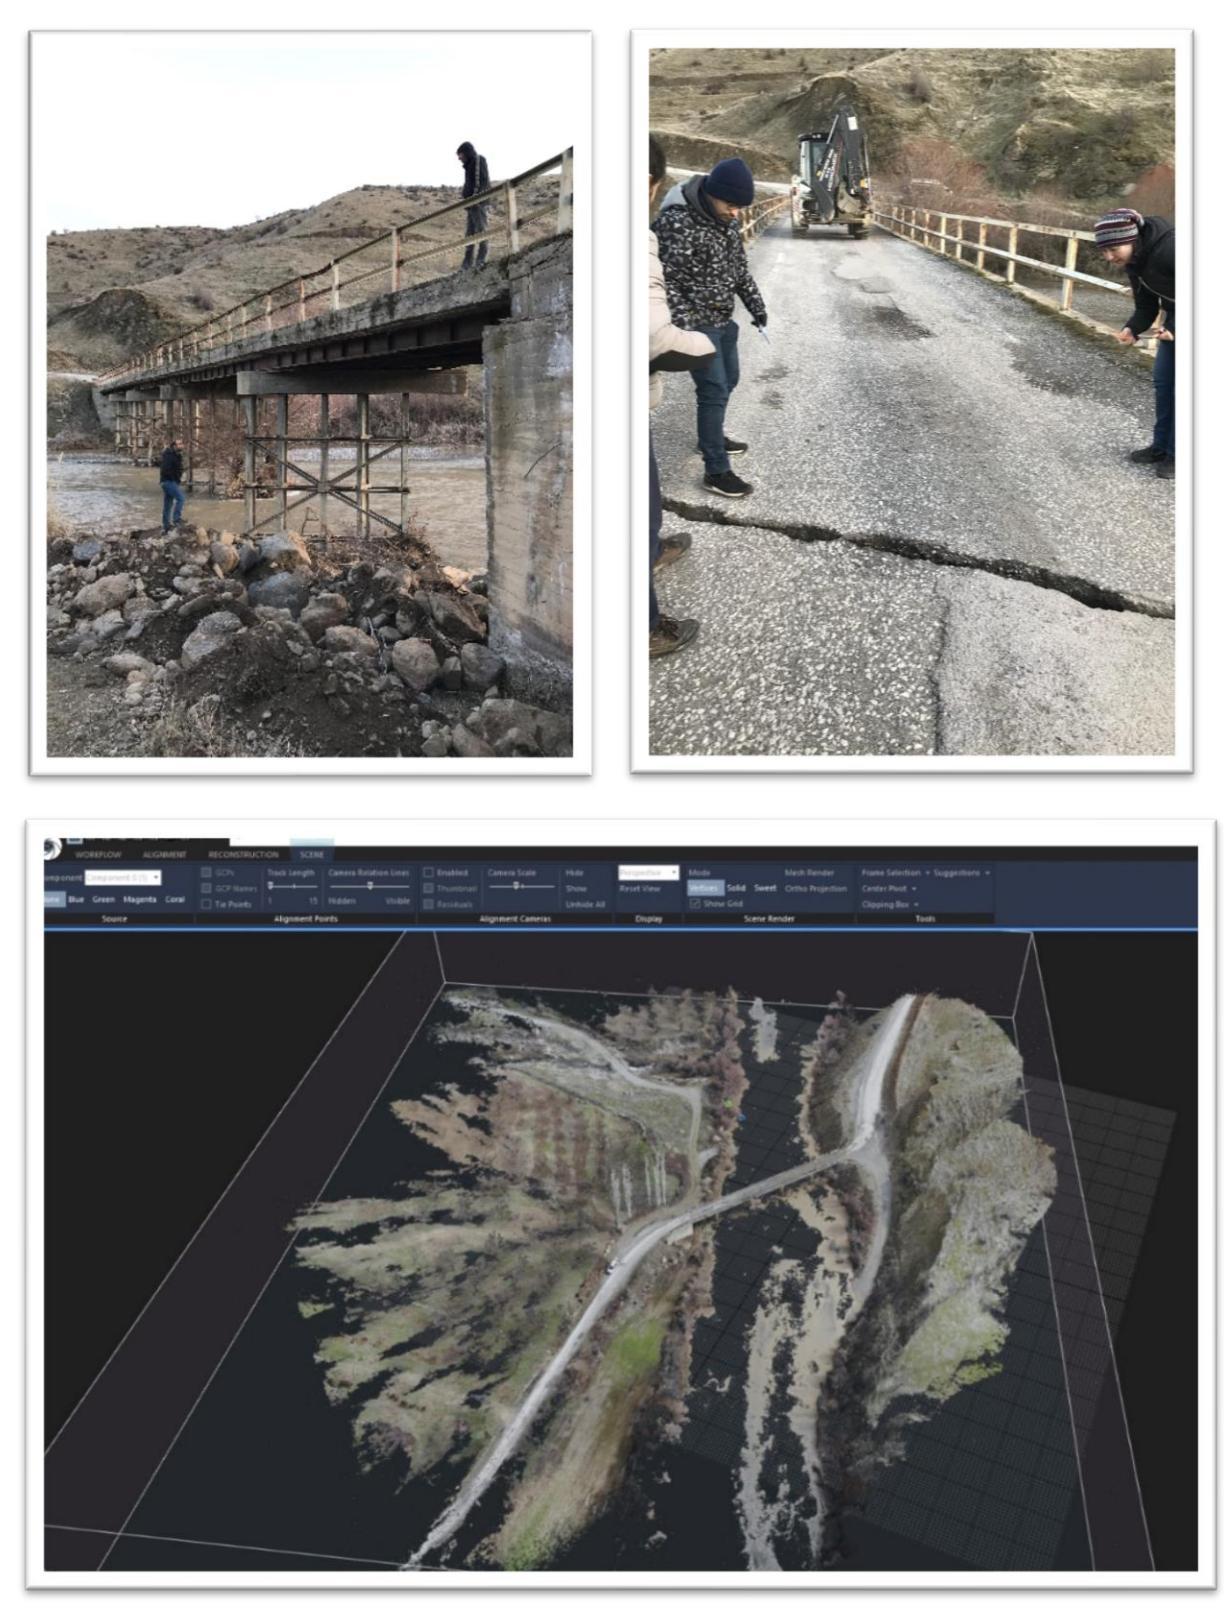
Figure 7.5 Steel composite village bridge (distance to epi-center: 19.7 km, distance to fault line < 1 km)

A village bridge very close to the Talis Bridge has a steel composite superstructure. The bridge had been observed to have a relative movement at the abutment of about 10 cm. The bridge is believed to be constructed around 1950's. Each pier has five steel columns and the last column at each pier has a rotation about its vertical axis. Based on the age of this bridge, total replacement can be considered instead of a repair. The bridge was still under service at the time of the visit as shown in Figure 7.5. Drone flies has been conducted around the bridge to develop a digital map to measure dimensions and distances.

- Out of 19 bridges, 17 of them has no damage at all. One slender bridge in the vicinity of the fault line by 1 km, has a relative movement of the superstructure at the abutment. The movement has not been tried to be restrained by shear keys as designed in modern bridges. A modern highway bridge about 20 km from the epi center of the earthquake has a crack at its shear key at the abutment due to lack of sufficient gap between girder and shear key. Most likely, if the gap was larger no damage will be observed during the earthquake. At each pier, there are five steel columns and the last column at each pier had a rotation about its vertical axis. Such a rotation can develop due to a past flood or current earthquake

- For aged bridges such as the steel village bridge, replacement may be the best option rather than trying to retrofit or repair them.
- In the Van Earthquake 2011, M<sub>w</sub> 7.1, the bridges around Van also satisfied the immediate use performance. Perhaps one of the main reasons, bridges did not subject to major damage is they are more engineered compared to buildings. One other reason may be some movement is usually allowed between the superstructure and substructure thru bearings that gives some mechanical flexibility to the system. In building structures most of the flexibility is based on ductility of the framing system that can easily get damage during earthquake.

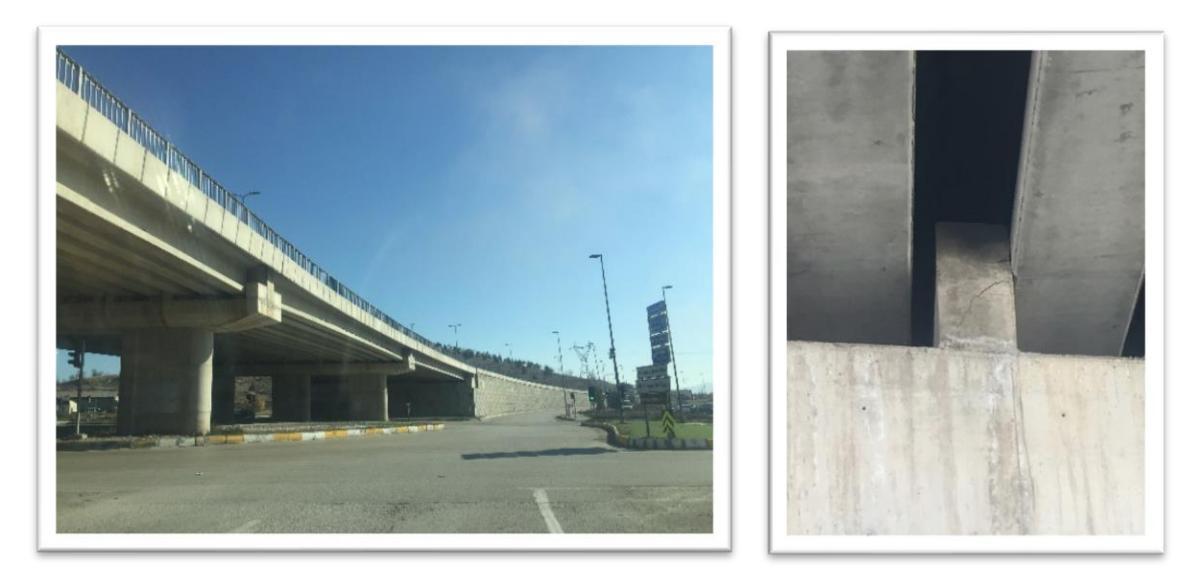
Figure 7.7 Typical Elâzığ city bridge (distance from epi-center: 35 km, distance to fault line: 19 km)

In the city of Elâzığ, there are couple of bridges and overpasses. Construction of precast girder on slab bridges are very common in the city very similar to the construction practice in Turkey. In one of the bridges, the shear key at the abutment has cracked due to close gap between girder and shear key as shown in Figure 7.7. As known in bridge engineering practice, these shear keys restrain the transverse movement of the bridge. Some of these bridges has reinforced earth system at their abutments and approaches. These soil retaining structures has observed to be functioning perfectly.
