A REPORT ON THE 19 MAY 2011 KÜTAHYA-SİMAV EARTHQUAKE (PRELIMINARY REPORT)

REPORT NO: METU/EERC 2011-02

JUNE 2011 ANKARA

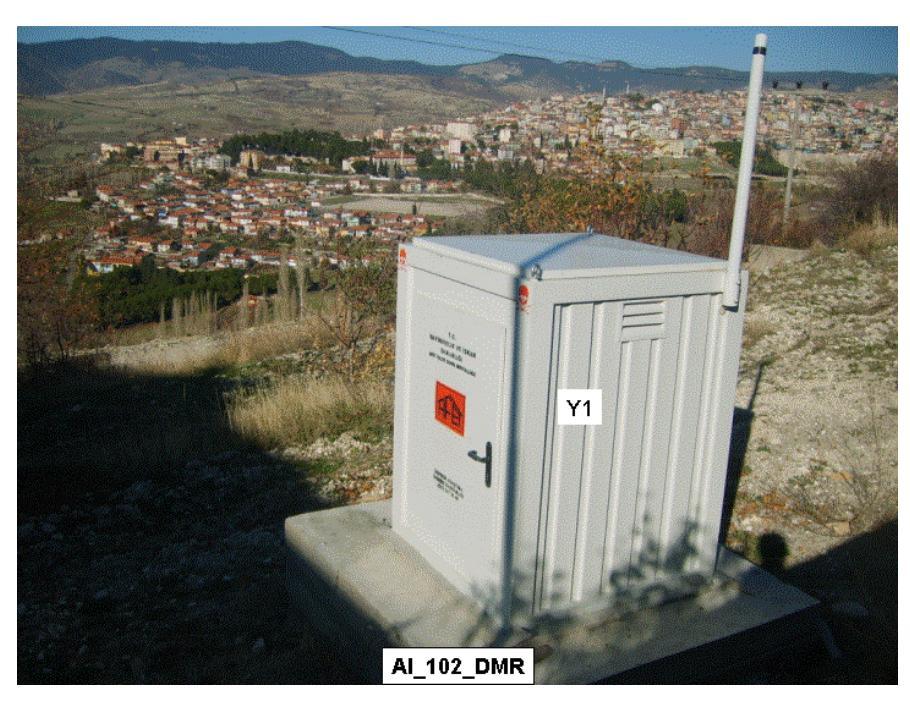
Unusually high peak ground acceleration of this recording that is recorded approximately 35 km from the ruptured fault led additional analysis to investigate the nature of this high frequency peak. This accelerogram was recorded at a free-field station deployed on a slopy hill as shown in Figure 8. The shear-wave velocity profile reaches about 475 m/s at depth greater than 30m (Figure 9) and suggests that the station is deployed over a relatively soft soil deposit (VS30=336 m/s). In order to observe the frequency content of this recording, the smoothed Fourier acceleration spectra (FAS) of horizontal and vertical components are calculated by applying Konno-Omachi smoothing procedure (provided in the public-open codes of Dr. David M. Boore, USGS Menlo Park California) as shown in Figure 10. The FAS trends of the 3 components are fairly the same except for the observed peak in the EW component around 8 Hz. In order to understand the influence of this frequency component about 8 Hz, the EW component is filtered with a series of hi-cut values (30 Hz, 20 Hz, 10 Hz

and 8 Hz). The resulting change in the peak acceleration is given in Figure 11. The amplitude of peak reduces significantly between 20 and 10 Hz hi-cut filter values. This can be interpreted as the significant contribution of the 8 Hz peak to the observed 0.8g peak in this component. The pedestal or the specific topographic features of the strong-motion site can play a role in this unusual peak. This will be investigated in the final version of this report.

Figure 8. A view of the free field station of Demirci Station

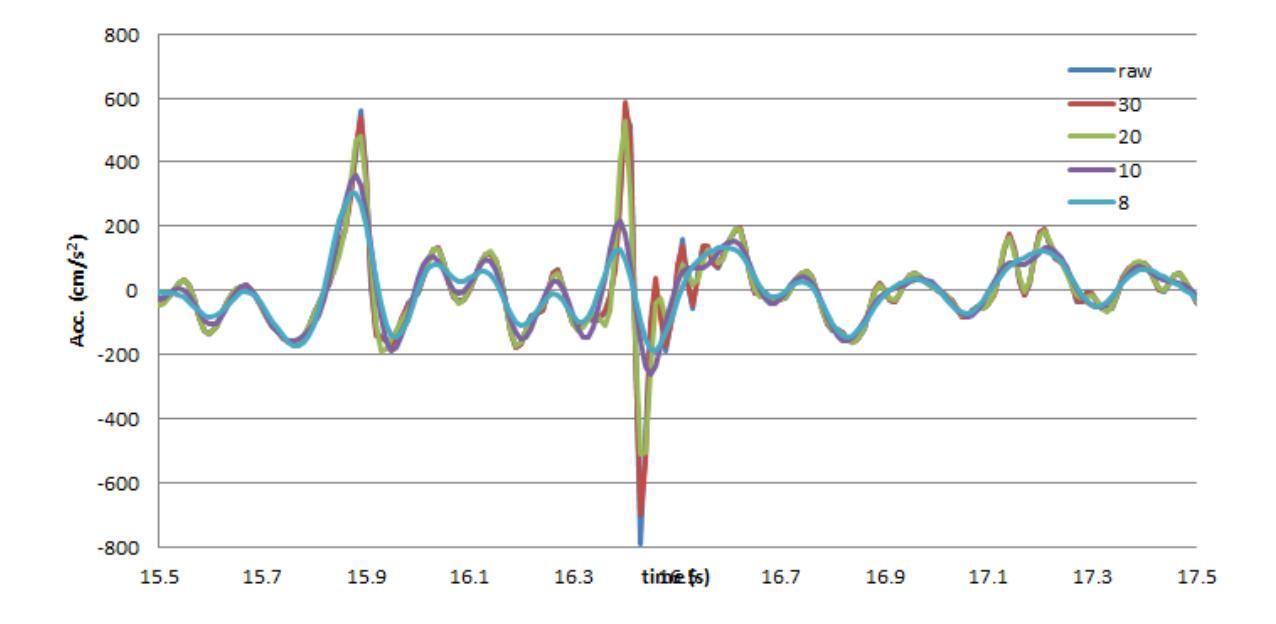
Figure 11. The acceleration time series of the EW component of the Demirci record for different hi-cut values

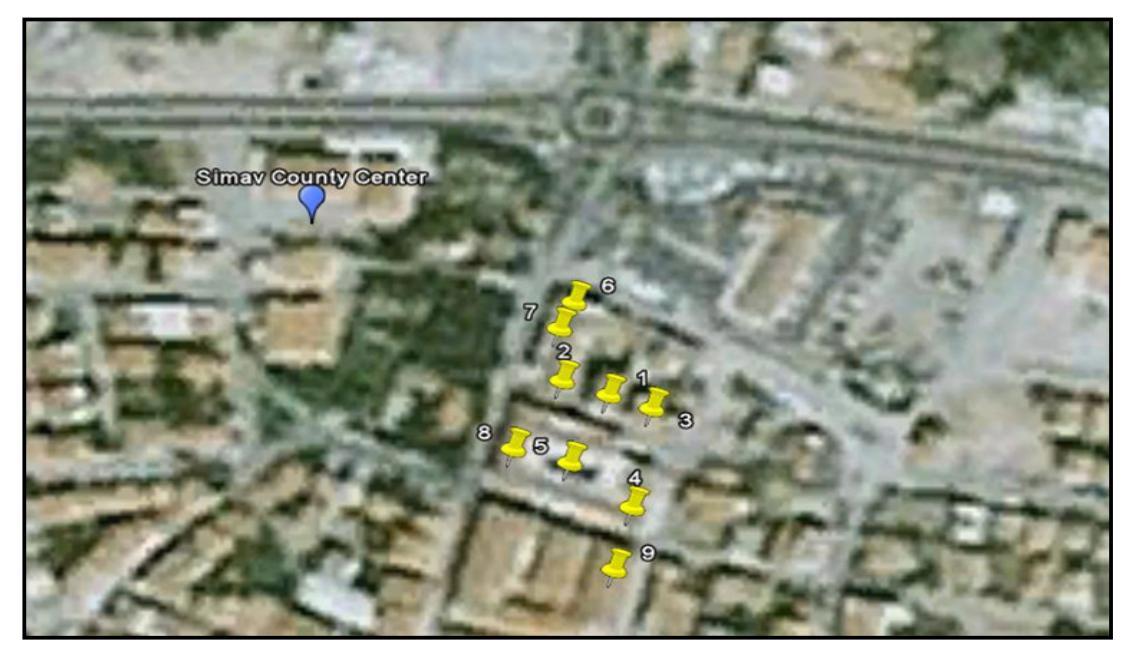
Figure 13. Map view of the buildings investigated in Simav county center

The site survey in Simav city center revealed that majority of the buildings had structural and/or non-structural damage. The main reasons of observed damage may be stated as structural system and member deficiencies, and fragility of the infill walls. Soft story formations and inadequate gap between buildings (i.e. to prevent pounding effect) are among the major structural deficiencies, as noticed by the first investigation of the damaged buildings from outside. The dense settlement in the city center and usage of the first stories as shops or stores (i.e. taller first stories and disuse of walls for exterior cladding) may be regarded as the reasons of these deficiencies. The soft stories caused by higher first floors and disuse of infill walls for exterior cladding may contribute to the extensive damage in the entrance level of these buildings. Such a building is presented in Figure 14. Although the building seemed to be undamaged from outside, wide shear cracks were observed on the first story columns, which had inadequate transverse reinforcement (Figure 14.b and 14.c).

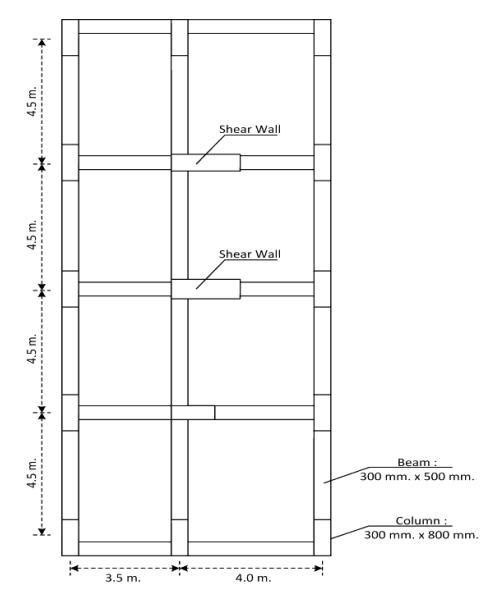
The most crucial structural system deficiency of "Building 1" was the arrangement of columns. As illustrated in Figure 18, the strong axes of all columns are in one direction only (i.e. parallel to each other). Therefore, the building did not have sufficient stiffness and strength to sustain the lateral earthquake demands in the short direction, resulting in total collapse. In order to mention the importance of this deficiency, the structural plan of another building (i.e. "Building 2"), which is located 10 m away from "Building 1" and had almost no structural damage due to earthquake, is presented in Figure 19. When structural plans of these two buildings are compared, it may be observed that "Building 2" has shear walls

located in the short direction. The light damage experienced by "Building 2" with a minimum shear wall ratio indicates the significance of walls in providing structural safety.

Figure 19. The Structural plan of "Building 2"

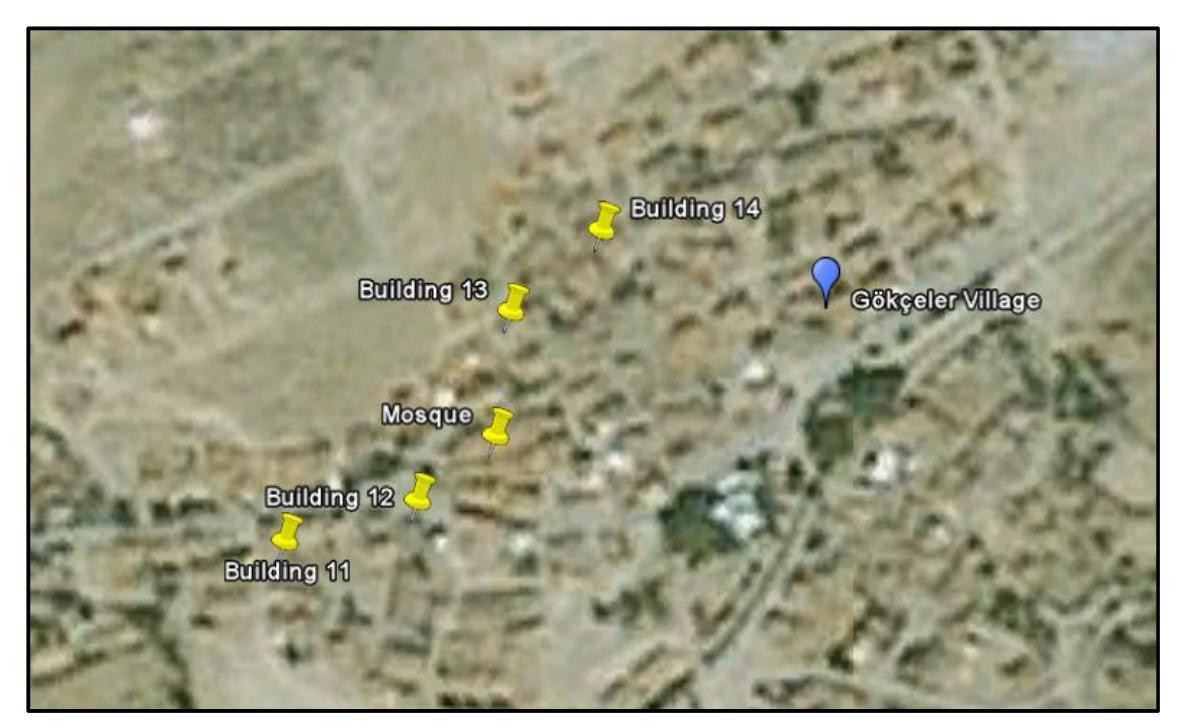
Figure 23. The map view of the buildings in Gökçeler village

Gökçeler village is approximately 6 km away from the epicenter of the earthquake. After the first survey in the village, it was reported that 158 of 208 buildings in the village were damaged due to earthquake. The reason of this high damage ratio is the poor masonry construction of buildings in the village. The most significant damage was observed in some old and abandoned masonry buildings. The map locations of the buildings which experienced moderate or heavy damage are presented in Figure 23. The GPS coordinates and damage state of these buildings are also provided in Table 5.

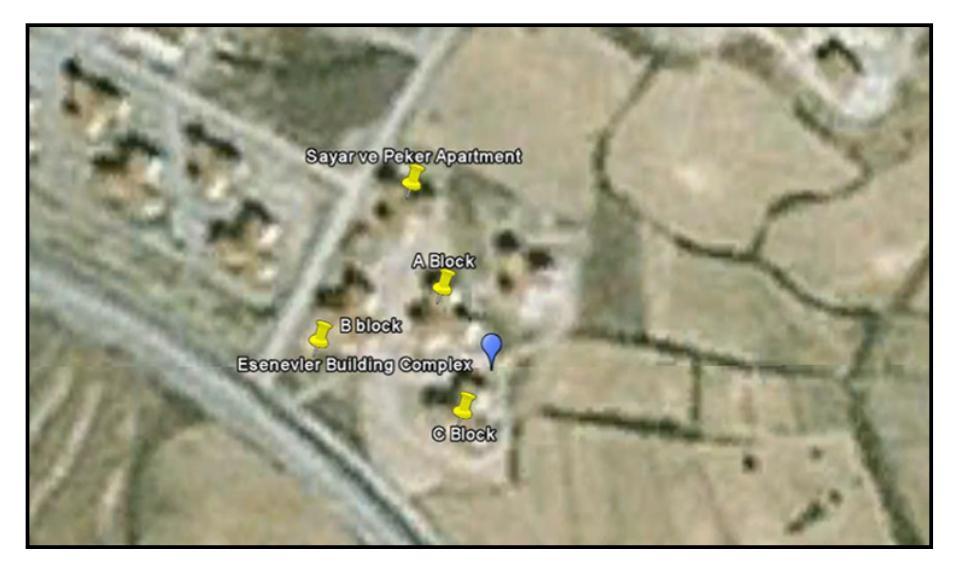
Figure 26. The map view of buildings in Esenevler building complex

The eight-story reinforced concrete buildings of the complex, which were constructed between 1995-99, are considerably less damaged compared to the other buildings in other districts of Simav. During the survey, it was deduced that the code regulations were mostly applied during the design and construction stages of the buildings. All buildings had shear walls as lateral load carrying systems which has cross-sectional dimensions of 250 mm x 1250 mm. The occupants who were present during the construction of buildings indicated that the lateral reinforcement spacing was decreased at both column critical ends (i.e. having a spacing of 100 mm). It was also stated that ties were provided at the beam-column joints. The major observable deficiency of the buildings was the use of plain rebars for both longitudinal and transverse reinforcement. Another observation was that poor plaster and infill wall quality. This may be observed as fallen-off plasters in large areas (Figure 27.c). These non-structural damages not only caused a psychological effect on the occupants but also resulted in incursion in their living spaces. Therefore, some of the occupants did not want to go into the buildings even there were no structural damage.
