MIDDLE EAST TECHNICAL UNIVERSITY
EARTHQUAKE ENGINEERING RESEARCH CENTER

**THE OCTOBER 30, 2020
İZMİR-SEFERİHİSAR OFFSHORE (SAMOS)
EARTHQUAKE ($M_w=6.6$)
RECONNAISSANCE OBSERVATIONS
AND FINDINGS**

REPORT NO: METU/EERC 2020-03

**NOVEMBER 2020
ANKARA**

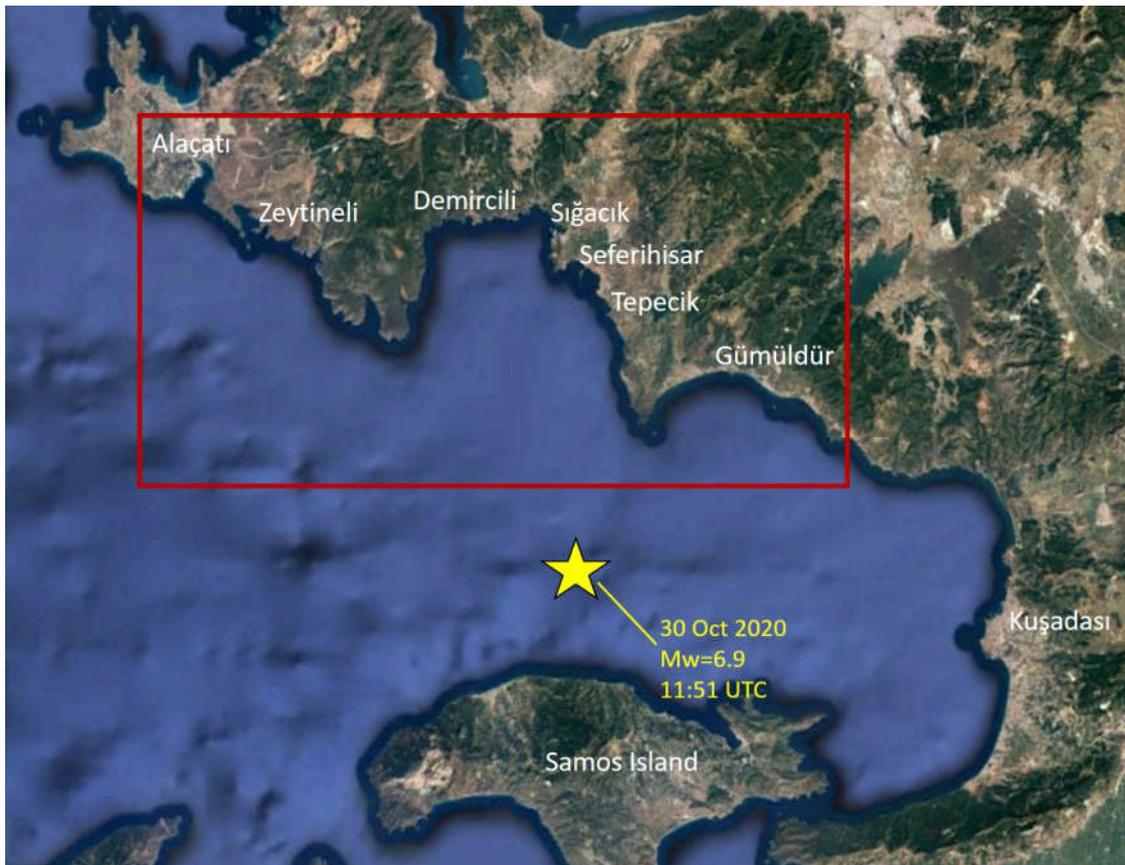
Fig 4.2 shows the survey area covered by the team, where the survey locations eyewitnesses were inquired, local authorities were contacted, measurements were taken, and observations on the tsunami waves and audiovisual recording were performed.

Fig 4.2 Post-tsunami field survey area where observations of tsunami waves were obtained from locals, debris or traces identified

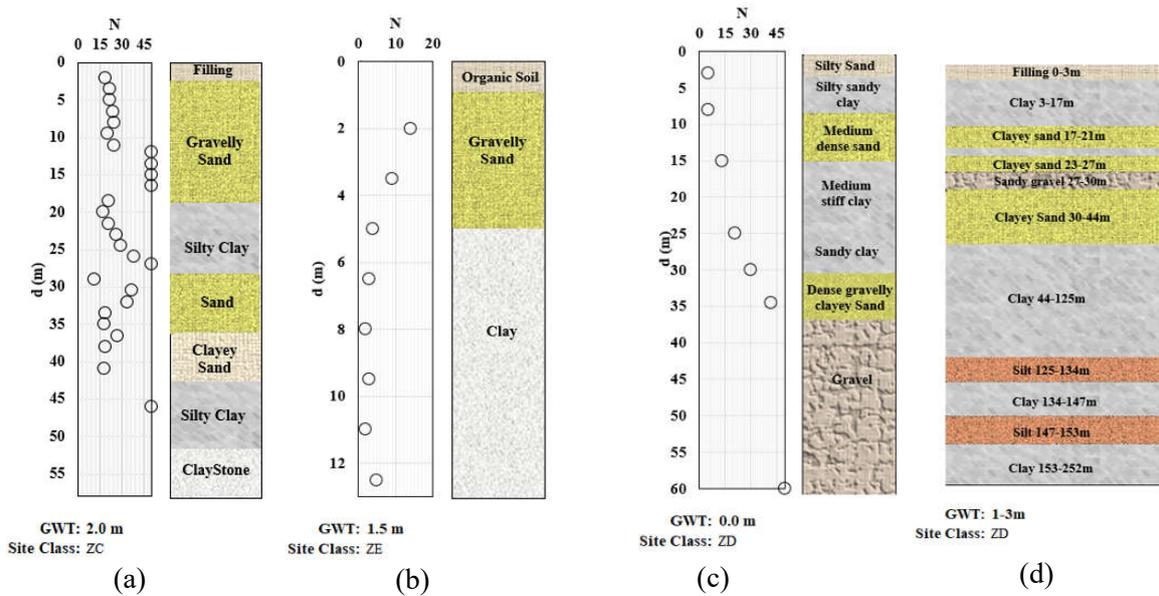
For the purpose of assessing local soil site conditions, Fig 5.4 is prepared, which presents typical borelogs from selected residential districts. Deep alluvial soil layers underly residential structures at Bayraklı, Bornova and Mavişehir Districts.

Fig 5.4 Typical borelogs from selected residential districts a) Gümüldür, b) Sığacık-Seferihisar, c) Mavişehir and d) Bayraklı

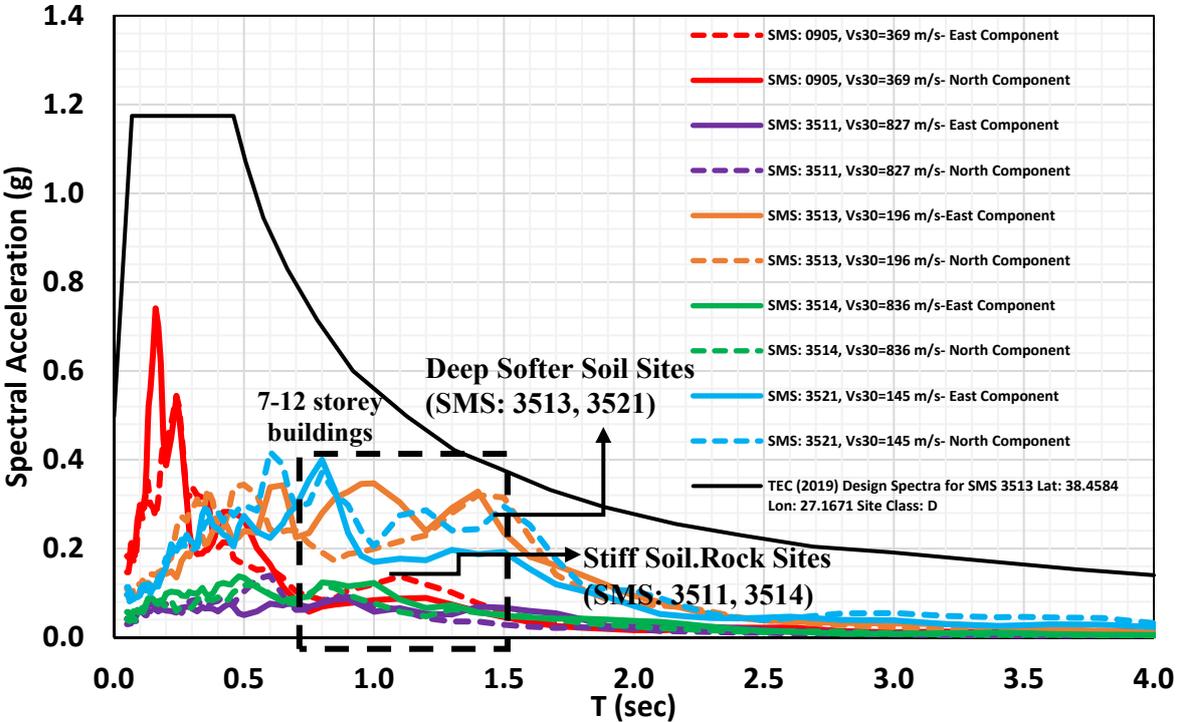
Surprisingly, at approximately 70 kilometers away from the source of energy release, deep soil sites at Bayraklı and Bornova districts were observed to be shaken by long period excitations approximately two to five times the intensity of a shallower stiff soil or rock site. This is illustrated by Fig 5.5. This, 2-5 times increased demand in higher periods due to local soil site effects resonated 7-12 story residential buildings, which is judged to contribute to the observed increased structural damage levels at deep alluvial soil sites (e.g.: Bayraklı and Bornova districts) accompanied by poor structural design, construction and detailing practices. It should be noted that the soil profile in Bayraklı consists of deep alluvial deposits, more specifically, of alternating thin gravel, silty sand, silty clay and clay layers, with SPT-N values less than 30 blows/30 cm in the upper 200 m. The groundwater table in Bayraklı is at 1-3 m depth. The depth to engineering bedrock layer is documented to vary in the range of 1100 m to 1200 m (Pamuk vd., 2017)

Fig 5.5 Elastic response spectra of select strong ground motion records

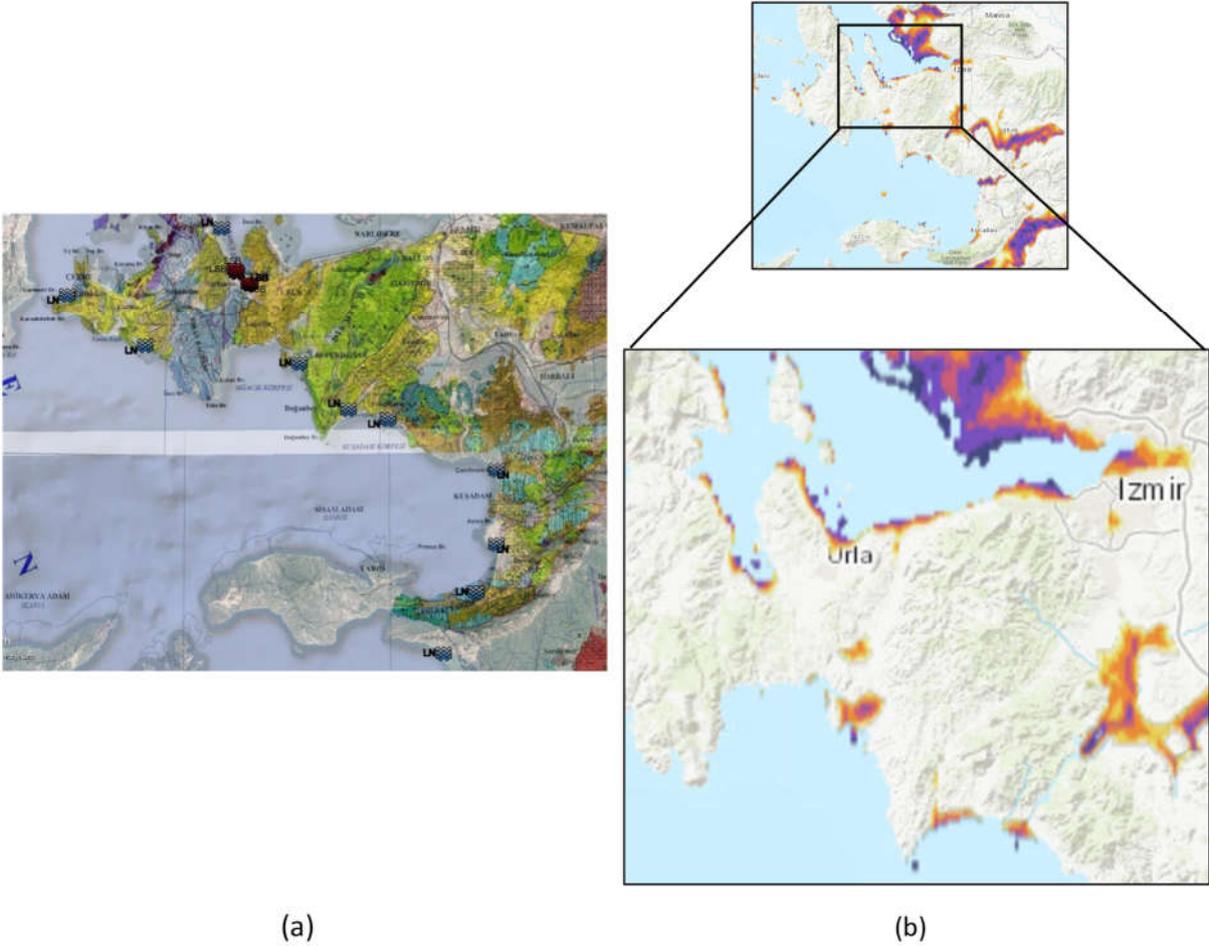
Potentially liquefiable alluvial basins are shown in Fig 5.6a. These regions are visited by the reconnaissance teams. Despite event specific liquefaction triggering predictions of the USGS as shown in Fig 5.6b, no surface manifestation of seismic soil liquefaction was seen at these basins located in the south of Seferihisar (Fig 5.7a). However, consistent with USGS predictions, at 45-50 kms away from the zone of energy release, along the shores of İçmeler and Gülbahçe districts, sand boils were observed (Fig 5.7b). These sites were in close proximity to Gülbahçe fault zone, and artesian pressures along with hot water springs are known to be present, which are also believed to contribute to the observed soil liquefaction triggering. The soil samples were retrieved from sand boils and soil ejecta, and they are to be tested at Civil Engineering Department Soil Mechanics laboratory at Middle East Technical University.

Fig 5.6 a) Potentially liquefiable alluvial basins and b) liquefaction hazard map released by USGS after the event

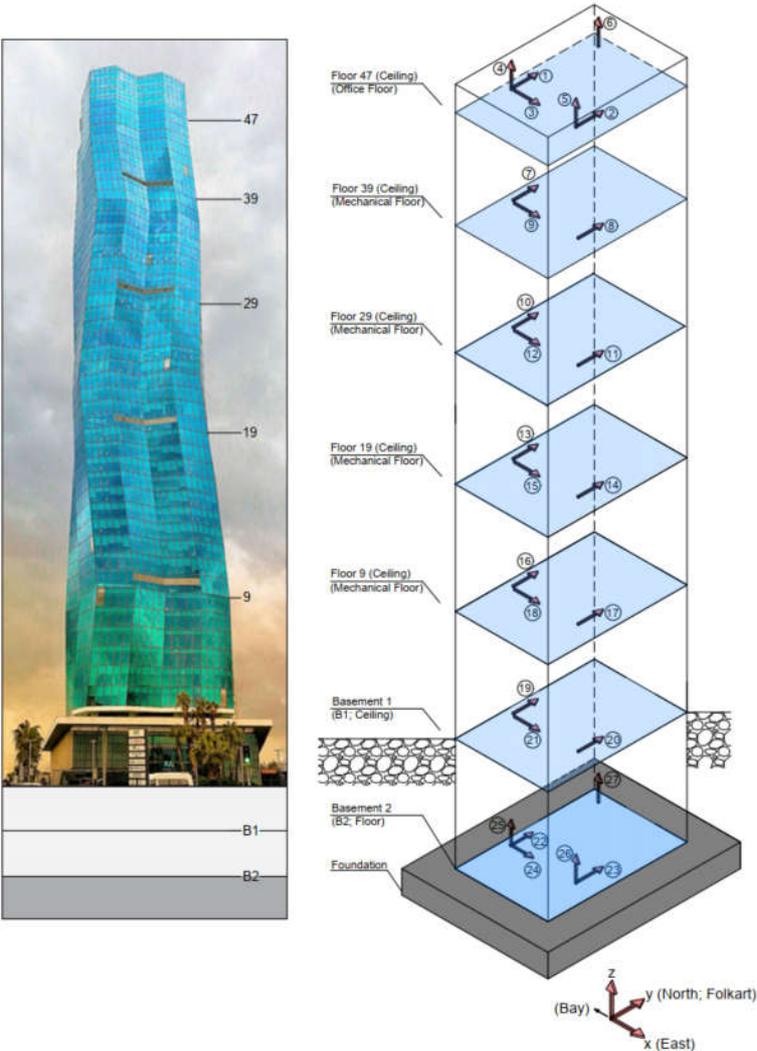
Fig 6.13 Instrumentation scheme

The tallest building in İzmir, the 216 m tall 48-story Mistral İzmir Office Tower in Konak district, has been monitored since January 27, 2019 within the scope of a research project entitled “Guidelines for Structural Health Monitoring Systems on Tall Buildings and a Case Study,” which is undertaken at METU and funded by the Disaster and Emergency Management Presidency of Turkey (AFAD) under its National Earthquake Research Program. The building was permanently instrumented with a 27-channel structural health monitoring system (Fig 6.13) and vibration records from the building and seven AFAD strong motion stations in the vicinity of the building have been streamed in real time to METU (Gumus and Celik, 2019). Recorded floor accelerations and calculated floor displacements during the M_w 6.6 İzmir Seferihisar (Samos) earthquake (30.10.2020 14:51:24) are presented in Fig 6.14. The maximum floor acceleration is 0.28 g at the 48th floor and 0.11 g at the second basement while the maximum displacement is 16 cm at the 48th floor. No damage was reported, and the building is in continued use following the earthquake.

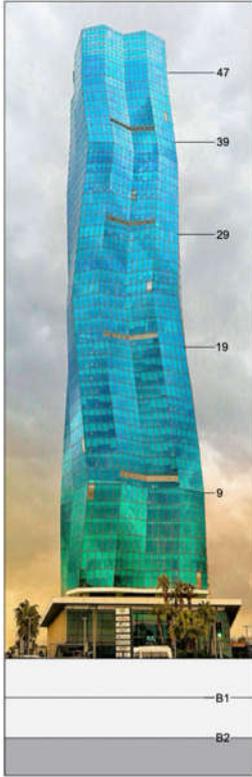
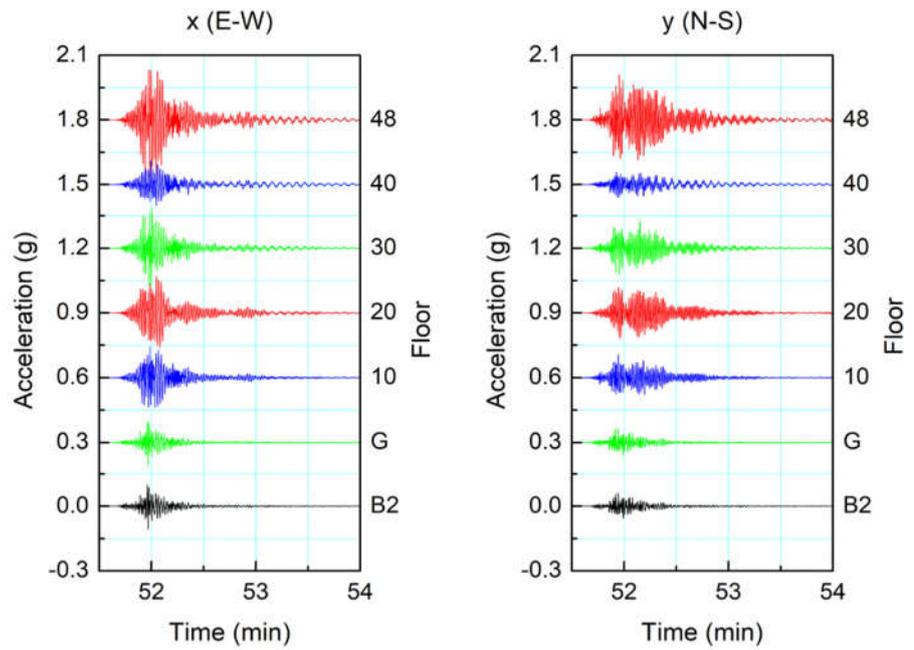
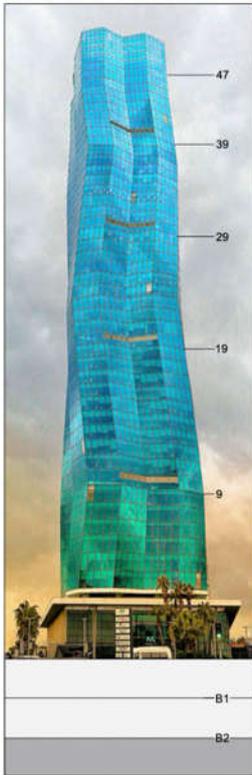
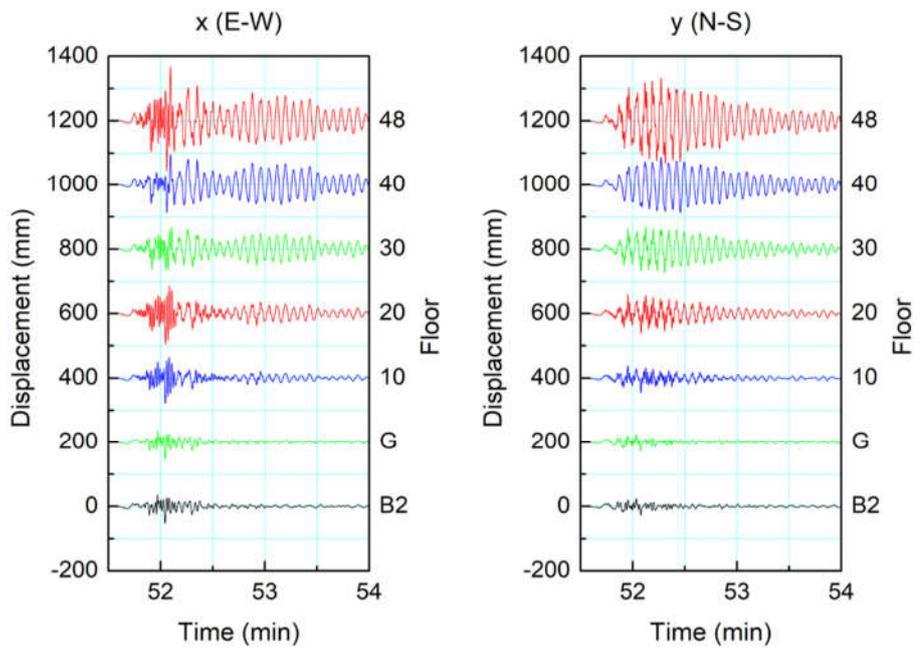
Fig 6.14 Floor accelerations and displacements

Max acceleration: 0.28 g (48th floor), 0.11 g (2nd basement)

Max displacement: 16 cm (48th floor)

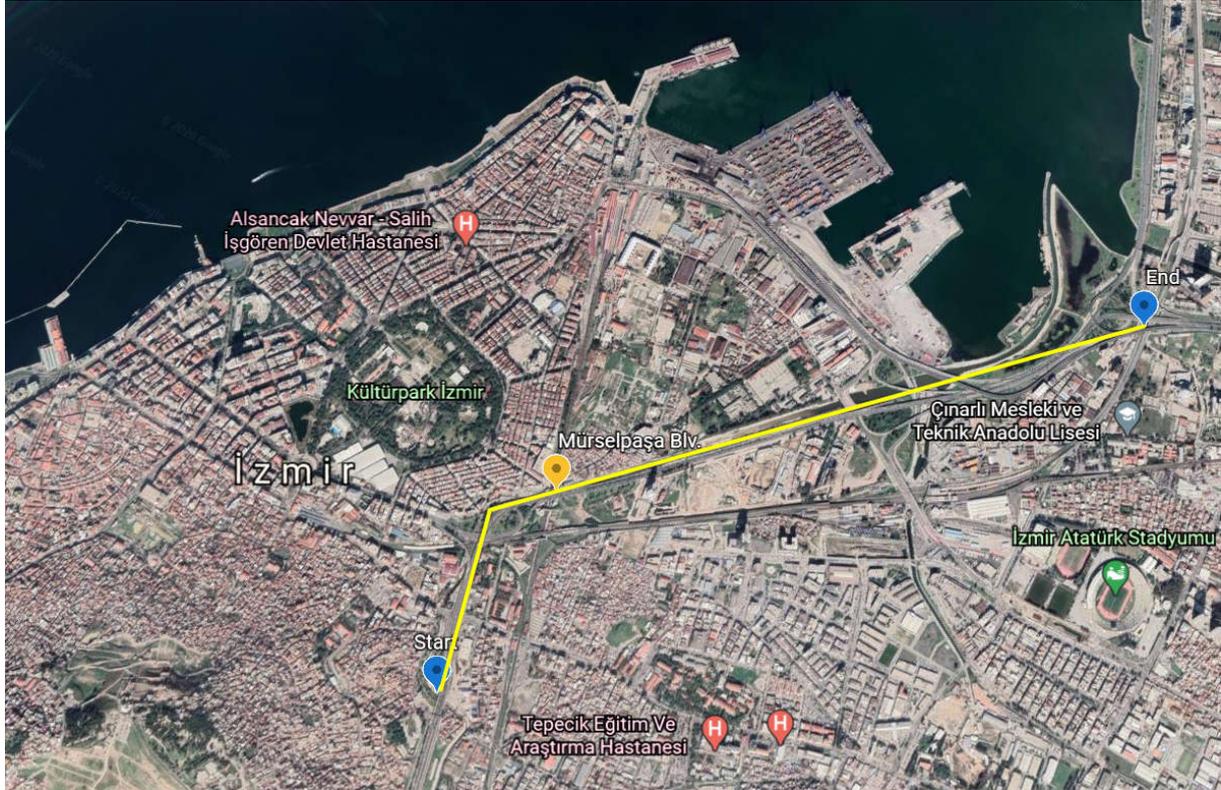
Fig 6.15 Inspected line

As is known, the bridges are approximately 70 km from the earthquake epicenter. No permanent movement has been observed in the superstructure beams and supports. The bending or shear capacity of the bridge columns and foundations has not been exceeded and no cracks have occurred due to the recent earthquake. There was no settlement on the foundation over soft soil. No movement was observed at the bridge expansion joints. No loss of function such as rupture or fracture has been observed in non-structural bridge elements (precast panels, pedestrian railings, lighting poles, etc.). The earthquake performances of longitudinal joints between twin bridges are adequate as expected and some small concrete pieces not more than 2-3 cm fall on the ground only at some very local zones. After the examination of the superstructure and infrastructure of the bridges, no earthquake-related damage was detected.
