March 08, 2010 Başyurt-Karakoçan (Elazığ) Earthquake

Supplementary Report

March 25, 2010

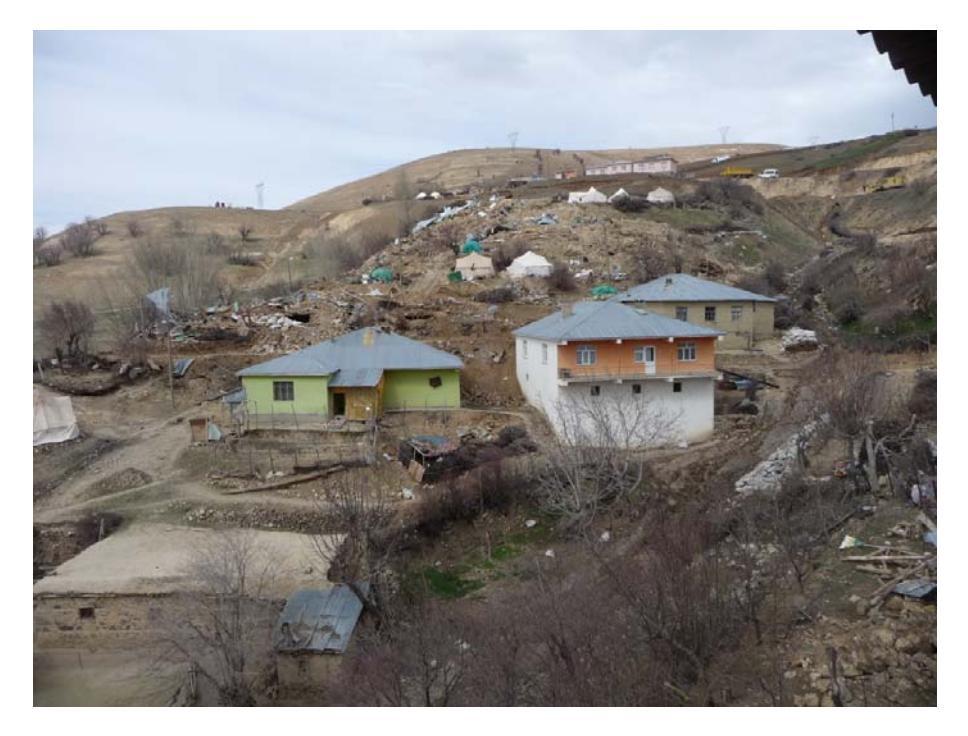
Figure 19. An overview of Okçular village

that were not occupied collapsed completely, which most probably avoided additional deaths and injuries. An overview of the village is shown in Figure 19.
